## **Dam Safety: The Question of Tailings Dams**

### **Abstract**

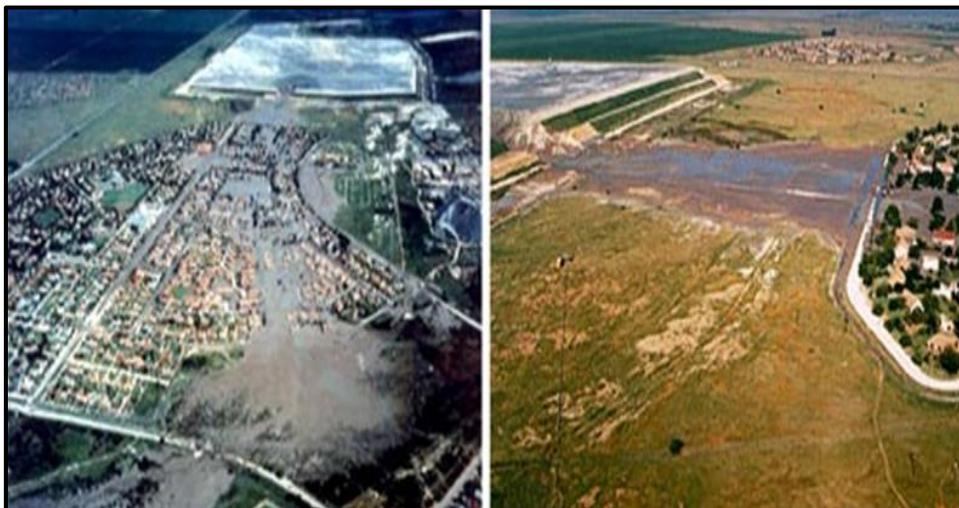
The mine was located near the town of Merriespruit. On the 22<sup>nd</sup> February 1994, the Merriespruit Tailings Dam failed by overtopping as a consequence of heavy rains causing static liquefaction and flow slide of part of the embankment once enough toe material was eroded away. Water mismanagement was to blame, which caused 600,000  $\text{m}^3$  of tailings to mobilize out of the impoundment where the flow eventually stopped 2 km away in the town of Merriespruit drowning 17 people, and scores of houses were demolished. Figure 7 shows the extent of the damage to the town and the scale of the breached embankment.

**Figure 7: Merriespruit tailings engulf the town.**

The failure could have been prevented if a suitable operating manual, and emergency plan had existed and been implemented successfully. The operation of the facility leading up to the major failure was outside the designed operating procedures. The facility was closed as a result of earlier embankment slips but still process water and tailings were being discharged to the impoundment. This suggests that an emergency plan was not in place to implement intervention actions, or it could have been that documented procedures were overridden by an individual making an executive decision. Whichever the case may have been, the lack of understanding of the operational procedures and the seriousness of the events prior to the main failure had not been realized. Moreover, if a well-structured and executed operational plan had existed, then the tailings operator(s) would have known to intervene, continually monitor the closed impoundment for change and prevent further discharge to the facility.

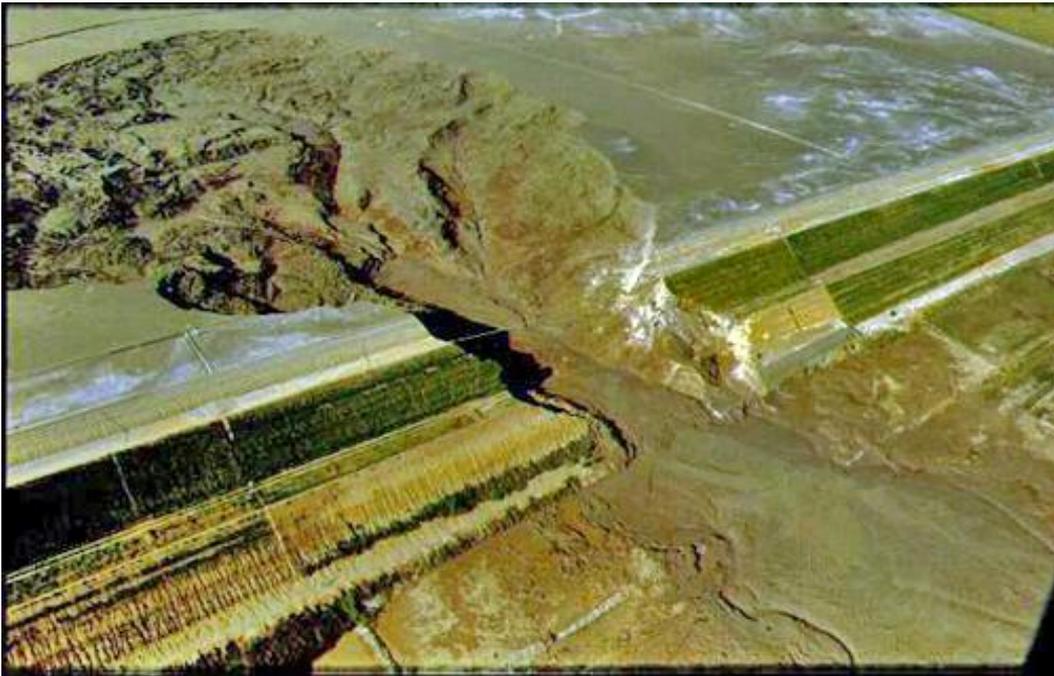
The 31 m high embankments had problems prior to the major failure. Small slips caused the impoundment to close temporarily, and only mine water with small amounts of tailings were deposited. The deposition of these tailings caused the floating material (supernatant pond) to move to the opposite side of the impoundment away from the decant system rendering it inoperable. A satellite recorded the transition stages of the decant pond relocation as more tailings were deposited with the mine water. Heavy rains that fell on the day of the failure (30-55 mm in 30 minutes), combined with no possibility of emptying due to the idle decant system, caused the overtopping. The failure event is illustrated in Figure 8. A close up of the breach is shown in Figure 9.

**Figure 8: Aerial of the Merriespruit failure.**

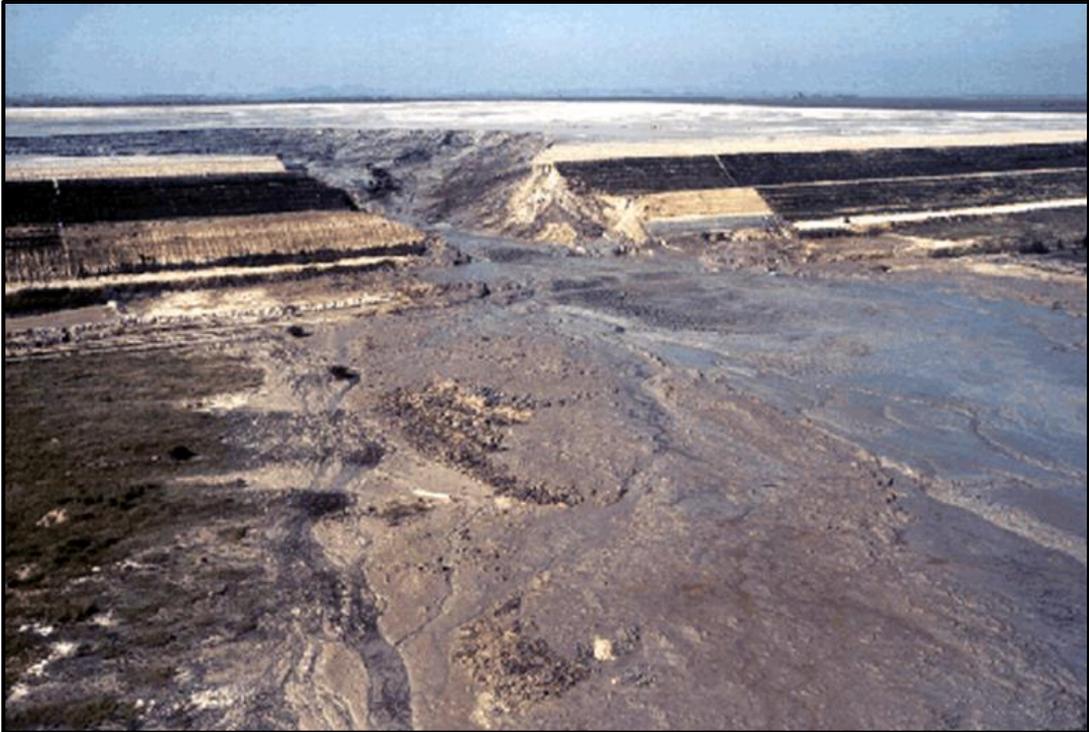
**Figure 9: Close-up of the embankment breach.**
