Dam Safety: Sediments and Debris Problems

Abstract

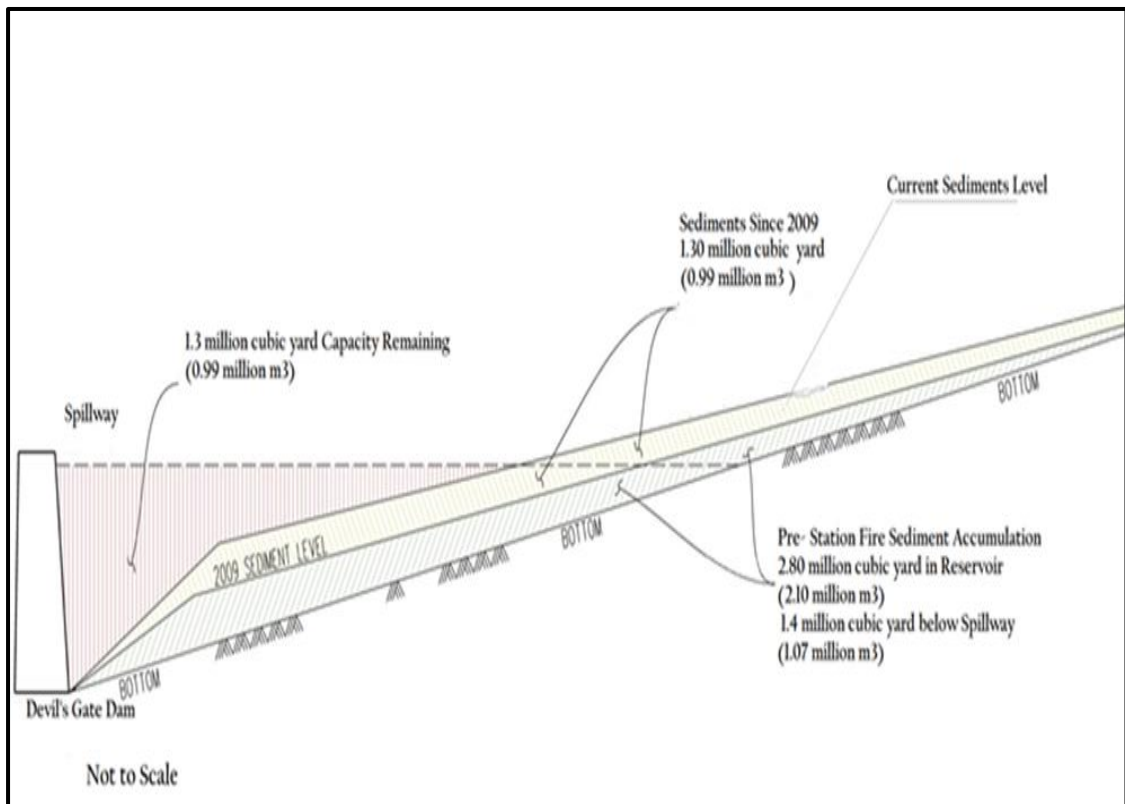
Following the devastating 2009 Station Fires in California, denudation of over 160,000 acres (64,800 ha) of forests had left vast areas of the catchment in San Gabriel Mountains denuded and susceptible to sediment erosion. During the 2009-2010 storm season 1,000,000 cubic yard (765,000m³) of sediments and debris were deposited into Devil's Gate Reservoir. For comparison; that one-year volume was ten times the total amount deposited in the reservoir during the previous sixteen years. The sudden sediment accumulation buried one of the dam's outlet gates and threatened to block the other outlets and spillway ports. Additionally, sediments

reduced the reservoir’s volume, and it no longer had a capacity to safely contain another major flood and debris event. Figure 1 shows Devi’s Gate Reservoir Sediment History Profile after 2009 Station Fires storms [7]. In Figure 2, the diagram shows past accumulation of sediment and the remaining free capacity in 2011 cross section of the dam showing sluice gate, outlet valve and sediments accumulation in 2011 [7].

Figure 1: Devi’s Gate Reservoir Sediment History Profile after 2009 Station - Fires storms [7].

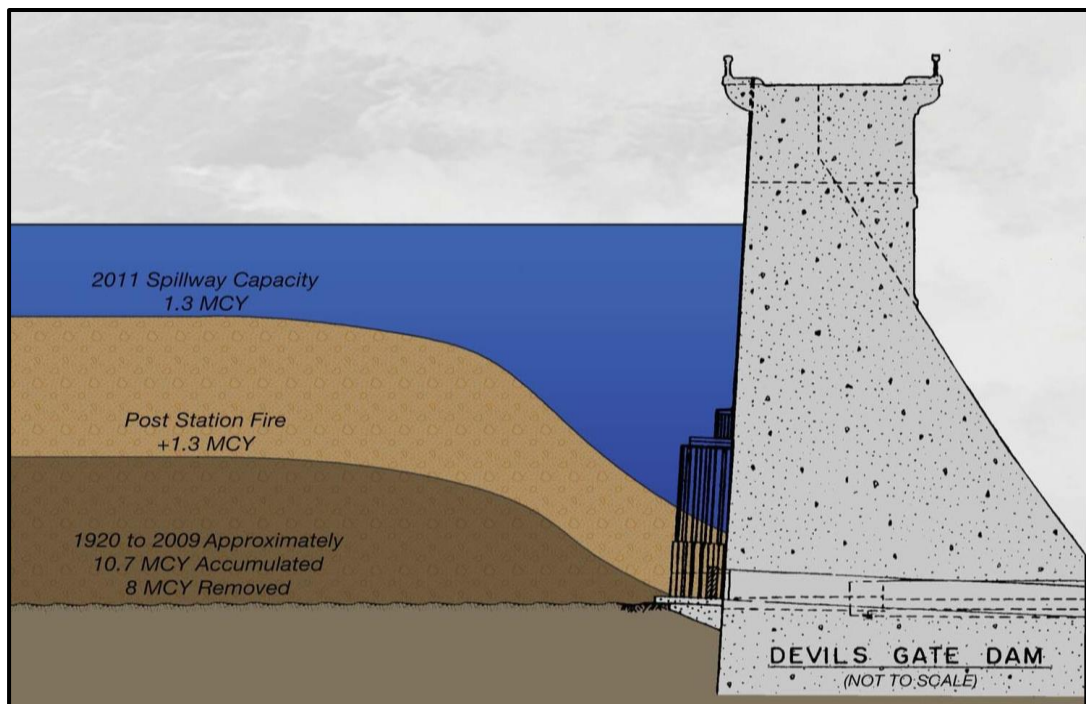
Figure 2: Devil's Gate Dam Cross Section showing accumulated sediments [7].

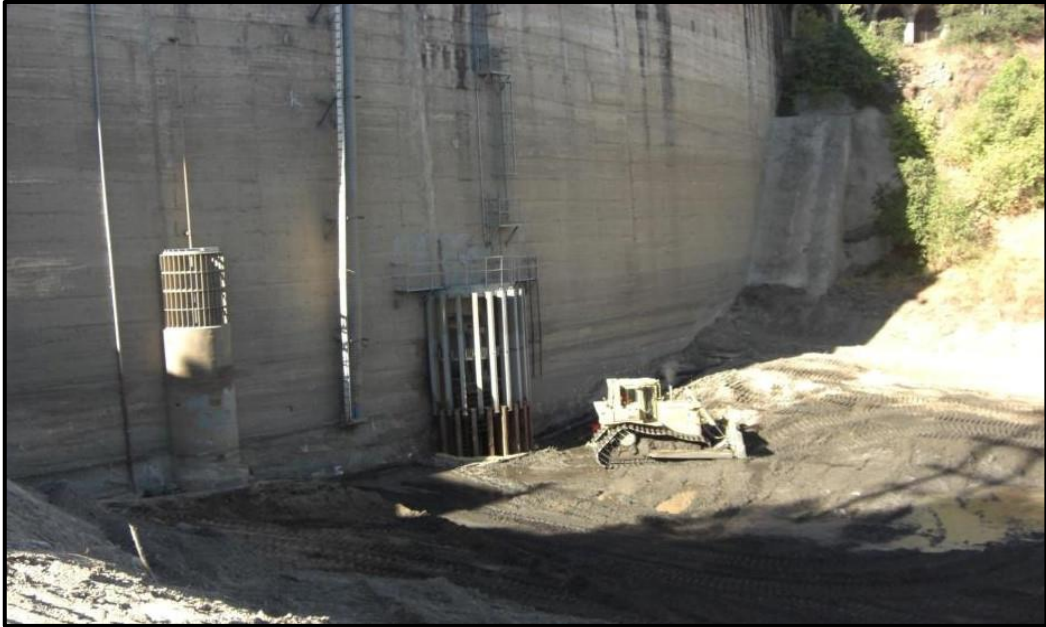
**Figure 3: Intake Structure cleared pre- Station Fires of 2009
(Photograph dated on 8th June 2009 October 2010) [6].**

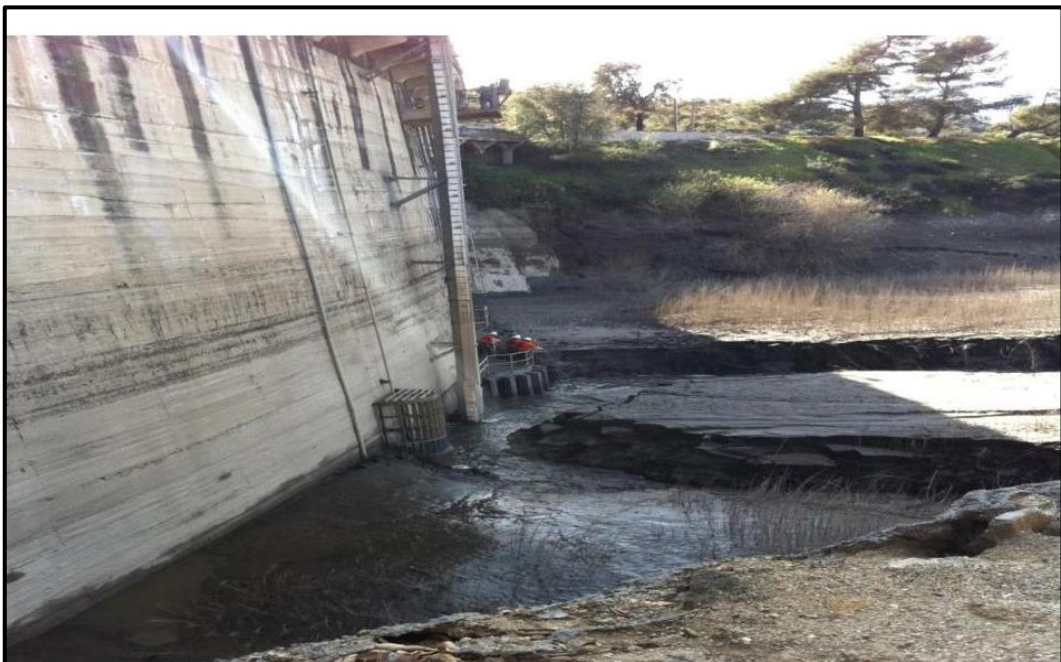
**Figure 4: Sediments Threatening Sluice Gate Post- Station Fires of 2009
(Photograph dated on 3rd October 2010) [6].**

In a temporary measure to minimize the anticipated impacts until the sediment would be removed, a Risk Reduction Plan was developed that included an interim operating plan, physical dam modifications, and a Flood Hazard Warning and Contingency Plan. These measures were estimated to cost a \$960,000 capital outlay as well as an annual maintenance expenditure of up to \$1,250,000 depending on the severity of each of following storm seasons.

The Interim Measures Project included minor dam modifications to help keep debris from plugging the outlet works and allow for removal of up to 25,000 cubic yard (19,000 m³) of sediment per year from the dam face until the project associated with a proposed Environmental Impact Report (EIR) and plan would be started. In 2011, 13,000 cubic yard (9,940 m³) were removed from the dam face. In 2012, approximately 1,525 cubic yard (1,166 m³) of sediment and 419 cubic yard (320 m³) of green waste were removed from the dam face and hauled to Johnson Field and Scholl Canyon Landfill, respectively. In 2013, 1,200 cubic yard (900 m³) of sediment and 12 to 14 loads of green waste were removed from the dam face and hauled to same landfill. These interim risk reduction measures were to be implemented until the sediment would be removed from the reservoir following the completion and approval of the Environmental Impact Report (EIR). Photographs showing sediments removal operation during 2009 – 2011 are presented in Figures 3,4, and 5.

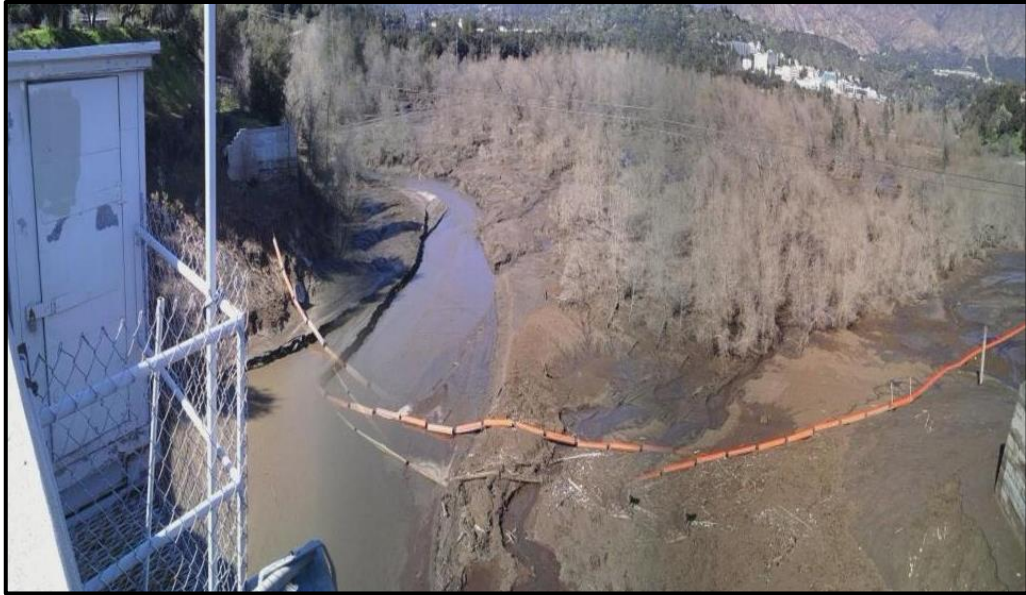
Figure 5: Upstream view of the Reservoir upstream of the dam (Photograph is dated 2nd February 2010) [6].

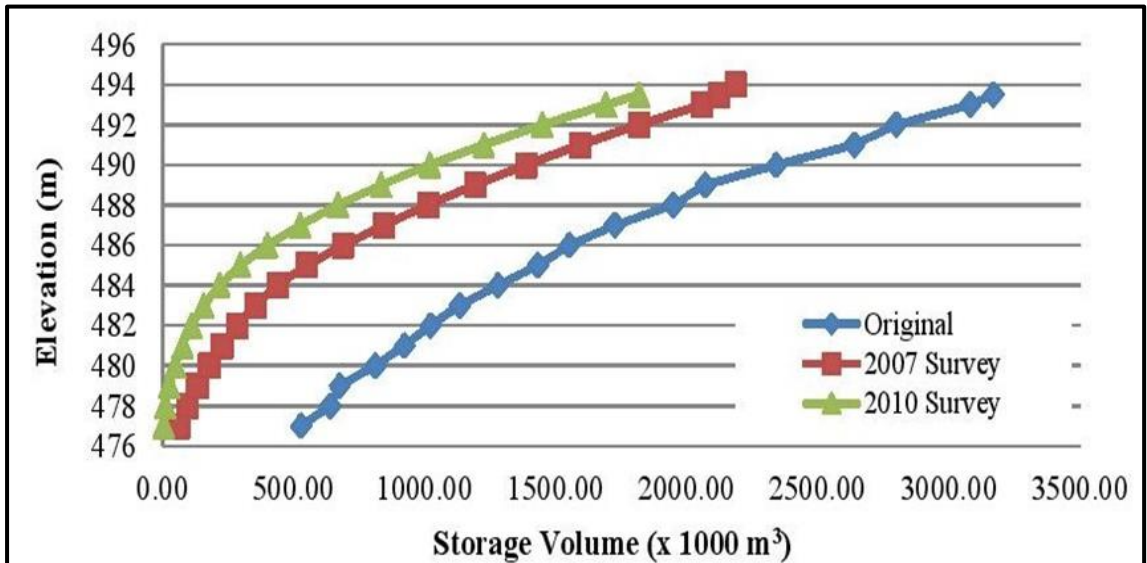
Figure 6: Elevation Storage Curve for Jor Reservoir Showing Continued Loss of Storage.

The curves in Figure 6 show that Jor reservoir has lost almost half its storage capacity due to sedimentation between 1968 and 2010. The data analyzed in the study was used to develop a revised Elevation-Storage Curve which is crucial for dam operators to plan for the future power generation and flood control.

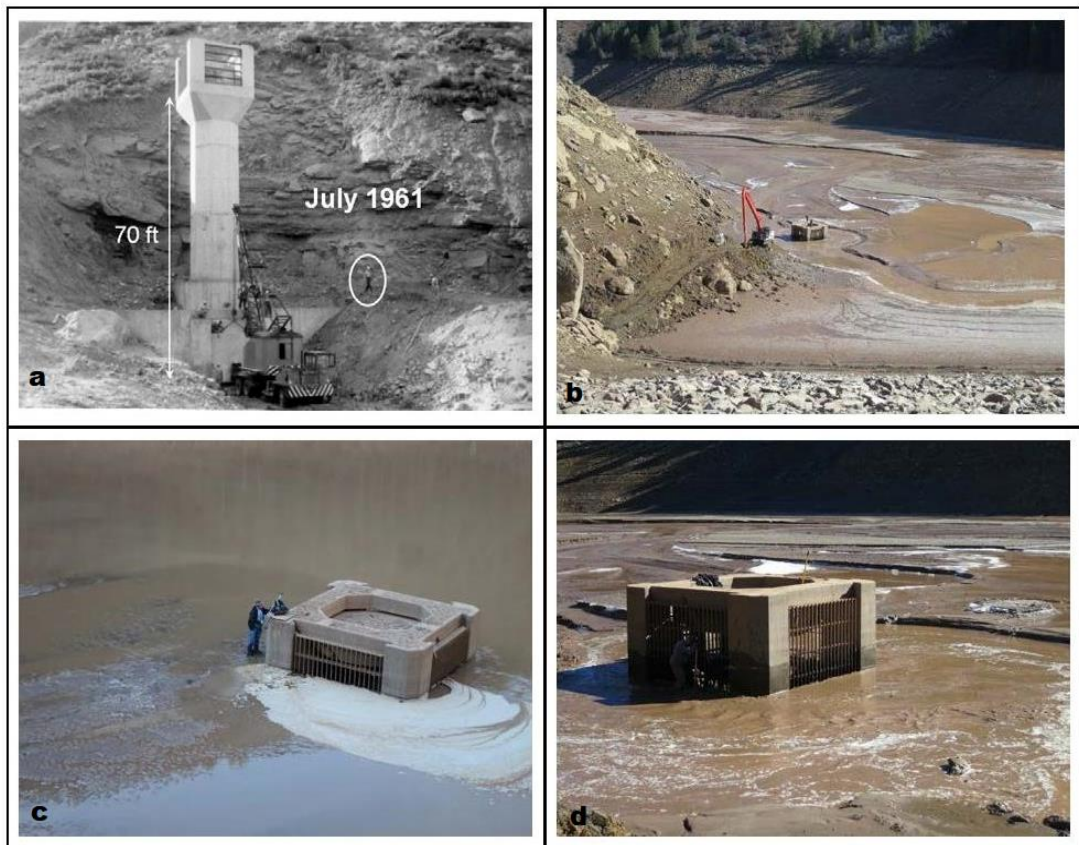
of the problem at the reservoir had been building up since the dam was finished in 1962. Year by year, sediment quietly collected on the reservoir bottom, gradually raising its floor. Once the sediment was level with the dam outlet, where water is released downstream, any debris that washed into the reservoir threatened to clog the opening and make the dam inoperable. In the fall of 2014, personnel worked 10-hour days for two weeks to clear logs, branches and dirt from the outlet by hand and with an excavator. Some of the workers stood directly on waterlogged sand, digging out the grates with pitchforks. When the dam was newly built, they would've needed a crane 70 feet tall to reach the same spot, Figure 10 [16, 17].

Figure 10: Paonia Dam, a) Intake structure in July 1961, b) During 2014 a long reach excavator was used to clear wood and sediments, c) and d) Sediments level 3 ft higher than inlet bottom sill level.

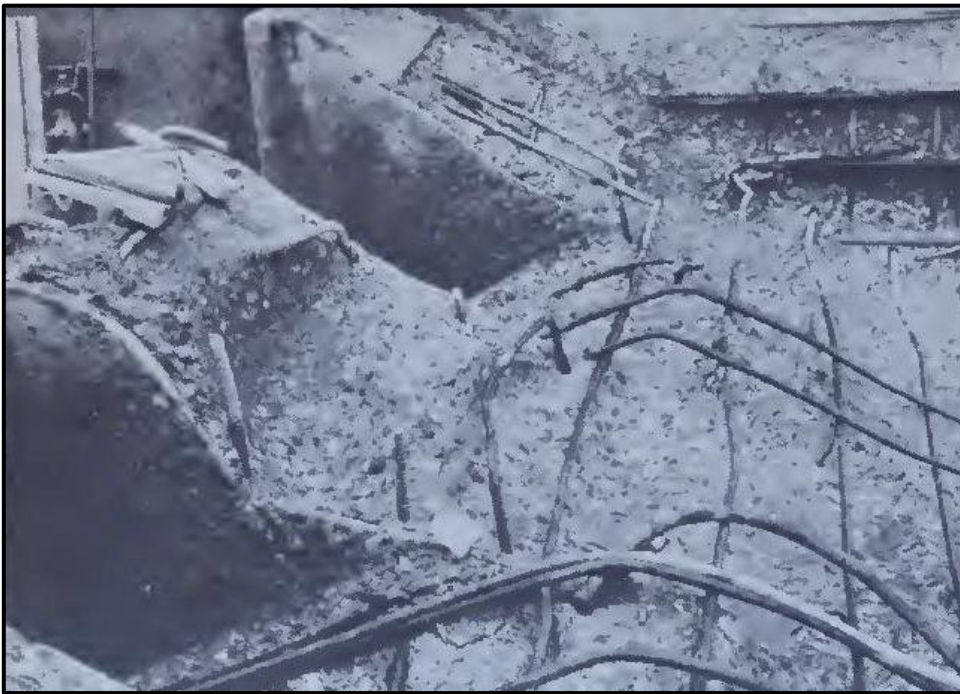
Figure 11: Abrasion erosion on concrete in the dentates, walls, and floors of the Yellowtail Afterbay Dam Sluiceway stilling basin. The “ball mill” action of cobbles, gravels, and sand in turbulent water abraded the concrete, thus destroying the integrity of the structure.

Characteristics of this type of erosion are the badly worn reinforcing steel and aggregate as shown int in this figure. In Figure 12, the abrasion effects of coarse sand particles on the spillway at the Milburn Diversion Dam near Sargent, Nebraska are clearly shown, and Figure 13 is a close up photograph of this abrasion [18] and [19].

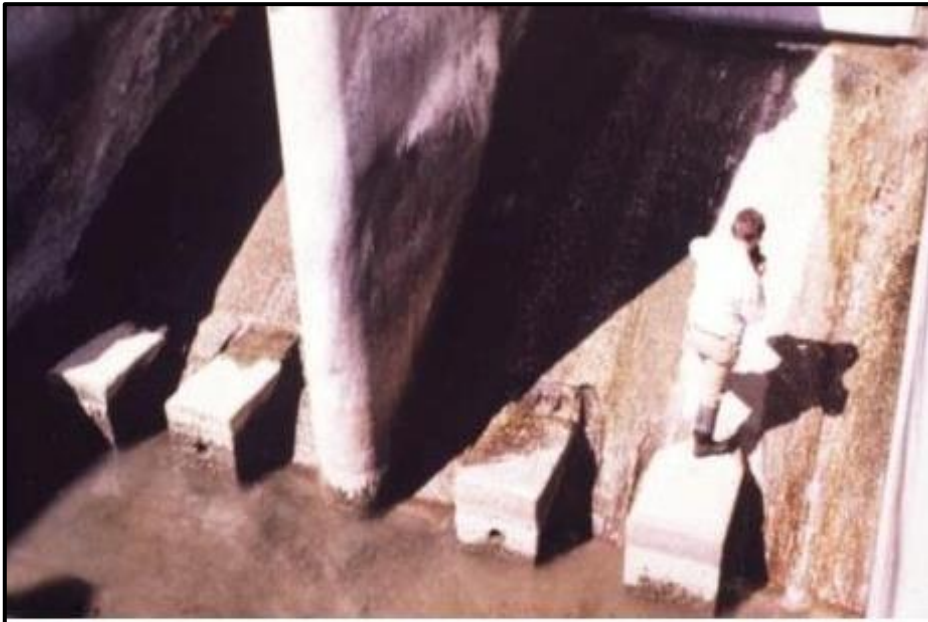
Figure 12: Sand has abraded the spillway at the Milburn Diversion Dam near Sargent, Nebraska [18].

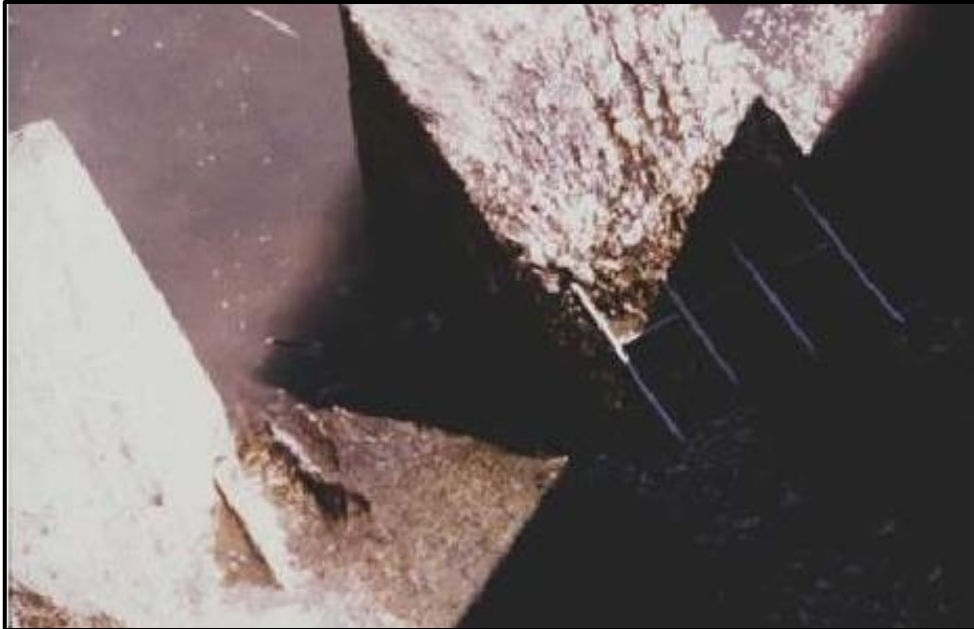
Figure 13: Close up photograph of sand abrasion of the Milburn Diversion Dam Spillway near Sargent, Nebraska [19].

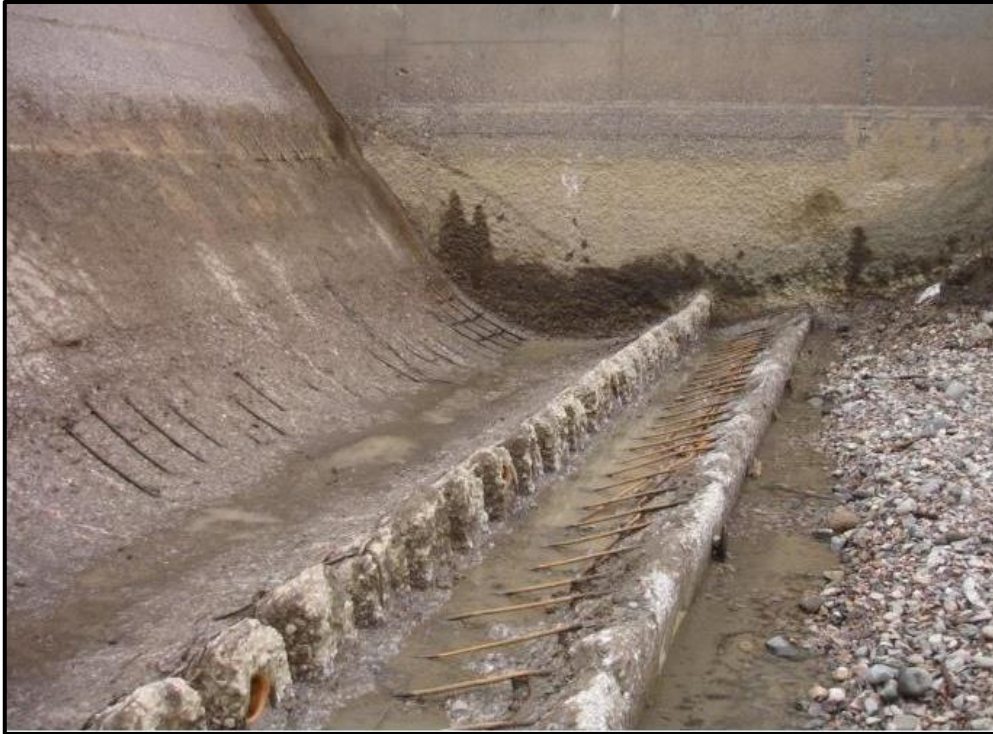
Figure 14: Abrasion erosion damage to the flip bucket and energy dissipaters.

The underlying cause of the damage was not determined prior to starting repairs. Many others such as abrasive impacts are reported in an article by the authors titled “Dams Safety and problems in Aging Dams” (in the print).

In many cases major repairs or rehabilitation is required. One example of such work was the repair of abrasion erosion damage to a spillway water diversion structure shown in Figure 14. After surveying the extent of damage, it was ascertained that the cause of damage to be abrasion erosion and, after cleaning, it became apparent that the damage was much more widespread and more serious than originally thought. In this particular case, concrete was easily removed to a significant depth over most of the spillway. Thorough investigation was conducted by obtaining and examining concrete cores from several areas, and it was only possible then to determine the best treatment program [20].

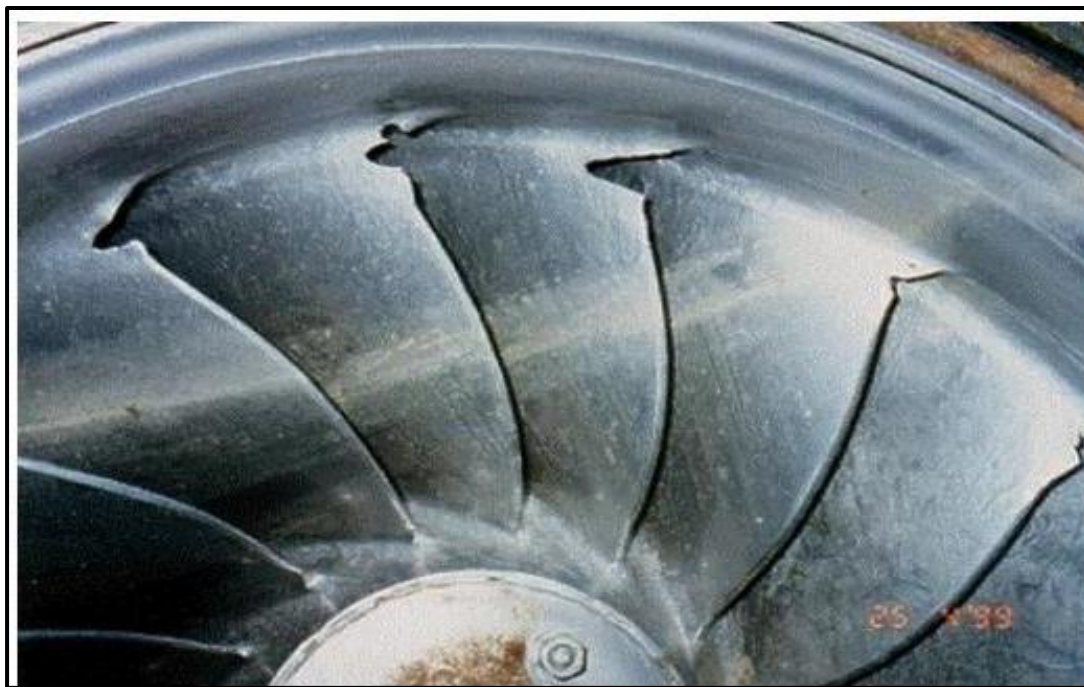
The Khimti hydropower project in Nepal represents a typical high head power plant in the Himalayan River that is affected by sediments [21]. In Figure 15, a photograph is showing sedimentation abrasion on the turbine runners of the high head power plant; the Jhimruk hydropower plant in Nepal also [22].

Figure 15: Sedimentation abrasion of the turbine runners at the Jhimruk hydropower plant, Nepal [22].
