Hill slope housing development in Vinikilang, Yola, Nigeria: A geo-disaster risk

Nsikak E. Bassey¹, Abubakar S. Ahmed² and J.M. Ishaku³

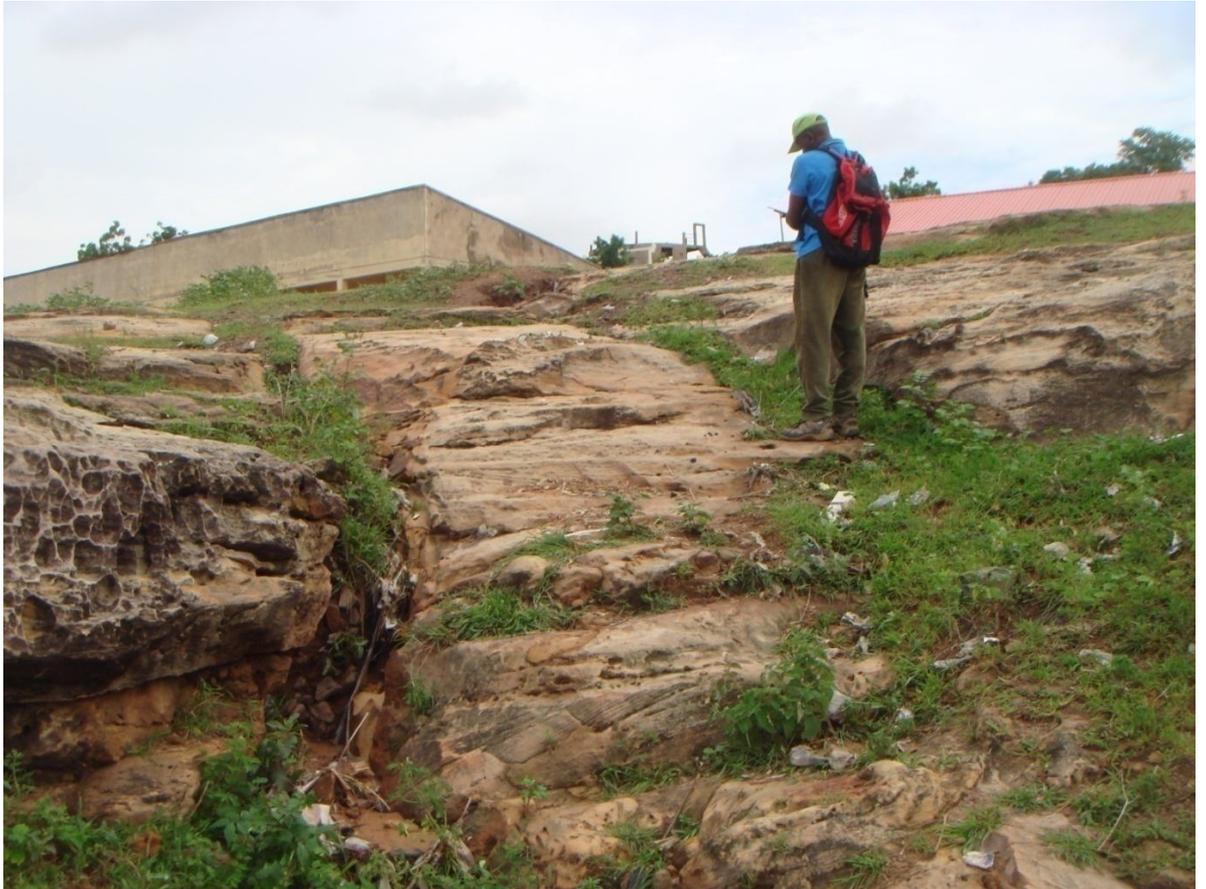
Photograph 1: Part of a heavily fractured slope in study area, buildings at background are part of a school compound.

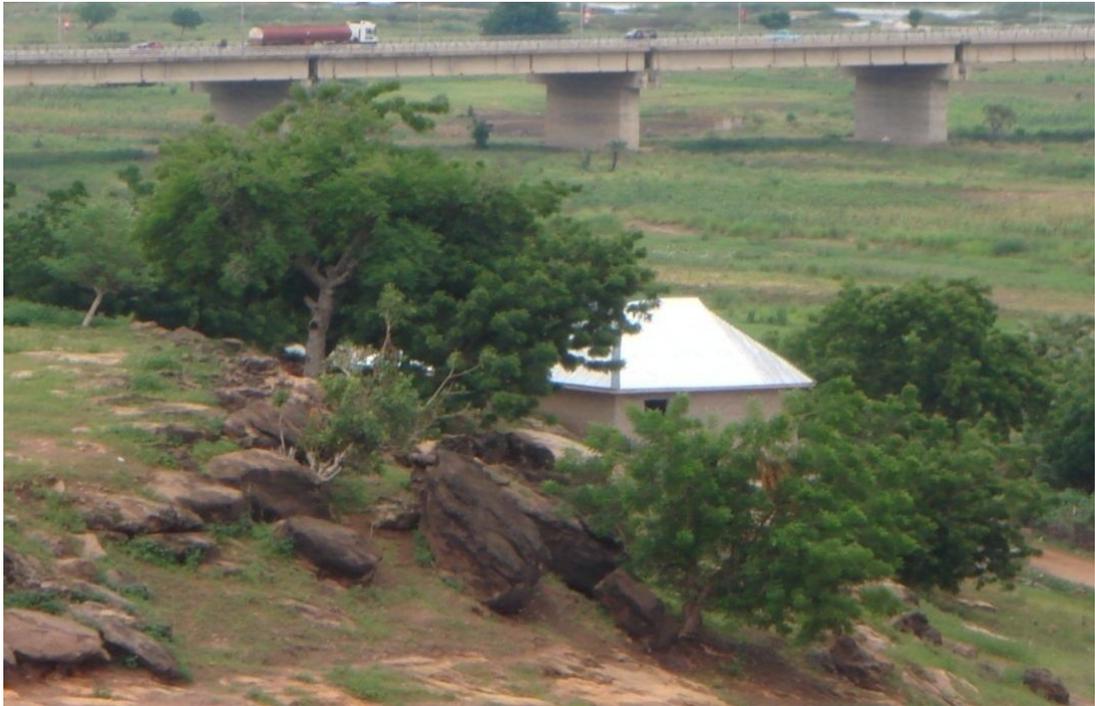
Photograph 2: Boulders sliding down slope due to soil creep placing the building shown at risk. At background is Jimeta bridge over the Benue, the bridge spans 1.4 km.

The study area is part of an evolving tectonic slope. Evidence for this are the numerous boulders that litter the base of the hills possibly due to rock fall, while some are in sliding positions on the hills (Photograph 2).

The following recommendations are made and their implementation should be effected without delay. The land use authorities (Ministry of environment) should put a stop to further construction of houses in the area. Occupants of buildings near overhanging boulders should be made to relocate to safer grounds. Operations of heavy vibrating machines on the hills should not be allowed. The best solution to a threatening geo-disaster is to evacuate or relocate the citizens. This is strongly suggested. Geodetic monitoring scheme should be set up without delay and sustained to study and advise on soil creep and slope movements in the area. The Survey and Informatics dept of Modibbo Adama University of Technology can be consulted to undertake this. These recommendations are important considering the calamities that may result in the event of mass wasting.

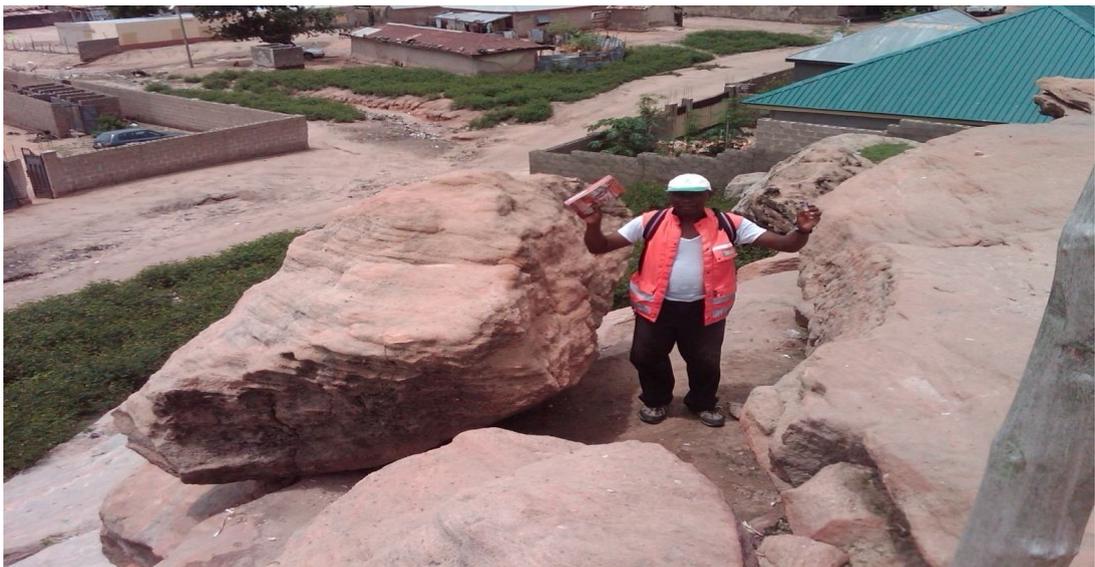
Photograph 3: Displaced boulders on hill slope puts buildings at the background at risk.

Any moderate slope experiences soil creep (Potter and Robinson, 1975). This is observed in Vinikilang and environs. The topographic height difference between the River Benue valley floor (under the Jimeta Bridge) and some of the highest built up areas is 48 and 61m respectively. Hence soil creep is an on-going mass wasting process in the area. This is evident from features observed at some locations during the study (Photograph 2). Some boulders are found at heights or positions that appear unstable; this puts some buildings at risk (Photograph 3).

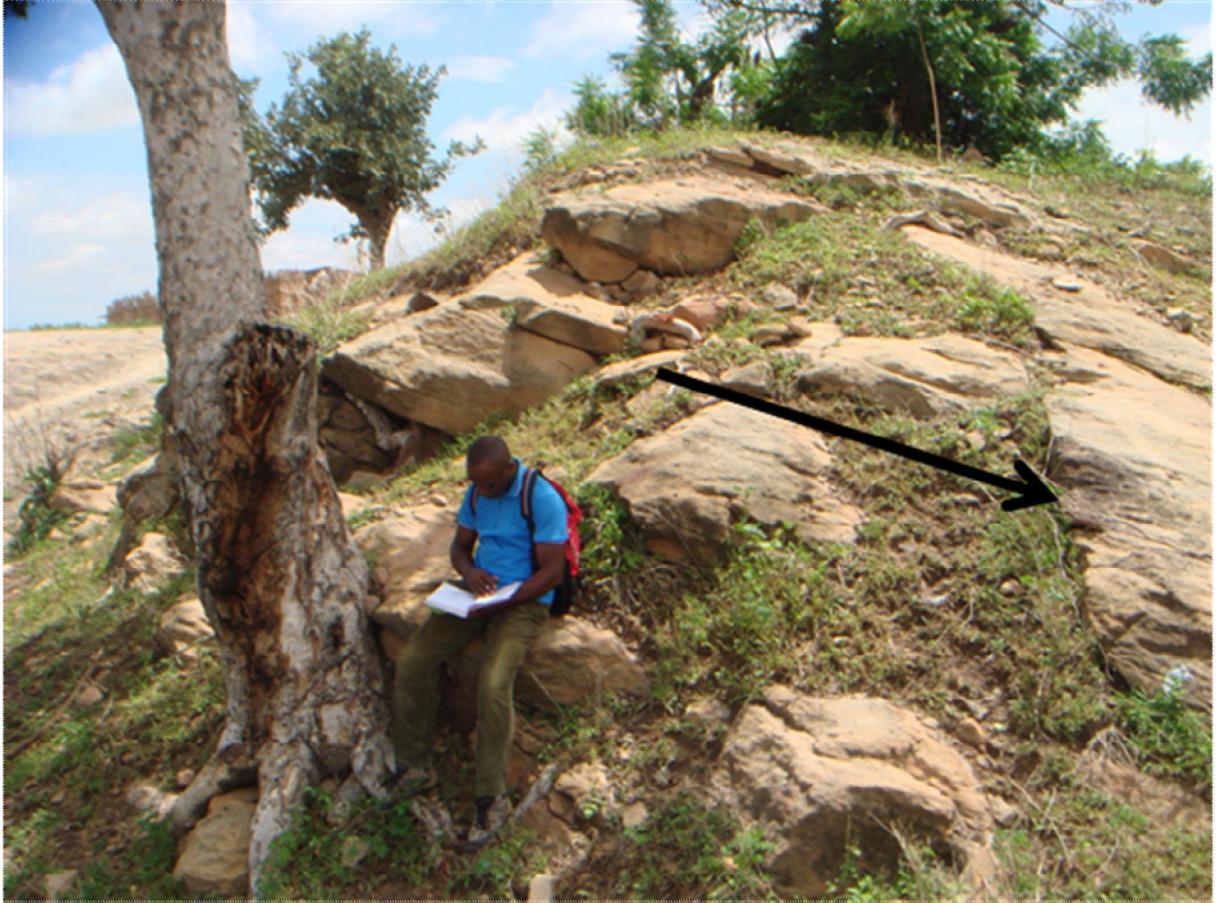
Location: N 09 18.521', E 012 29.387'.

Photograph 4: Dipping strata of Bima Sandstone in study area (arrow shows direction of dip), magnitude of dip is 12° NW, strike is $N68^\circ$.

Dipping surfaces such as shown serve as avenue for soil creep, and potential slide surfaces.

The stratification exhibited by the Bima sandstone make the rocks liable to mass wasting. This is because the stratum planes (bedding planes) are potential slip planes in the event of mass movement, especially where the strata are dipping (Photograph 4). By implication, houses in the study area are built on a heavily fractured and sloppy terrain. This can affect the foundation and walls with time. Photograph 5 shows the wall of a building constructed over a 50° trending fault zones. The fault has initiated a crack (indicated by broken line) on the wall. The

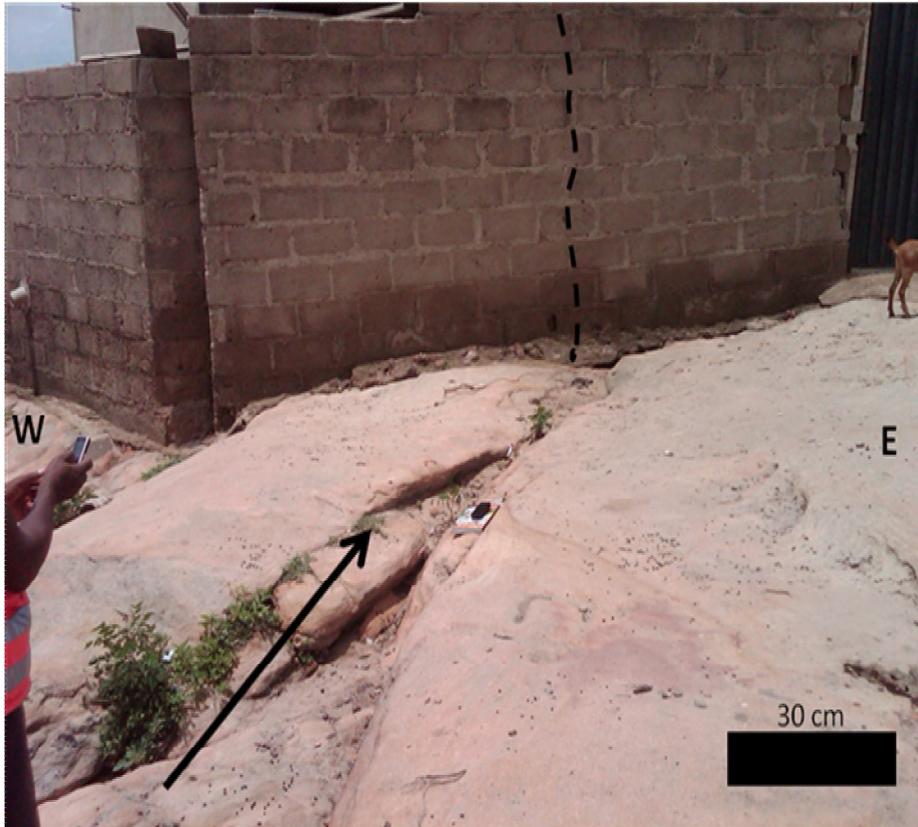
location of this structure is at N 09 18.300' and E 012 29.227'.

Photograph 5: Wall of building constructed over a fault zone. The wall has cracked at position indicated by broken line over fault trend. Fault trend is N50°E.

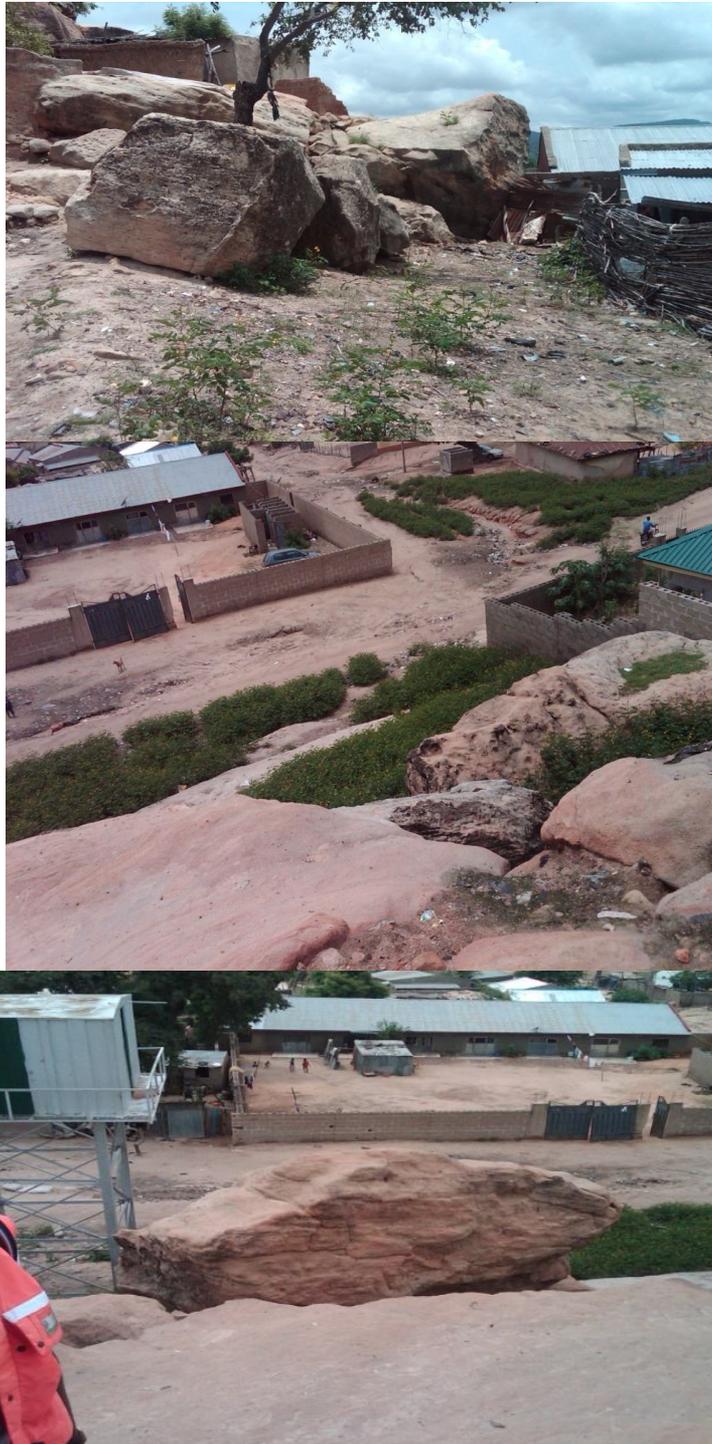
Plate 6: Composite scenes of some hill slope houses in Vinikilang.

Building construction in the study area constitutes a load on an already heavily fractured and unstable rocky slope. This increases the stresses on the rocks and can initiate slope failure at any time. Photograph 6 is composite scenery of buildings on the fractured slopes in the area.
