Mystery of Mosul Dam the most Dangerous Dam in the World: Foundation Treatment during Construction

Nasrat Adamo¹, Nadhir Al-Ansari², Issa E. Issa³, Varoujan Sissakian⁴ and Sven Knutsson⁵

Abstract

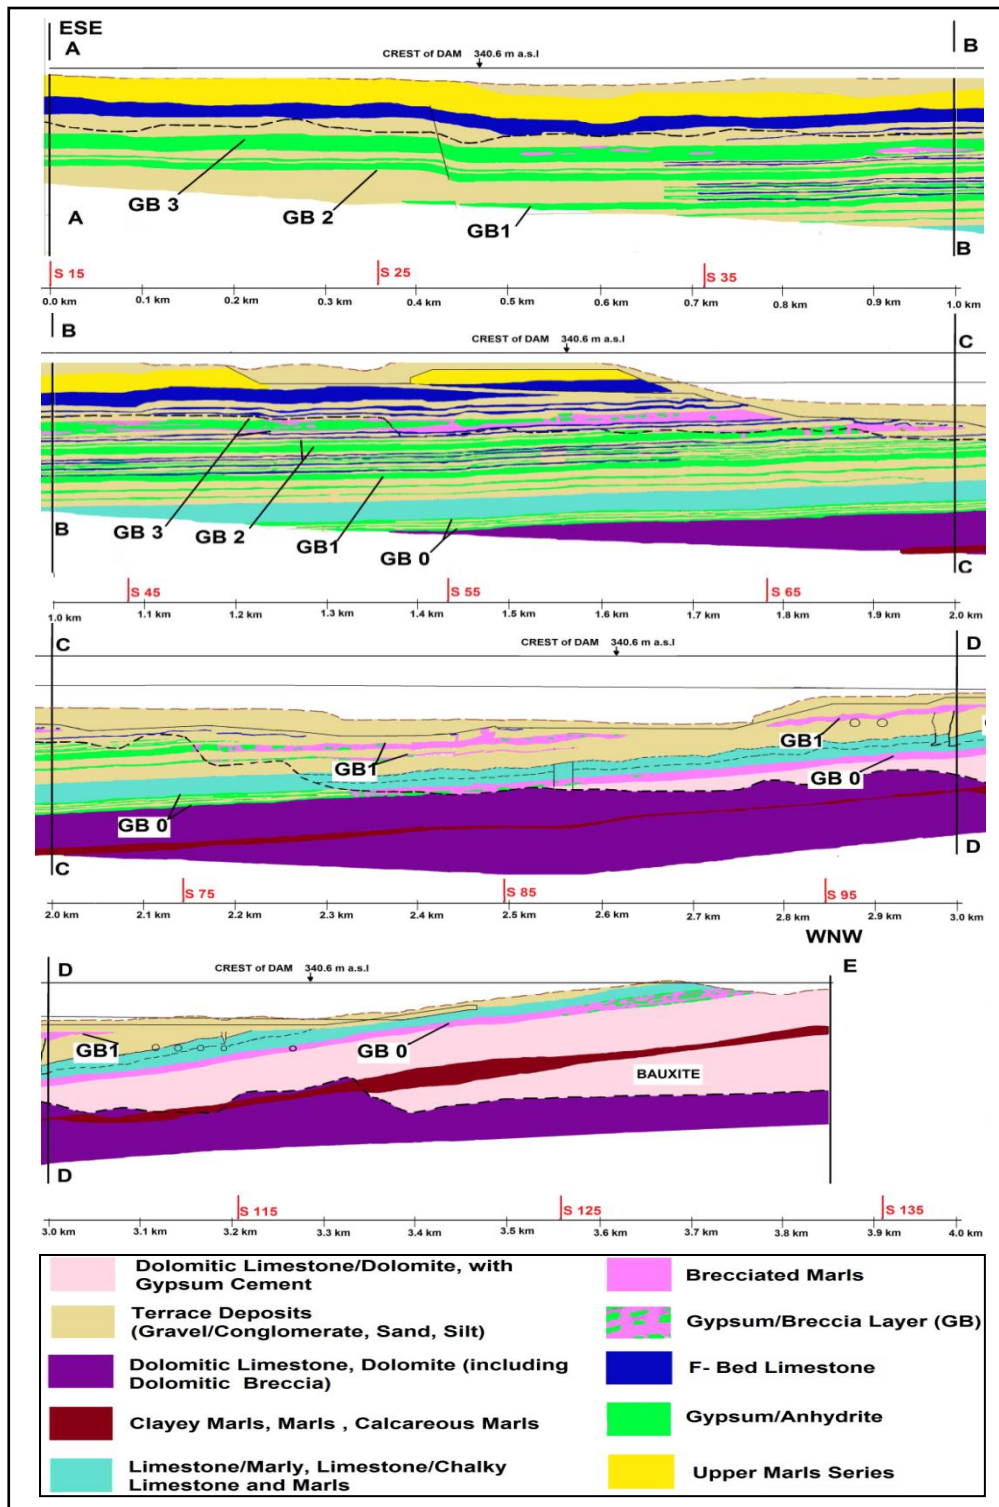
exploratory holes before starting grouting operation to find out later the efficiency of completed work. High permeability zones were found with average values of 28.7 Lu on the right bank from Sec. 87 to Sec. 113 and on left bank an average value of 54.5 Lu from Sec. 64 to Sec. 86 (Fig. 1).

Figure 1: Geologic cross section along the axis of the dam.
