# Mosul Dam the Full Story: Engineering Problems

Nasrat Adamo<sup>1</sup> and Nadhir Al-Ansari<sup>2</sup>

## Abstract

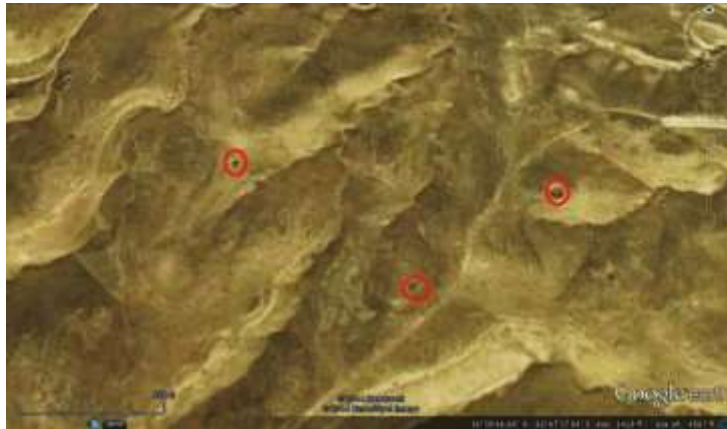
Figure 8: Enlarged Google Earth image showing many sinkholes (Dark spots encircled by red color) in the upstream area of the dam site [3] [4] [5] [6]

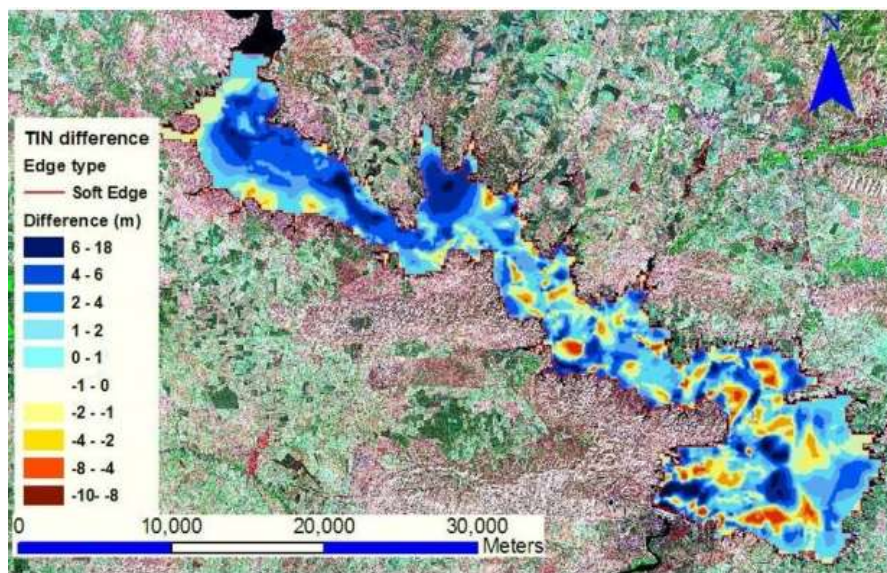
The sinkholes in the reservoir itself shown in figure (9) were mapped by a recent bathymetric survey which was carried out in 2011 by a Luleå university PhD student [2]. It is considered here that the development of such sinkholes will open new connections with the groundwater aquifer running below and around the dam site causing more problems of dissolution and formation of new sinkholes. The dam foundations itself is very complicated and the combination of gypsum/anhydrite layers with the cavernous limestone give rise to very favorable conditions for seepage and dissolution environment. Figure (10) gives a representative picture of this condition.

Figure 9: Sinkholes present in the Reservoir [2]

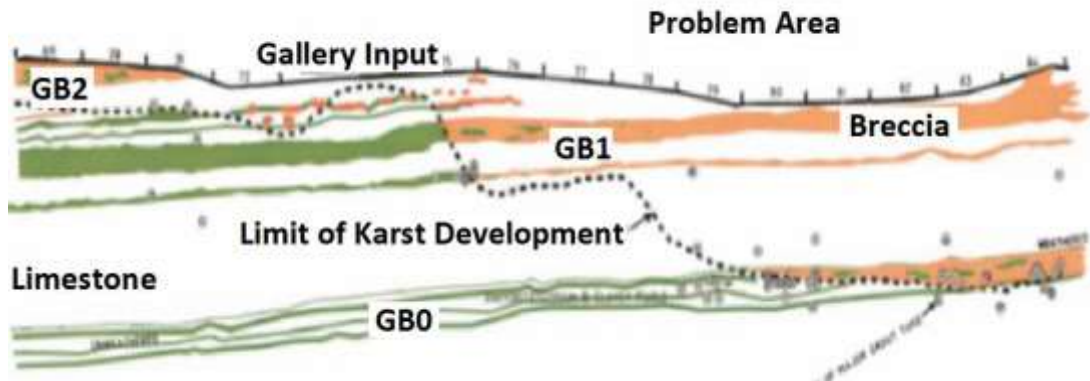
In figure (13) the dotted line is the estimated karsts line in sections 69-87 which is the problem area as visualized by the designers. This hypothetical karsts

line was estimated from the in situ permeability tests results in the boreholes drilled along the axis of the dam during the investigation. The dark dots on and above and on this karsts line indicate some of the areas of major grout take. Below this line according to these tests and designer's judgment karsts diminishes considerably and cease to exist. These results were used as the defining criterion for fixing the depth of the grout curtain. The design went further to add another 20 meters to this depth for ensuring the cutting out of any seepage path that might have been missed in these permeability testing.

Figure 13: Estimated karsts line in the problem area (sections 69-87). The dark dots show locations of some of the major grout take areas [7].

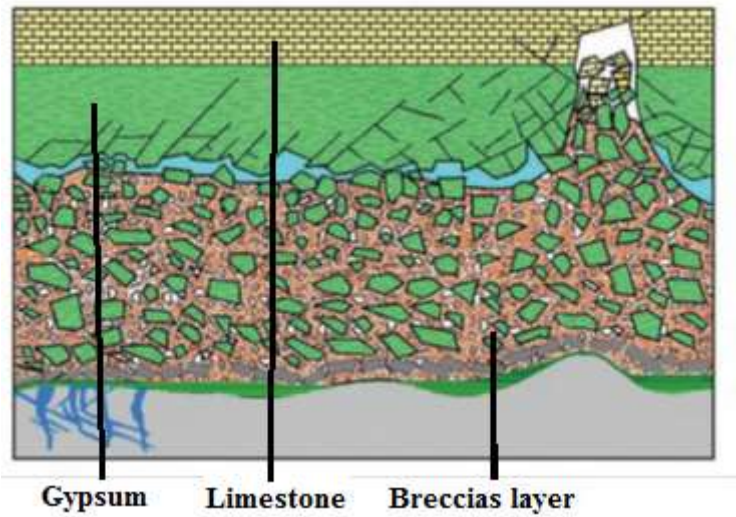
In Figure (14) the schematic diagram shown explains the process of the gypsum/breccias layer formation. Groundwater flowing through cavernous limestone and gypsum beds had resulted in the development of larger cavities in these limestone and gypsum beds, causing the collapsing in of gypsum, limestone and clayey marls filling these cavities and so forming a complex structure mainly of clayey material of very fine particles in which gypsum bits and particles and anhydrites blocks and even limestone flakes are embedded. These breccias layers due to their structure did not accept normal cement grouts or chemical grouts and many areas in the grout curtain within these layers could not be sealed and even

opened again under increased hydrostatic pressure which caused piping of the fine particles.

Figure 14: Schematic diagram showing the formation of a breccias layer

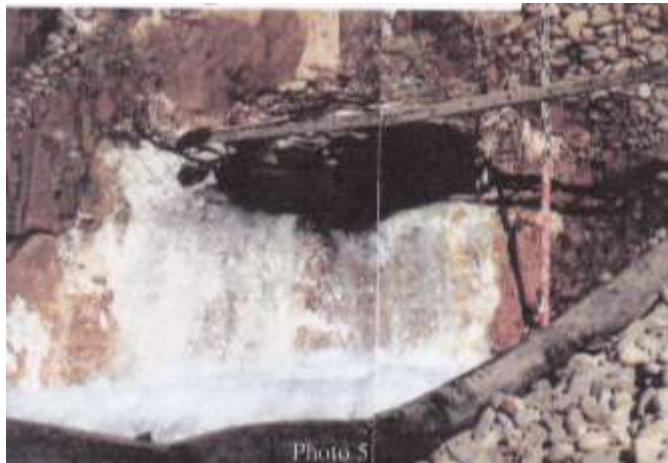
Similar seepage springs were encountered in the excavation of the tailrace tunnel and its intake structure. Grouting of these springs required extensive grouting works, and the continuation of the tunnel excavation was only possible after grouting the excavated face stage after stage. The quality of seepage water was much different from the river water quality and it contained a much higher concentration of Sulfates. Further studies showed that this water belonged to the very large Wadi Malih aquifer which is being fed from long distance upstream and which was running below and independent from the river aquifer. Figure (15) shows the water flow which was encountered during the excavation of the tunnel and which took considerable quantity of grouting until it was sealed works.

Figure 15: Flow (360 l/sec) from Underground aquifer into the intake/tailrace tunnel of the pump storage Scheme originating from Wadi Malih aquifer

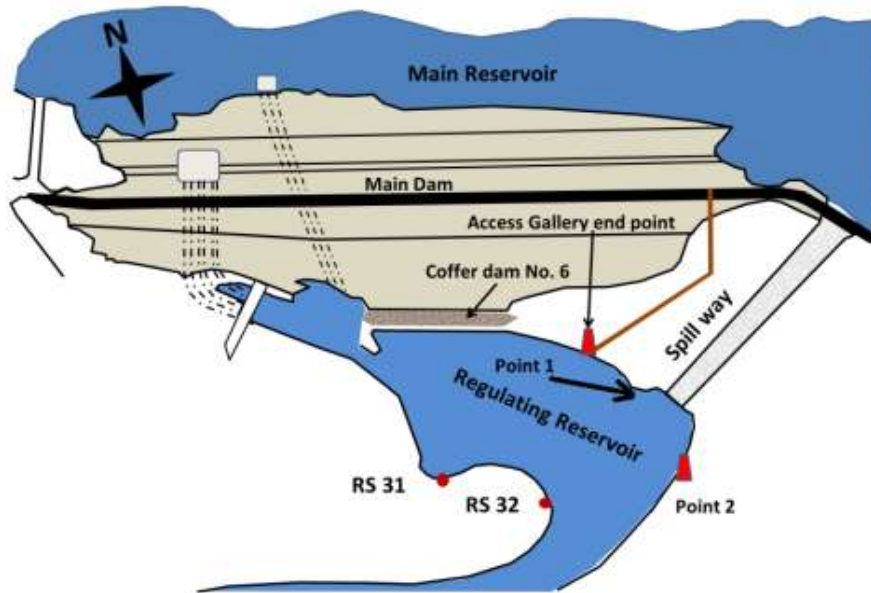
- a) Point (1), in the right side of the spillway at the end of the collection channel which collects seepage water from under the spillway that seems to originate from left side.
- b) Point (2), at left side of the spillway collects seepage water from under the dam further left and around the left side.
- c) Access Gallery end point collects seepages from under main dam from the river section to the spillway.
- d) Cofferdam no.6 measuring pond measuring seepage under the deep section of dam.

Figure 16: Seepage water Collection Points at Left Bank and cofferdam no.6  
Measuring point [18]

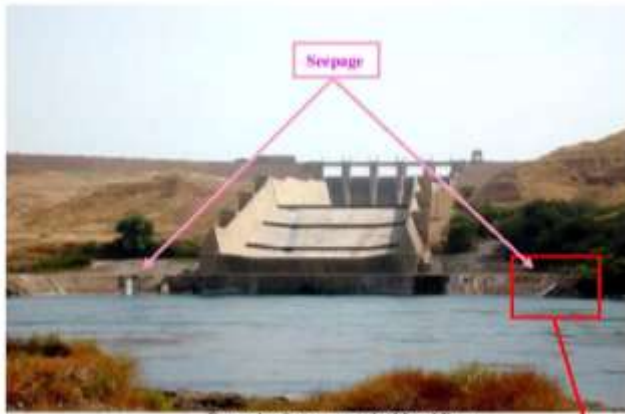
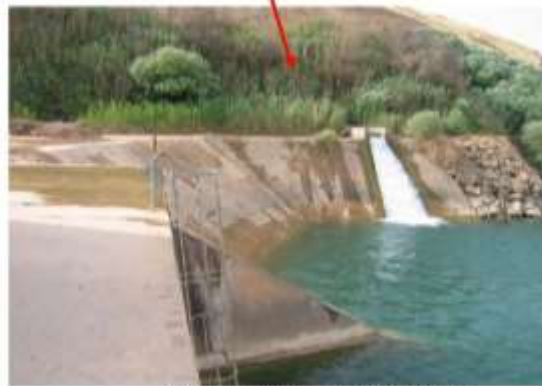
Example of seepage at the Mosul Dam

Close-up view of seepage at the Mosul Dam

Figure 17: Seepage at the left bank (courtesy USACE)

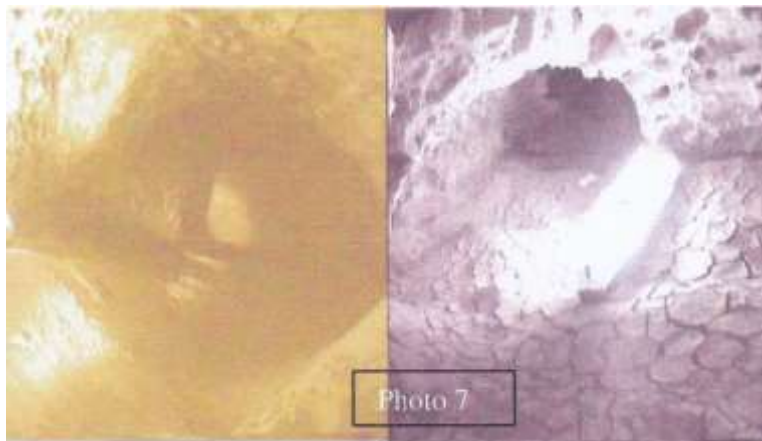
Figure 18: Large conduit found in March 2002 in the upper right rim of the reservoir

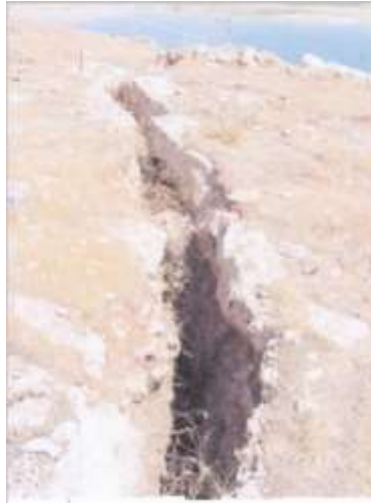
In figure (19) a ground fissure only 100m from the right abutment of the dam was also observed which was most probably caused by dissolution of gypsum layer at some depth resulting in a slide movement towards the reservoir.

Figure 19: Open fissure indicating slide slab movement at close proximity to right abutment resulting from underground dissolution.

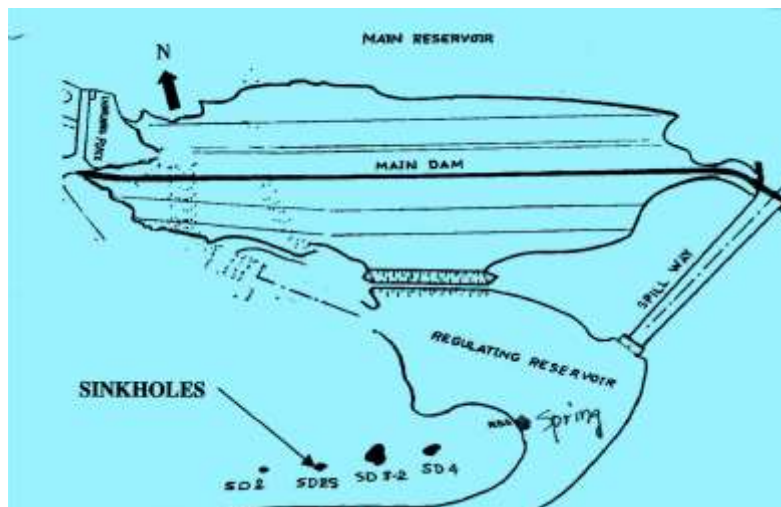
During the operation years of the reservoir, sinkholes developed downstream of the dam, and were observed on the right bank about 900 m downstream of the toe of the main embankment. Four sinkholes appeared in a linear arrangement in the period from 1992 to 1998 as shown in figure (20). These are SD2, SD2S, SD3-2 and SD4 (the largest).

Figure 20: Sinkholes downstream Mosul Dam-Right Bank

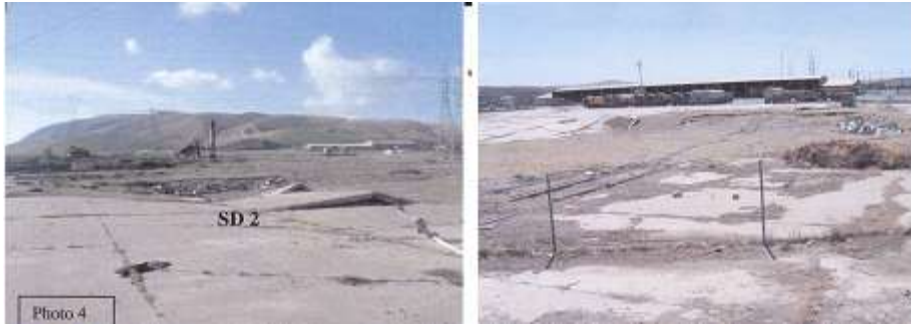
Figure 21: shows Sinkhole SD2 in the contractor paved yard before cleaning and after cleaning of these sinkholes.

The development of these sinkholes seems to be connected to the dissolution of gypsum in the underground layers due to the activity of Wadi Al malih aquifer on one side and the fluctuation of the tailrace water level resulting from the operation of the re-regulating dam downstream on the other side. The same dynamics was believed to be responsible for the appearance of water spring which was discovered after the washing away of terrace material by water discharging from the spillway at the opposite side of the river. The spring was on the same line of the sinkholes and its water had the same chemical contents of the sinkholes and the aquifer. Figure (22) shows the flow net of ground water flow towards the sinkhole and the discharge of this water into the river.

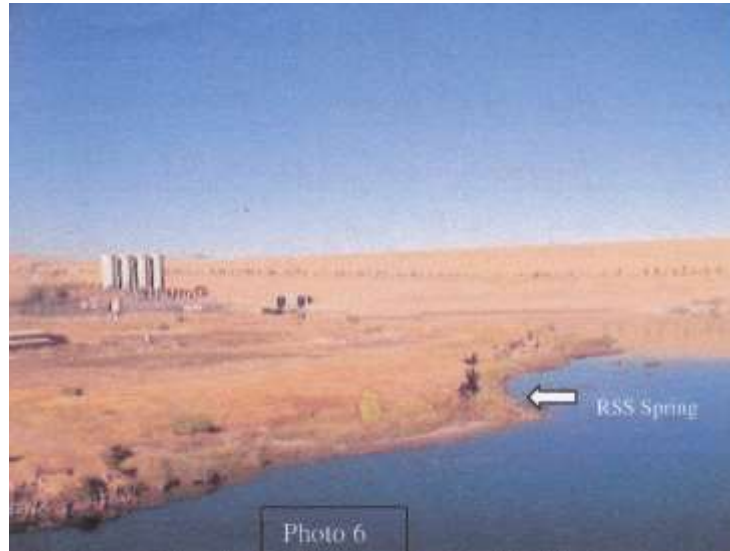
Figure 23: Spring on the right bank downstream of dam.

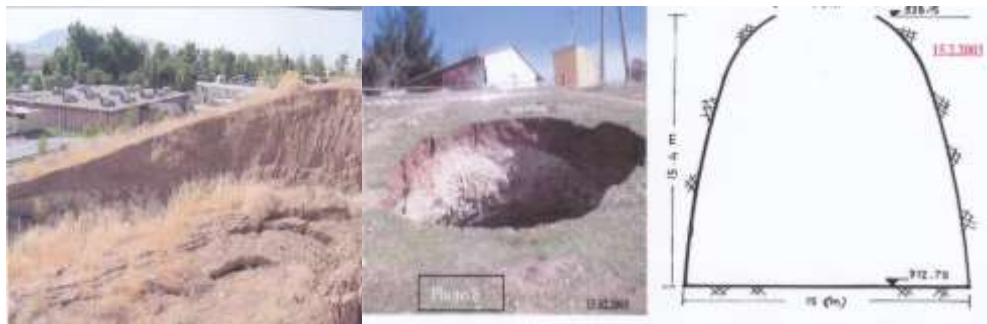
The formation of sinkholes was not limited to the right bank. In February 2002 one large sinkhole suddenly formed by the collapse of ground surface at a point only 150 m downstream of the dam toe at the left bank. It had a depth of 15 m and a diameter of 15 m as shown in figure (24). It was believed that its formation was due to seepage from under the left embankment somewhere along the axis causing the formation of big cavity in gypsum layer. The sudden collapse of the roof into this cavity was due to the infiltration of drainage water from nearby workers camp.

Figure 24: Left: Sinkhole before removing the collapsed material .Middle: After Cleaning: Right: sinkhole sketch showing dimensions.

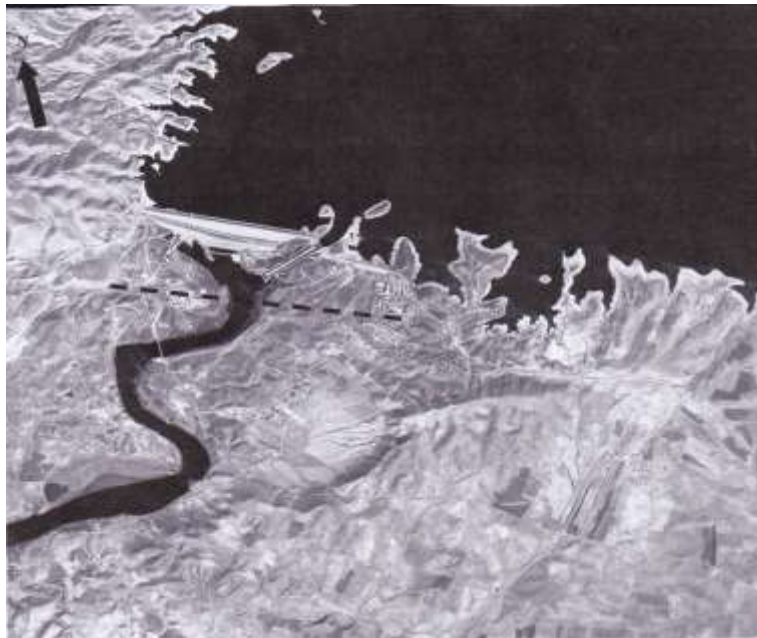
All these sinkhole seem to have formed in the same alignment on both banks as shown in figure (25), which may indicate the continuity of some geological feature.

The sinkhole formation process in Mosul Dam is a slow and dangerous process connected to the seepage and underground flow and the resulting dissolution of gypsum rocks. This could happen anywhere under the dam and around the site where and when the conditions are favorable. The danger stems from their unpredictable and sudden appearance and for that matter a very intensive observation of ground water movement using piezometers is a top priority to predict any abnormal activity in time.

Figure 25: Aerial view of the Dam area showing alignment of Sinkholes.

As a protection measure the maximum operation water level of the reservoir was limited to El 319 instead of El 330 in 2006. It must be mentioned also that this new level was not based on any concrete evidence to justify it, only that it may relax the situation somehow. The decision was taken on the understanding that it should be reviewed if further evidence is obtained in the future, but this has not been done so far.
