# Case Study: Investigation, Analysis and Mitigation of Rock Instability for a Potential Slope Failure in Highly Weathered Granite at Pinto Valley Mine in Arizona

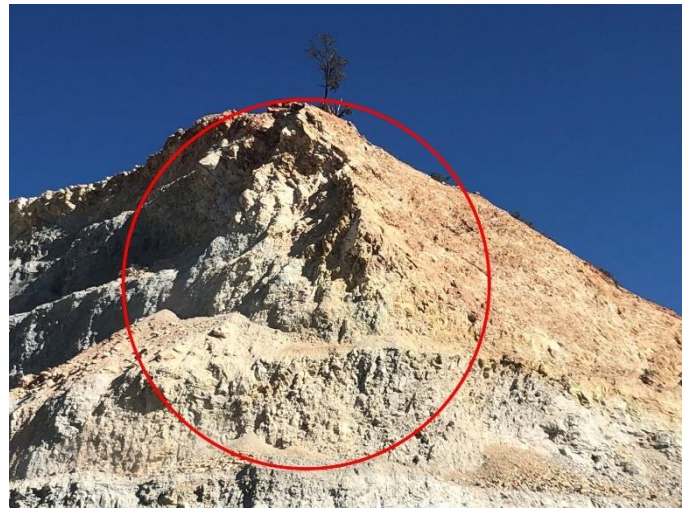
Fig. 1. Slope of interest (looking south)

Tension cracks were observed at the crest of the top of the three benches of the failure. These cracks were noted and relayed to mining personnel that potential movements are in progress. Minor, continuous rockfall was also observed prior to failure.

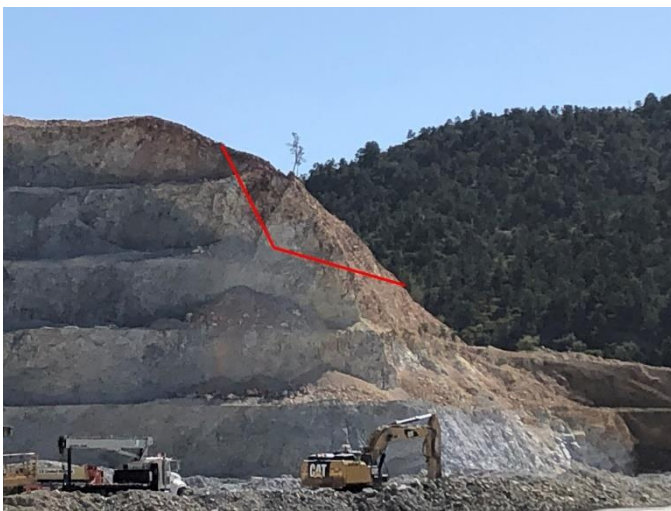
The slope finally failed in the late evening of 30 October 2019. Mining personnel indicated larger amounts of the rockfall began during the previous evening until the slope failed due to being severely weathered and having low rock mass properties. Several alerts were emailed from the SSR indicating urgent and geotechnical issues are in progress. The mine drone was flown above the failure and exhibited all inclusive images. Figure XX shows the drone photo of the failure from above and Figure XX shows the failure close up at the haul road. Figure XX shows the tension cracks at the crest of the benches prior to failure.

Fig. 1. Slope of interest before failure and excavation (looking south)

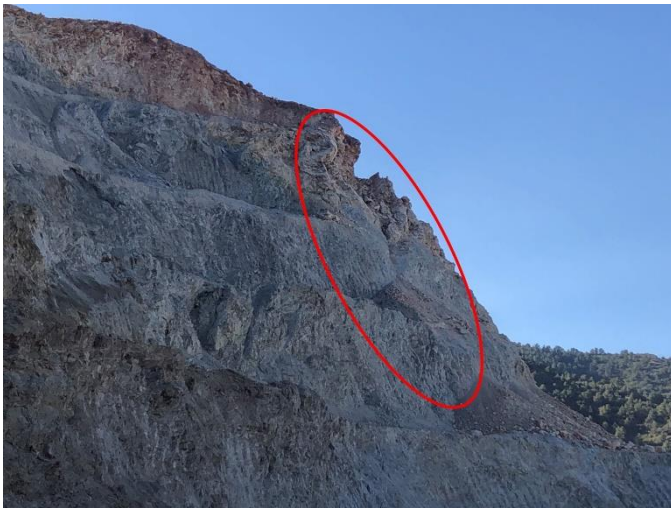
Once the failure reached equilibrium, mining personnel and engineers investigated the area to ensure no further movement would progress. The failure looked to be a circular failure as well as being severely weathered and having low rock mass strength.

Fig. 1. Intact rock at center of failure rock mass on slope

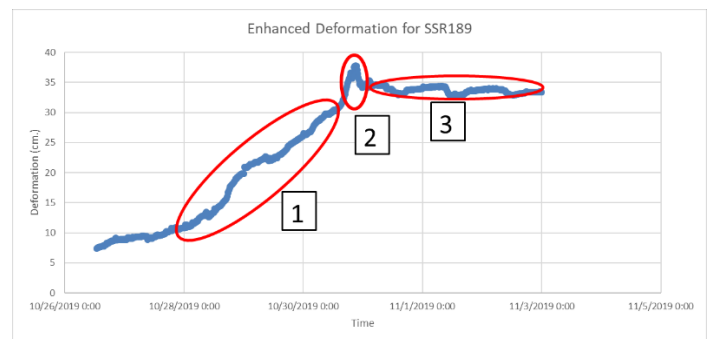
Fig. 1. Enhanced deformation for slope failure from the SSR

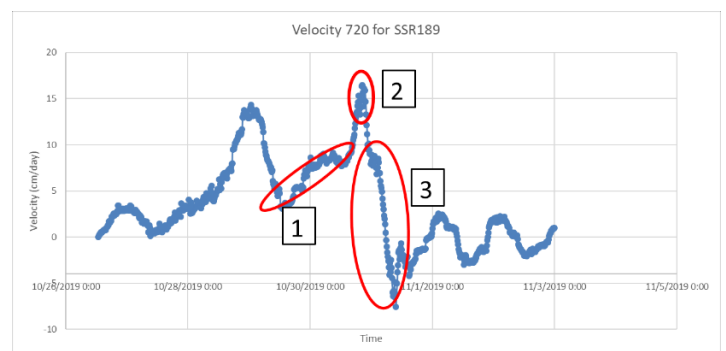
Fig. 1. Velocity data for slope failure from the SSR

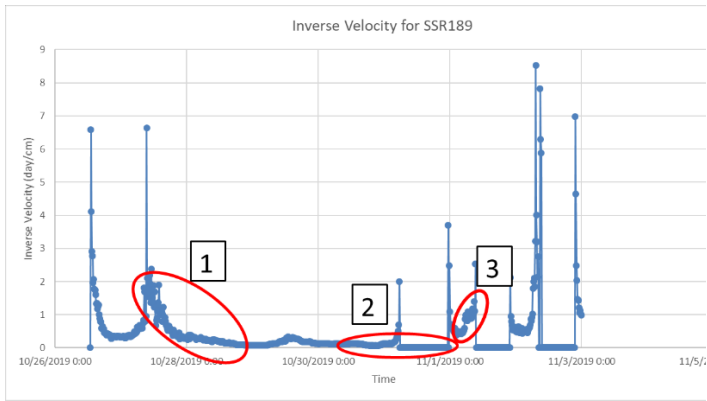
Fig. 1. Inverse velocity data for slope failure from the SSR

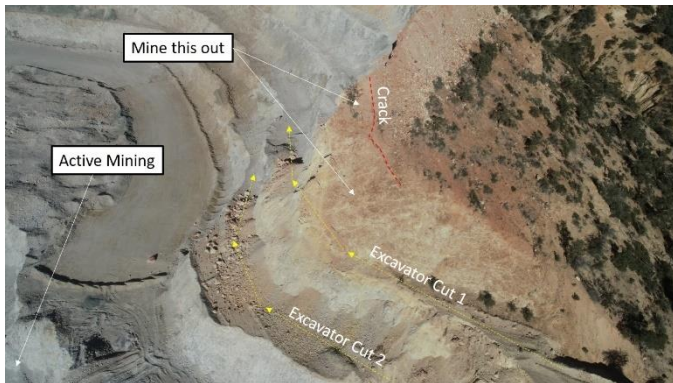
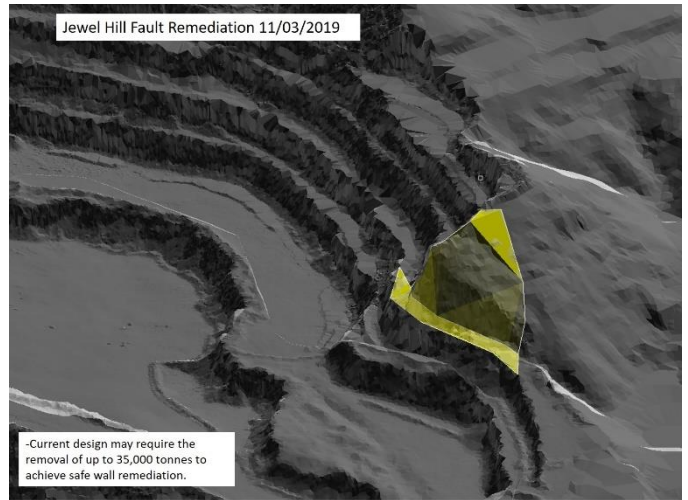
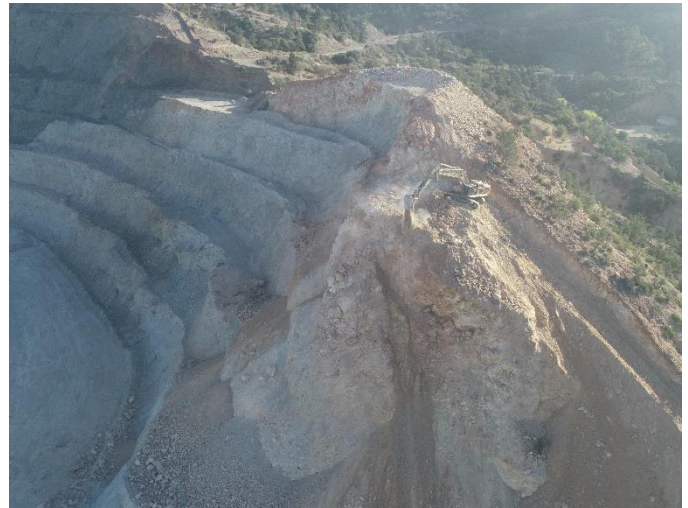
Before the failure, mining personnel were made aware of the possibility of a failure due to SSR data patterns, tension cracks at the crest of the slope and some rockfall/raveling. Since the slope is about 50 m from a contact with fault zone, there is a possibility of weaker rock mass due to the proximity to the fault. Rainfall was not observed for at least 2 weeks prior to the failure. A piezometer drill hole just to the east of the failure indicated no pressure head at the elevations where the failure took place. It also should be noted a small old drainage drift is located just to the south of the drift. The high walls at this drift exhibit signs of seepage. Although it is unlikely the seepage from this drift played a role in raising pore pressure at the slope failure, this should still be considered a potential cause. Figure XX shows location of slope failure and seepage area.

Fig. 1. Plan to excavate out remaining unstable ground

- Track Excavator created a safe ramp to excavate unstable rock (Photo 5).
- No mining personnel were allowed below slope to ensure no one was injured during excavation of unstable slope.

- Area below still bermed off where mining is taking place and haul road traffic was reduced to one lane for safety precautions.
- Slope was excavated into stable ground, beyond the last signs of tension cracks.
- Area will be closely observed.
