Field Observations of Water and Ice Problems in Railway Tunnels from a Maintenance Perspective

Abstract

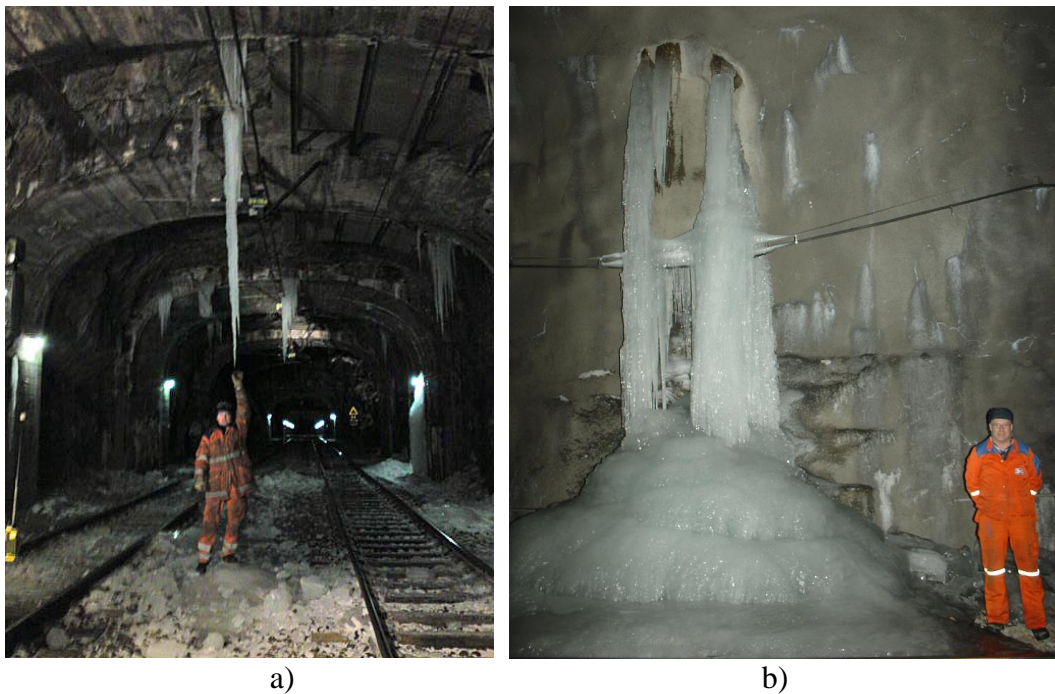
**Figure 1: a) Icicle in the Rönninge tunnel (Photo: Infranord, 2010)
b) Ice pillar in the Glödborget tunnel [1]**

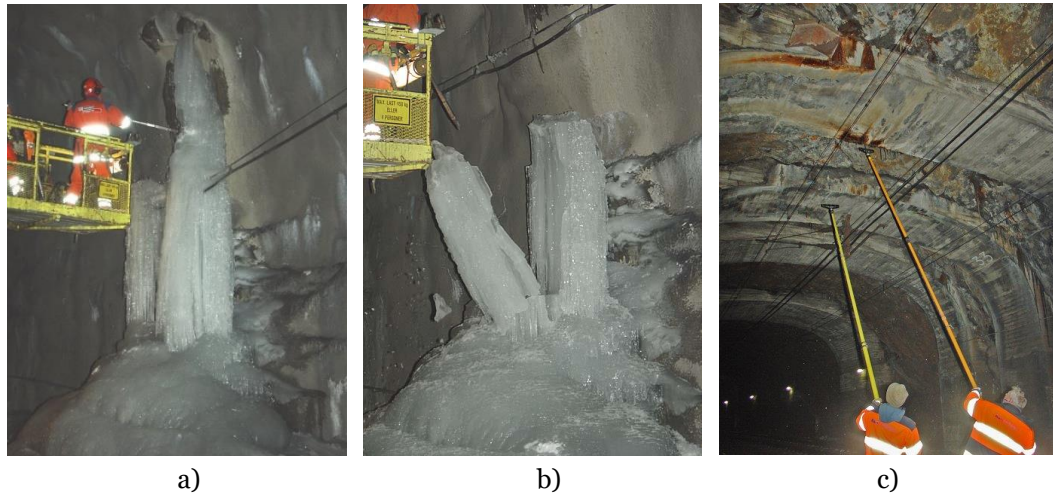
**Figure 2: a) and b) Removal of an ice pillar in the Glödborget tunnel [1]
c) Removal of icicles from the tunnel roof above the overhead contact line
using long insulating plastic rods in the Rönninge tunnel [1]**

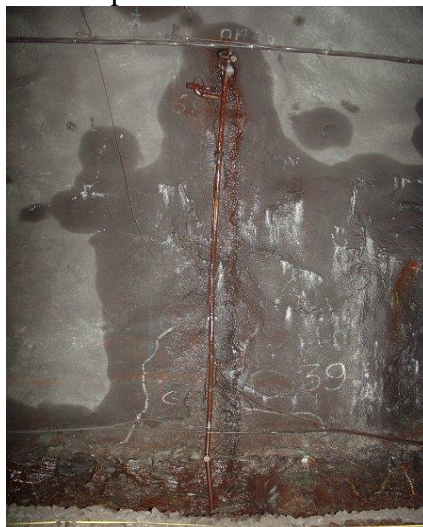
Before 1990, the Malmбанан went through an older tunnel that came into operation as early as 1902. A new tunnel was built because there had been major problems with ice formations in the older tunnel. However, problems with leakage and ice also arose in the new tunnel. The Swedish Rail Administration tried to reduce the problems by grouting the rock mass with polyurethane-based grout in 1992. During 1992-1993, attempts were also made to drain the surrounding rock mass by installing electrically heated drainage pipes in certain parts of the tunnel walls (Figure 7). The problems with ice continued and, in 1996, selected sections were also frost insulated with polyethylene mats covered with shotcrete. Furthermore, concrete elements with insulating rock wool were installed. Despite these measures, many problems remain and the tunnel requires many hours of maintenance during the winter months to address the problems with icicles and ice formation.

Figure 7: Drainage pipe at chainage km 1512+610, Nuolja 2004-10-07

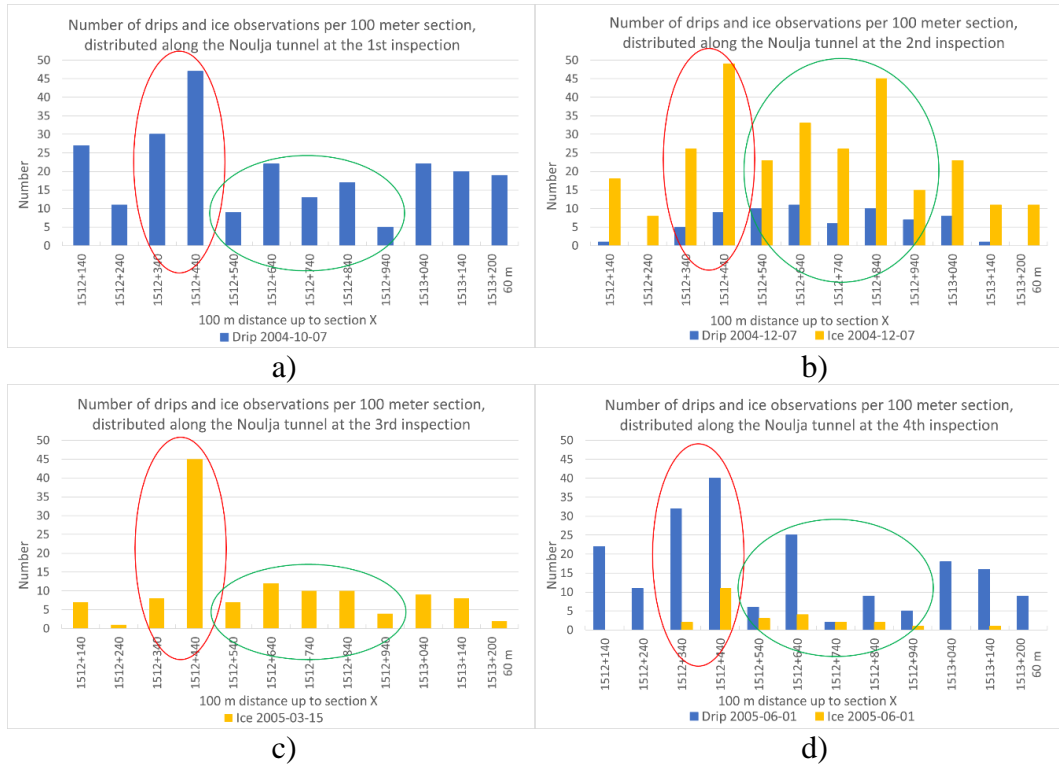
In the first inspection on 7 October 2004, the tunnel was very wet. The temperature had been above freezing and there had been a lot of precipitation in the area the month before the inspection (Figure 8). There were many damp and wet areas in the roof and on the walls of the tunnel. Drips from the roof and walls occurred along the entire tunnel, with an increased concentration between chainage km 1512+300 to 420 (red ellipse in Figure 9a). The green ellipse in Figure 9a shows an area that had only a slight leakage of water in the first inspection. In the second inspection, many ice observations were made (compare the green ellipses in Figure 9a and b). In the second inspection on 7 December 2004, the temperature had been just below freezing (Figure 8). The freezing rate had been slow, which had caused the leakage to continue at the same time as the temperature had been low enough for ice to form. Many icicles and ice layers were observed, and large ice pillars had formed at the leakage points in the walls (Figure 10).

ice formations had been formed despite the fact that, in the first inspection, there were not so many drip observations or as much moisture in this area (compare the green ellipses in Figure 9b and a). Some leakage from the roof and walls remained in the inner parts of the tunnel, despite the cold temperature outside the tunnel. According to the maintenance worker present, the beginning of the winter had been unusually mild and problems with icicles and ice layers had been relatively minor. The most severe problems often occur at the entrances, where many icicles grow when the cold period starts around the beginning of November. These problems decrease when the leakage points at the entrances 'freeze dry'. Compare the numbers of ice observations in the outer parts of the tunnel to the inner parts during the inspection in December (Figure 9b).

In the third inspection on 15 March 2005, the temperature had been below freezing for a long time (Figure 8). All drips had stopped and there were no moist surfaces along the tunnel. The concentration of ice formations between chainage km 1512+300 to 420 was similar to that in the previous inspection (red ellipse in Figure 9c). Ice formations had grown in several sections and become more extensive (Figure 12). In total, the number of ice observations had decreased from the second inspection, especially the concentration between chainage km 1512+500 to 900 (compare green ellipse in Figure 9c and b). Since the second inspection, ice had been removed during maintenance work and no new ice growth had taken place during that time.

In the fourth inspection on 1 June 2005, the temperature had been above freezing for a long time (Figure 8). There were still a few ice formations that had not yet melted. The tunnel was once again exposed to many drips, as well as moist areas on the walls and roof. The concentration of drips was again between chainage km 1512+300 to 440 (red ellipse in Figure 9d). Between chainage km 1512+500 to 900 (green ellipse in Figure 9d) only a few areas of dripping water were observed.

Figure 9: Number of drips and ice observations per 100 m section for the Noulja tunnel, 2004/2005

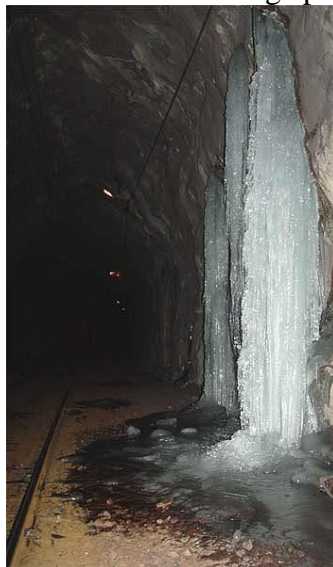
Many icicles and ice layers were observed during the second inspections and large ice pillars had formed at the location of the leakage points on the walls (Figure 10).

Figure 10: Ice pillar, Nuolja chainage km 1512+284 right, 2004-12-07

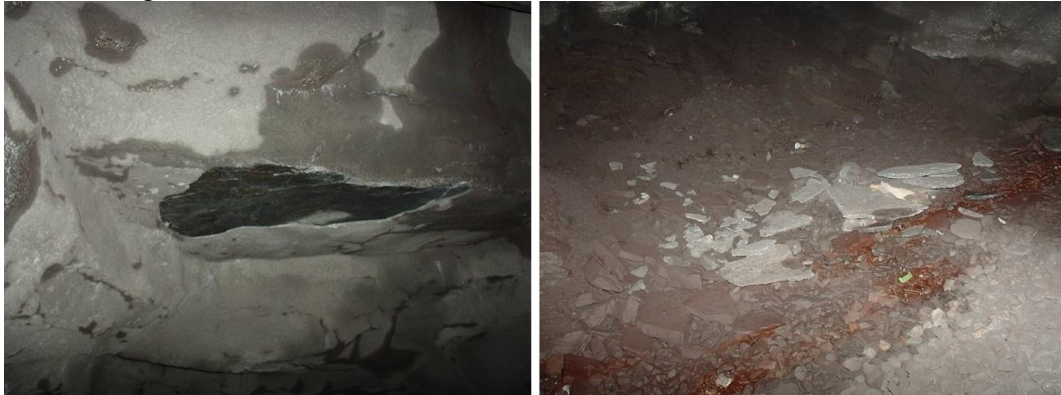
In the first inspection, it was observed that the shotcrete in the roof to the left of the track at chainage km 1512+210 had separated from the rock and fallen down on the ballast surface. The rock was exposed, and water leaked from the exposed rock surface (Figure 11).

Figure 11: Fall out of shotcrete in roof, Nuolja chainage km 1512+210 roof on the left side, 2004-10-06

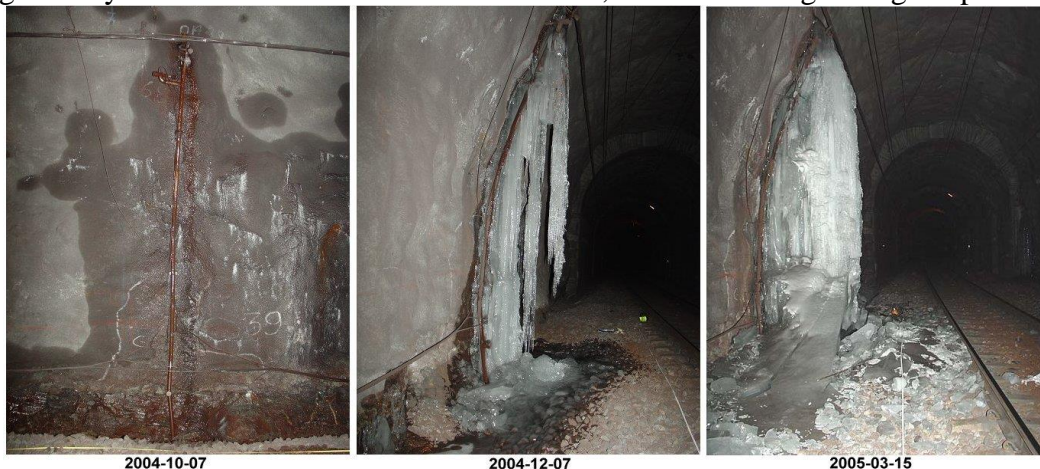
Figure 12 shows ice around one of the drainage pipes in the rock mass. These drainage pipes were initially heated by electricity and the idea was that the pipes would lead the leakage water down to drainage pipes on the tunnel floor. That worked relatively well until the heating system failed. The drainage pipes in the rock mass still carry a large amount of water into the tunnel but, instead of flowing in a heated drainage pipe, the water flows along the outside of the pipes and gradually freezes as it meets the cold tunnel air, which creates growing ice pillars.

Figure 12: Drainage pipe, Nuolja chainage km 1512+610 left, at different inspections

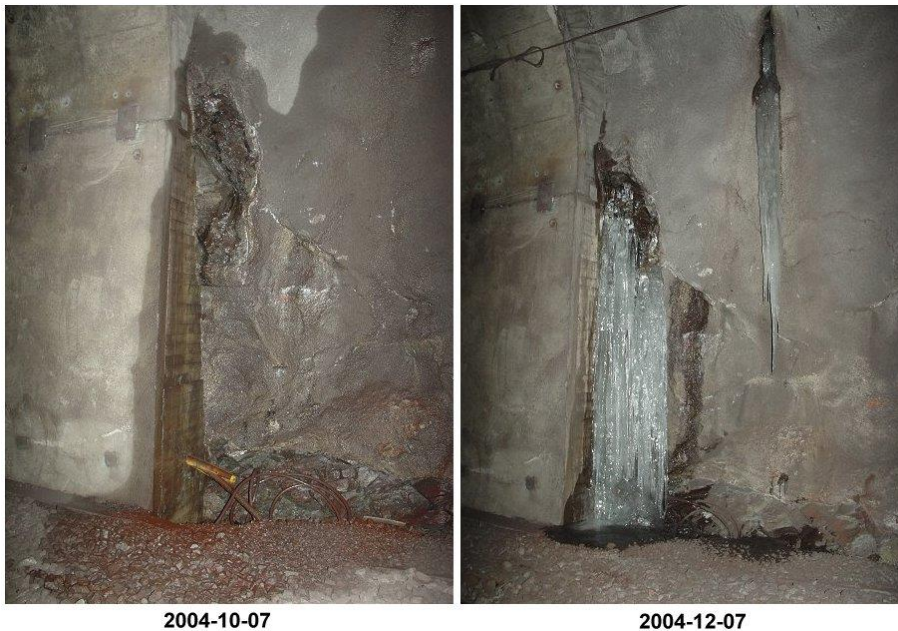
Another problem was leakage where the rock and the concrete arches are connected. At chainage km 1512+626, there was a leak that during the winter inspections had formed a large ice pillar (Figure 13). At the time of the inspection in December, the leak was still active.

Figure 13: Water leakage where the rock and the concrete arches are connected. Nuolja chainage km 1512 + 626

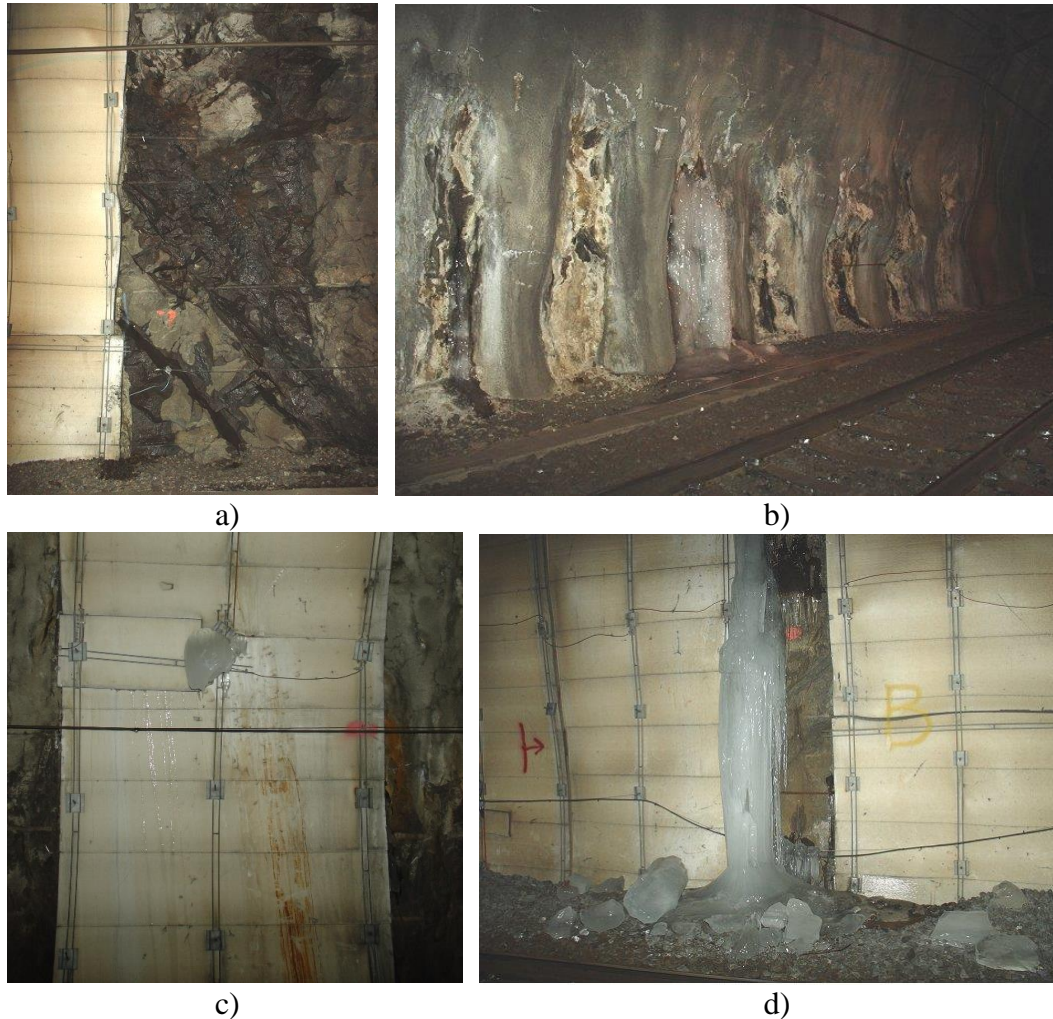
In the Laduberg tunnel, only the roof is sprayed with shotcrete and the rock walls are only reinforced with rock bolts where required. The drain mats are not covered with shotcrete. Many leaks in the tunnel are connected to the drains. In Figure 16a, the water leakage follows the fracture plane in the rock, which makes it difficult to seal the drain against the rock and get the water to stay inside the edge of the drain. Figure 16b shows water leakage and ice formation in an area that is reinforced with shotcrete arches. In Figure 16c, the leakage appears in the joint between two drain mats. An icicle has formed in the centre and a large area was wet. In Figure 16d, a large ice pillar has formed next to a drain, due to a gap between two separate drains. The ice pillar could have been avoided by extending the drain width and connecting the two drains.

Figure 16: a) Leakage that spreads in the fracture plane next to the drain, Laduberg chainage km 1104+675 left, 2004-11-04
b) Water leakage and ice formations at shotcrete arches in Laduberg chainage km 1105+185 left, 2005-01-27
c) Water leakage through drains resulting in ice formations, Laduberg chainage km 1104 + 911 right, 2005-01-27
d) Ice pillar between two drains, Laduberg chainage km 1104 + 932 right, 2005-01-27

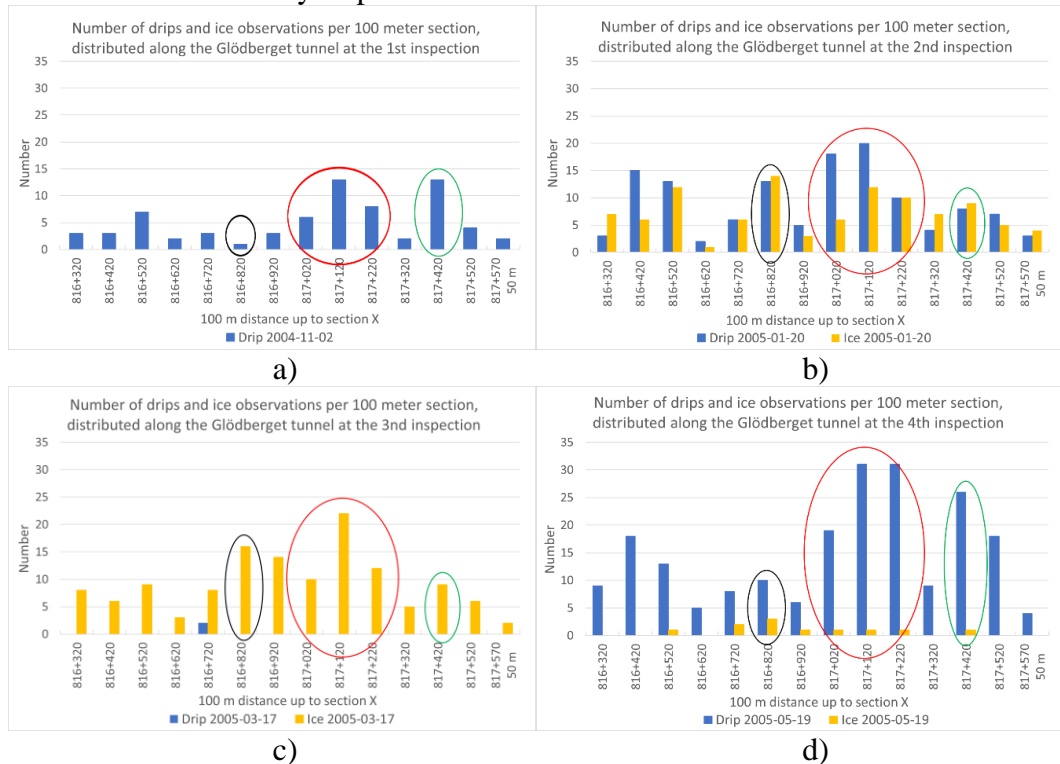
Prior to the first inspection, the temperature had been below freezing on only a few occasions (Figure 17). The first inspection was carried out on 2 November 2004. A large part of the tunnel walls and roof were moist. The distribution of drips was more even throughout the Glödsberget tunnel than the two previously described tunnels, but between chainage km 817+020 to 220 and between chainage km 817+420 there were more drips than in other parts of the tunnel (see red and green respectively ellipse in Figure 18a). The black ellipse in Figure 18a (between chainage km 816+760) marks an area where there were no major drips in the first inspection. In the following inspection, on 20 January 2005, ice formations were observed at this location, despite the lack of drips in the first inspection (Figure 18b and c).

Before the second inspection on 20 January 2005, the outside temperature fluctuated around 0°C (Figure 17). Therefore, the leakage points in the tunnel remained unfrozen, but the temperature inside the tunnel was cold enough for ice to form. Many drips were observed in the tunnel, mainly from the roof and from the left shoulder. The dripping water had resulted in large ice pillars and large ice layers on the ballast and tracks. The same sections marked with red and green ellipses in Figure 18b were still relatively moist and a large number of ice formations were observed (Figure 18b). The larger areas that were relatively dry in the first inspection were still dry and free from ice observations. An exception was the section marked with the black ellipse in Figure 18b. Here the roof was dry and the wall was damp in the first inspection but, at the second inspection, the wall was wet and several ice pillars had formed. There was even a leak from the roof with icicles forming as a result.

freezing (Figure 17), which led to the tunnel being almost completely frozen during the third inspection on 17 March 2005. The surface of the tunnel was dry and only one leak was still active, a known problem at chainage km 816+665. A large ice pillar was applying load to a cable in the left shoulder (Figure 21, date 2005-03-17). Incidentally, there were many large ice pillars along the walls and large areas of ice layers on the ballast and tracks. Ice formations were found in approximately the same places as in the second inspection (Figure 18c). In the section around the black ellipse, many ice formations had formed, while at the green ellipse, fewer ice formations had formed than might have been expected taking into account the number of drip observations in the first inspection (compare Figure 18a and c). After the third inspection, the temperature was above freezing almost all the time until the fourth inspection on 19 May 2005 (Figure 17). In that inspection, the tunnel had thawed and was very moist. A few ice formations were observed in the tunnel. These examples were from sections where the ice pillars had been very large and had not had time to melt down. Otherwise, the ice had melted away and the tunnel was very moist. The number of drip observations had increased significantly compared to the first inspection, see especially the red and green ellipses in Figure 18a and d. In the section around the black ellipse, the wall was completely wet and there were drips of water from the roof. This was completely different from the conditions observed in the first inspection as, at that time, that section did not have much moisture or many drips.

Figure 18: Number of drips and ice observations per 100 m section for the Glödsberget tunnel, 2004/2005

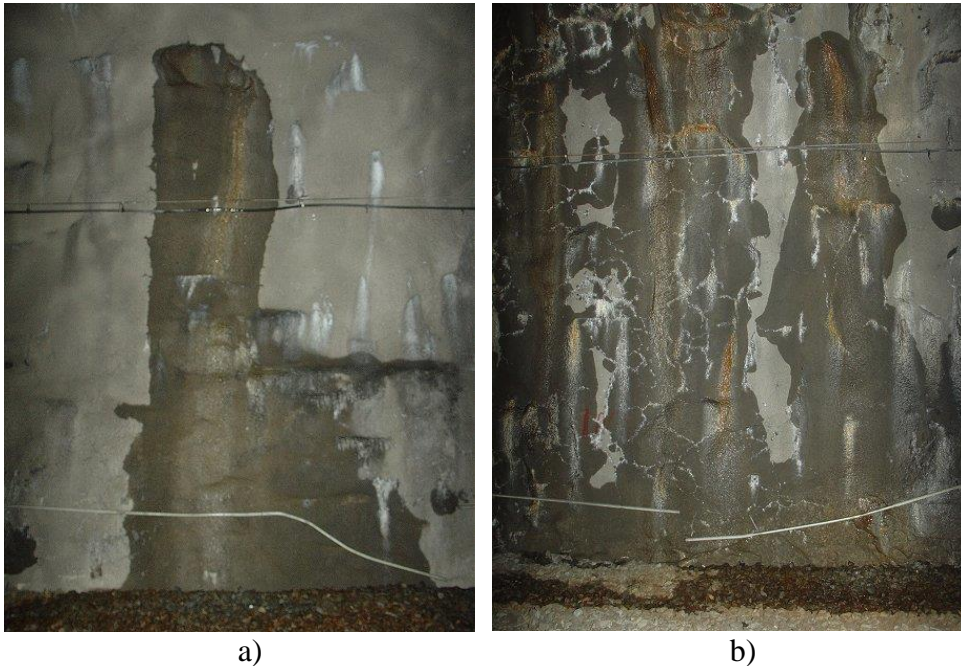
A problem observed in several places was broken handrails (Figure 19a and b). These problems often occurred near the locations of leakage points. The damage to the handrail was probably caused by the formation of large ice pillars during the winter, which broke the brackets holding the handrail to the wall and the handrail itself. Another problem observed was cracked shotcrete along the walls and roof (Figure 19b). Many cracks were calcareous, but moisture and drips penetrated through several cracks.

Figure 19: a) Broken handrail near a leak, Glödberget chainage km 816+665 left, 2004-11-02
b) Cracked shotcrete and broken handrail, Glödberget chainage km 817+104 left, 2004-11-02

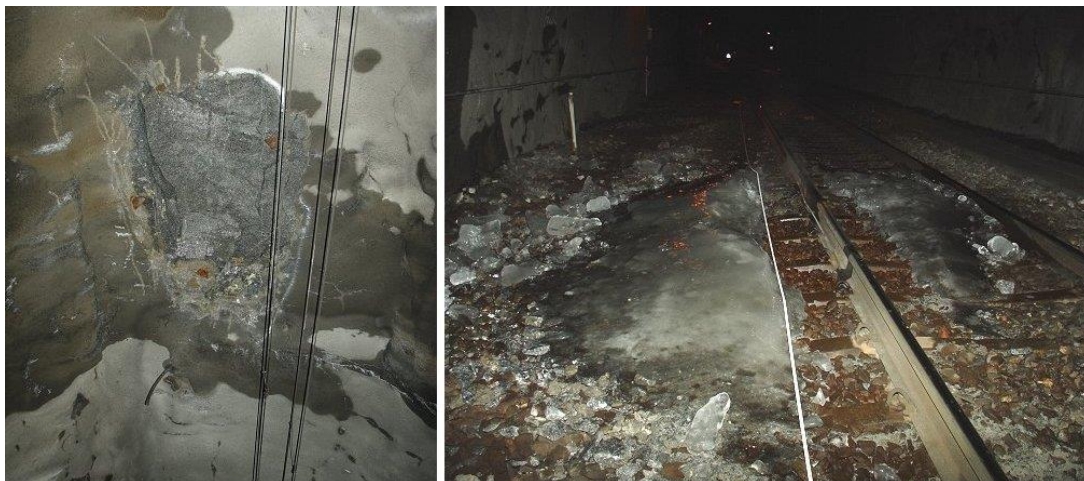
In the roof at chainage km 816+597, shotcrete had been scaled and the rock surface was exposed. There were many water leakage points in the section and a large ice layer had formed over the track (Figure 20). The ice layer had been removed from the rails to prevent derailment.

Figure 20: Exposed rock surface after scrapping of shotcrete and ice layer at the track, Glödborget tunnel chainage km 816+597, 2005-01-20

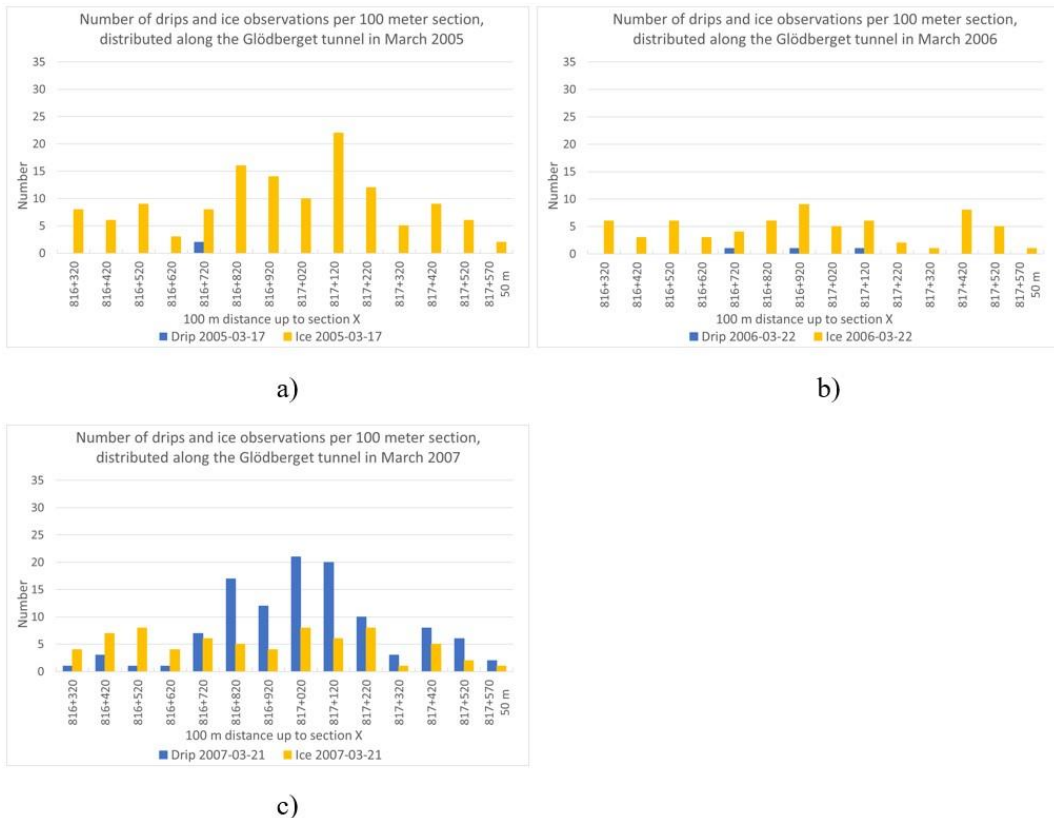
Figure 24 shows the number of drips and ice observations along the Glödsberget tunnel in March during the three years 2005, 2006 and 2007. The number of drip observations during the 2007 inspection was significantly more than during the previous two inspections, which probably reflects the temperature conditions before each inspection. Differences in the number of ice observations, and also the extent of the ice formations, can be explained by the fact that in 2004/2005 the beginning of winter was relatively mild and there were many temperature fluctuations around 0°C (Figure 23). The tunnel air was too warm to freeze the rock surface around the source of the leak, but cold enough to produce ice formations when the water reached the cooled tunnel wall or ballast surface. In 2006, the temperature fluctuations around 0°C were significantly fewer, and the temperature was relatively low for longer periods (Figure 23). This caused the leakage points to freeze, which led to fewer ice formations (compare yellow bars in Figure 24a and b). In 2007, the temperature fluctuated around 0°C until the beginning of January, when the temperature dropped rapidly, and a longer period of freezing temperatures started (Figure 23). The tunnel probably froze quickly, which led to fewer ice formations and the ice pillars were not so extensive (Figure 24c).

Figure 24: Number of drips and ice observations per 100 m section in the Glödsberget tunnel, March 2005, 2006 and 2007

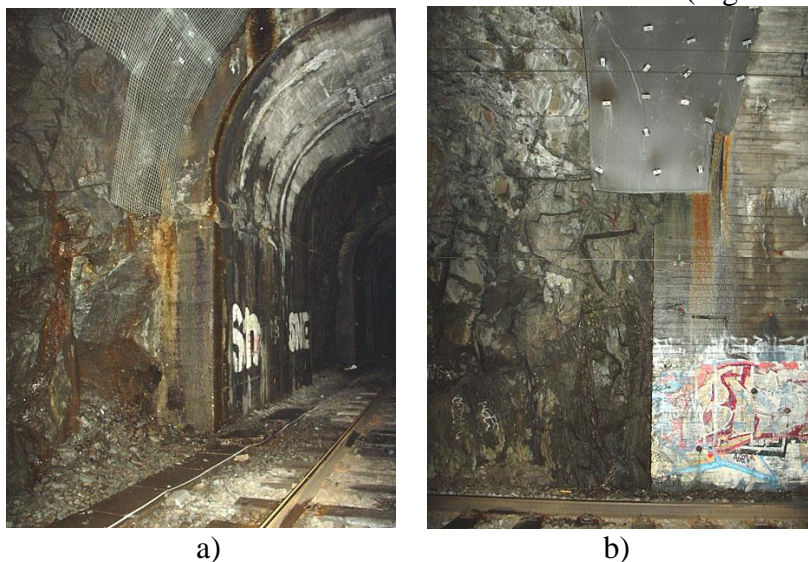
The tunnels were reinforced with cast-in-place concrete arches as early as 1915 (Figure 25a). After a large rockslide in Rönninge in 1925, additional reinforcements were carried out between 1925 and 1927 using additional concrete arches. The rock surface in the rest of the tunnel is not reinforced except for some selective bolting, as well as some smaller surface support with rock safety mesh. There are sporadic drain mats installed along the tunnel. These are mainly located where the rock and the concrete arches are connected. They consist of uncovered PE mats that are fastened with bolts and some drain mats are covered with nets (Figure 25b).

Figure 25: a) Cast-in-place concrete arches, Rönninge South chainage km 29+714 left, 2004-12-16
b) Uncovered PE mats Rönninge North chainage km 29+448 right, 2004-12-16

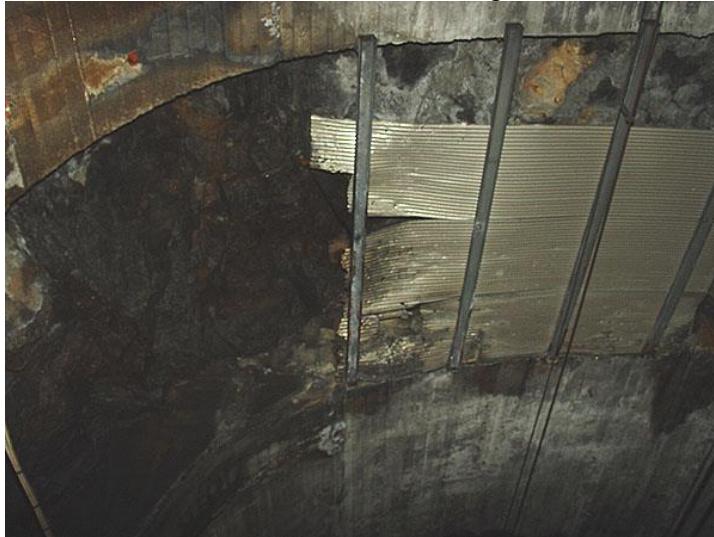
Attempts have been made to lead the water away from the roof with metal plates lying on the beams between the concrete arches (Figure 26).

Figure 26: Sheet metal lying on beams between the concrete arches, Rönninge South chainage km 29+730, 2004-12-16

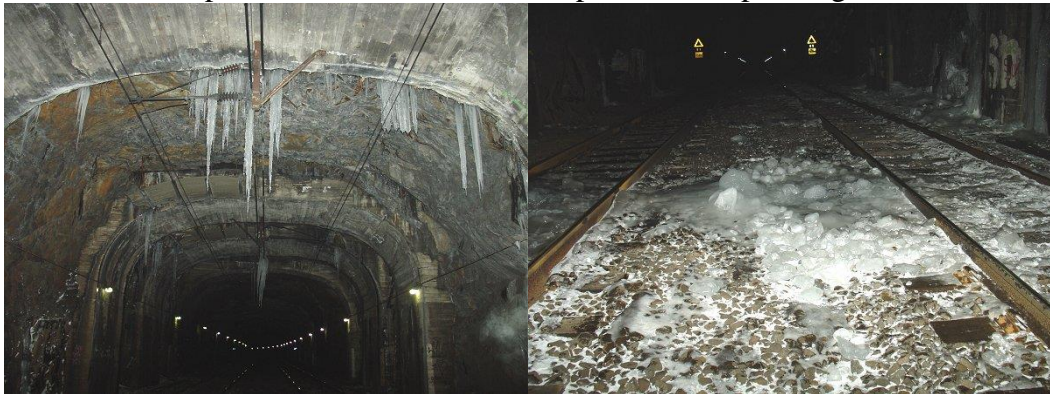
Figure 28: Icicles at an active leakage point and ice layers on the tracks, Rönninge South chainage km 29+720 the first picture photographed to the south, the second to the north, 2005-02-25

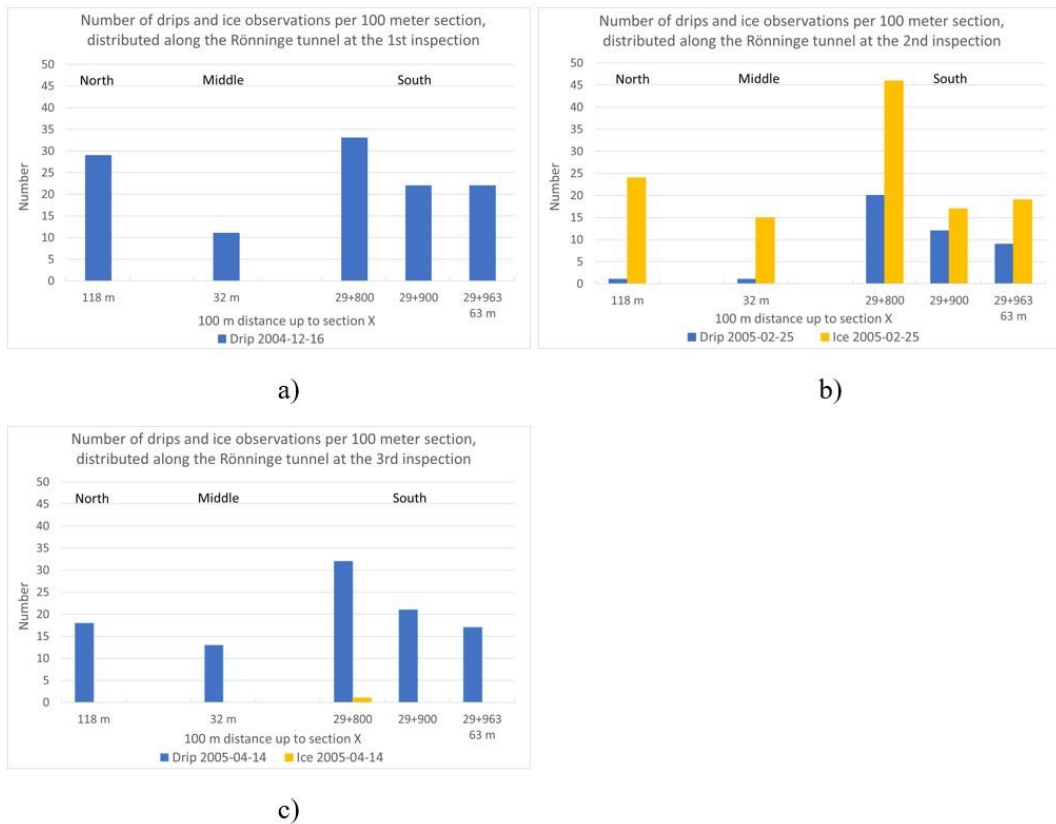
In the first inspection on 16 December 2004, the temperature had been below freezing. However, in the days before the inspection, the temperature had risen above 0°C. There had not been much rainfall (Figure 27). The tunnels had moist surfaces, often where the rock mass and the concrete arches connected. There were several leakage points from the roof. In some places, attempts had been made to direct the water away from the roof with steel plates lying on beams between the concrete arches (Figure 26). These were rusty and broken, resulting in leaks on to the track area. For the north and south tunnel, the concentration of drips and moist surfaces was at the northern entrance (Figure 29a).

Between the first and the second inspections, the temperature had fluctuated around 0°C, with a large amount of ice forming as a result (Figure 27). Under these temperature conditions, maintenance inspections must take place every night to remove icicles and ice layers on the tracks, a very costly and time-consuming job. In the second inspection on 25 February 2005, there was only one leakage point still active in the two shorter tunnels (northern and middle), while in the southern tunnel there were more leakage points and moist surfaces. Adjacent to these leakage points, concentrations of ice were observed. This was especially the case in the northern entrance of the south tunnel, where there were leakage points along the entire roof and walls. Many icicles had formed here, as well as a large layer of ice on the track area (Figure 28). The concentration of ice formations matched closely the areas that had the most drip observations in the first inspection, compare Figure 29a and b.

At the time of the third inspection on 14 April 2005, all the ice had melted in the two shorter tunnels, while in the southern tunnel there was still one ice formation. All tunnels were again moist with concentrations of water in the same places as in the first inspection, but to a somewhat lesser extent than before. According to the maintenance worker present, it had not rained for several days, which resulted in the tunnel not being as wet as it usually was (Figure 27). When comparing Figure 29a and c, the leakage in the northern entrance of the south tunnel is similar to the

Figure 29: Number of drips and ice observations per 100 m section for the Rönninge tunnels, 2004/2005

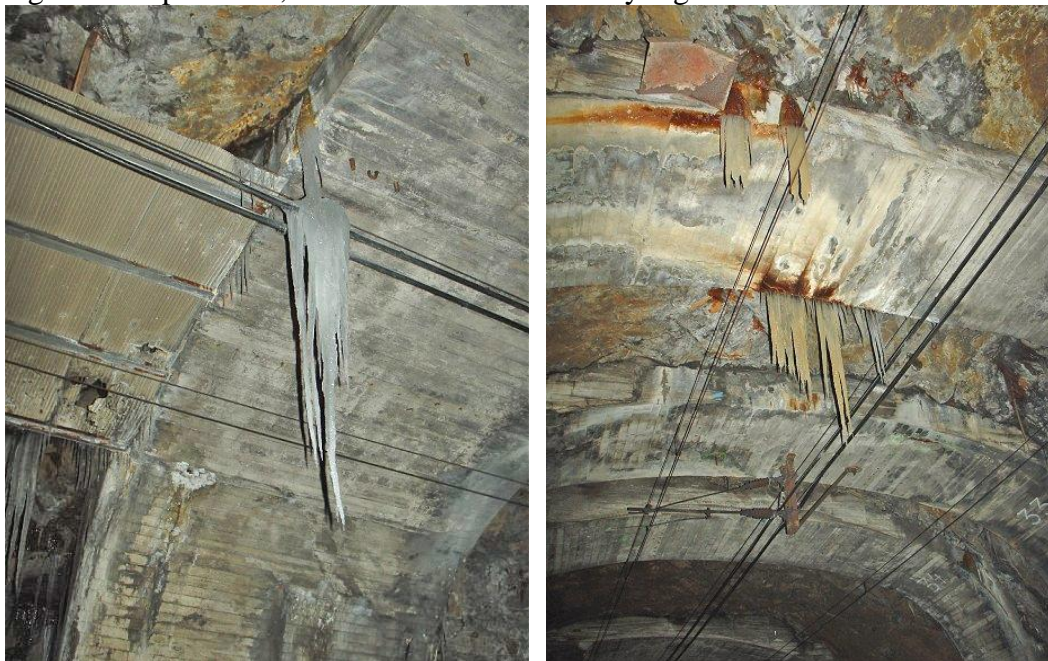
In the Rönninge tunnels, the majority of the ice observations were icicles in the roof (Figure 31). According to maintenance workers, Rönninge is one of the tunnels in the Stockholm regions that requires the most maintenance. During periods of negative temperatures, ice must be removed every night.

Figure 31: Rönninge South chainage km 29+734 and km 29+813 photographed to the south, 2005-02-25

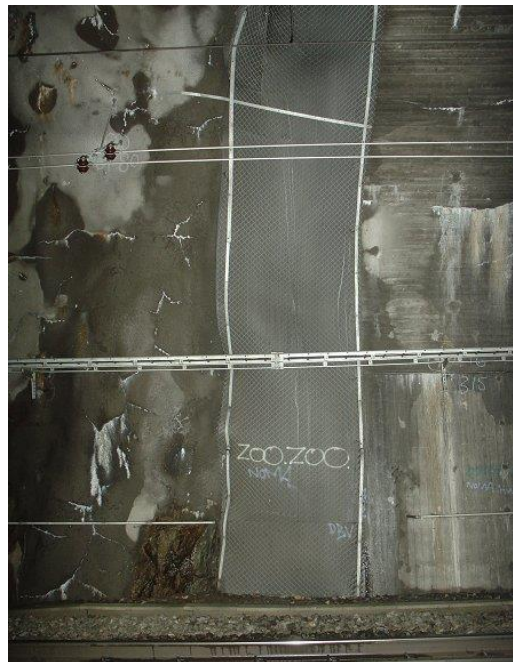
The railway tunnels were built without continuous pre-grouting. Only major crush zones were grouted. The frost insulation used consists of drains constructed from approximately 1 m wide insulation mats covered with mesh or fibre-reinforced shotcrete. In addition, uncovered drains have been set up with strips along the edges (Figure 32).

Figure 32: Uncovered drain, Kvedesta North chainage km 39+241 right, 2004-12-17

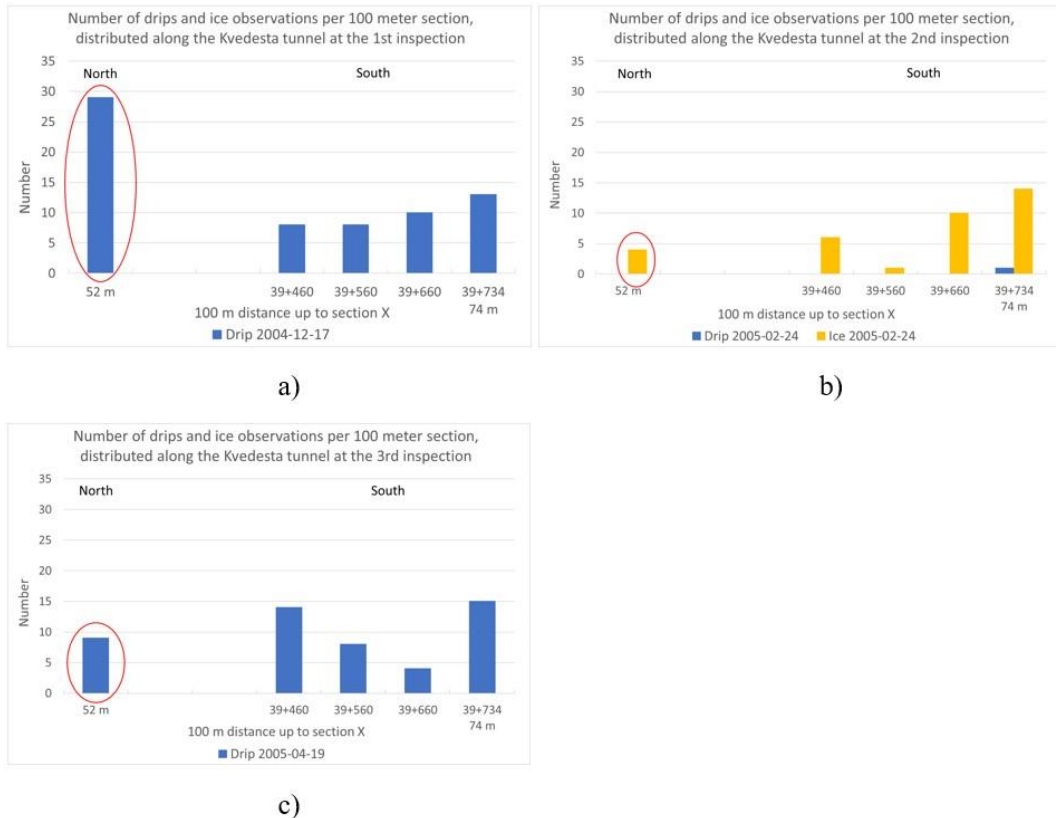
Before the first inspection on 17 December 2004, the temperature had been below freezing, but the days before the inspection the temperature was over 0°C. There had not been much rainfall (Figure 33). In the first inspection, almost the entire northern tunnel had moisture on sections of the walls and roof and many drips were observed (red ellipse in Figure 34a). The southern tunnel had less moisture and the drip observations were concentrated around the roof near both the northern and southern entrances.

Between the first and the second inspections, the temperature had fluctuated around 0°C (Figure 33). Under these temperature conditions, maintenance inspections must take place every night to remove icicles and ice layers on the tracks. In the second inspection on 24 February 2005, only one leak was still active in the southern tunnel. In the northern tunnel, only four ice formations were observed, despite the fact that this tunnel had many leakage points during the first inspection (compare red ellipse in Figure 34a and b). In the southern tunnel, some ice formations were observed and they occurred, as the leakage points in December, near both the northern and southern entrances.

and there was no ice left in the tunnels at the time of inspection. In the northern tunnel, there were leakage points in the roof and on the walls, but not to the same extent as in the first inspection (compare red ellipse in Figure 34a and c). In the southern tunnel, the concentration of leakage points was similar to the first inspection, near both the northern and southern entrances (compare the South tunnel in Figure 34a and c).

Figure 34: Number of drips and ice observations per 100 m section for the Kvedesta tunnels, 2004/2005

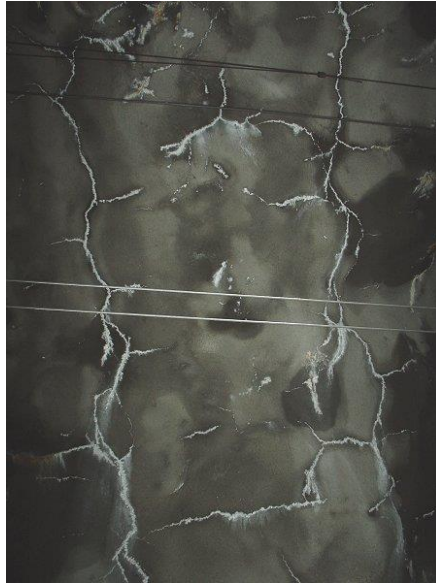
In several places in the Kvedesta tunnels, the shotcrete was cracked and there were moist areas in the shotcrete around the covered drains, which indicates that water was seeping out around the side of the drains (Figure 35).

Figure 35: Cracks around a covered drain, Kvedesta South chainage km 39+372 left, 2004-12-17

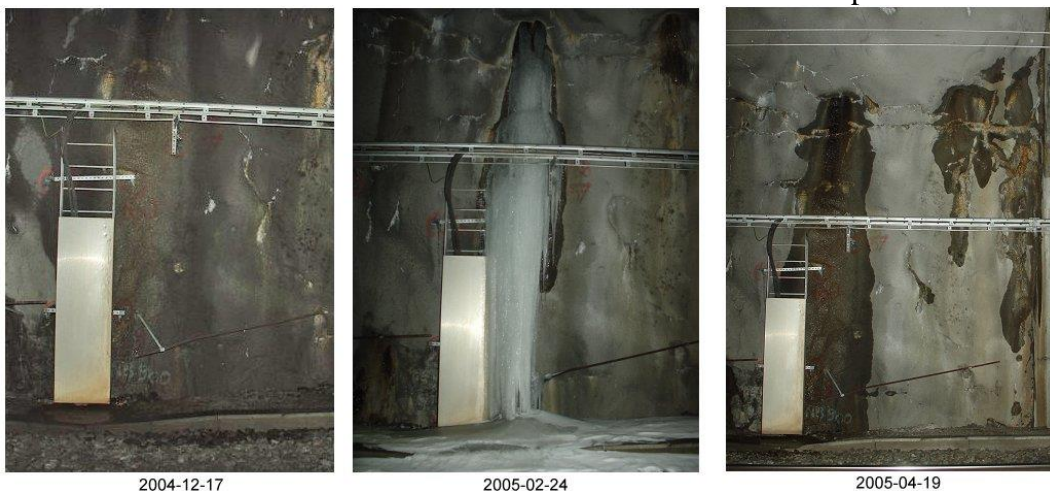
In the Kvedesta tunnels, one recurring problem was on the right side at chainage km 39+367 in the south tunnel (Figure 36). Ice must be removed from the electrical cabinet every cold period. This tunnel section is 10 m from the northern entrance and is, therefore, affected almost directly by the temperature changes outside the tunnel. In the first inspection, the entire wall was moist. In the second inspection, a large ice pillar had formed next to the electrical cabinet and pushed the cabinet out of its original position. In the third inspection, the tunnel was dryer, but the leakage point just above the electrical cabinet was active. Note the difference in the moisture on the wall between the first and last inspection.

Figure 36: Differences between the three inspections, Kvedesta South chainage km 39+367 right
