Mystery of Mosul Dam the most Dangerous Dam in the World: Karstification and sinkholes

Abstract

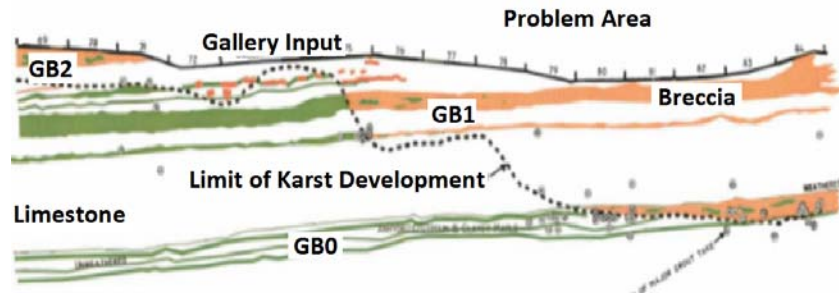
At Mosul dam site, major dissolution occurs at the “karstic line”, where anhydrite converts to gypsum and this unit is subsequently dissolved and eroded by seepage (Fig. 4). This phenomenon of evaporites dissolution by groundwater and the void is generally filled with collapse breccias from the overlying beds (Fig. 5) [11].

Fig. 4: Major Grout Takes in Sections 69-84 [7].

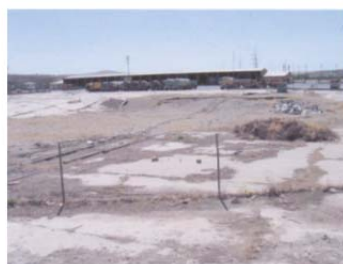
First appearance of the sinkholes on the right bank down-stream was not until approximately six years after beginning of the reservoir filling (Fig. 6). The surface expression of the sinkholes suggests that they are caused by an under-ground collapse. Concentric tension cracks appear to have developed around the central void as the sinkholes have developed progressively [7].

Fig.6: A sinkhole appeared during the 90's at the downstream right bank near the contractor yard.

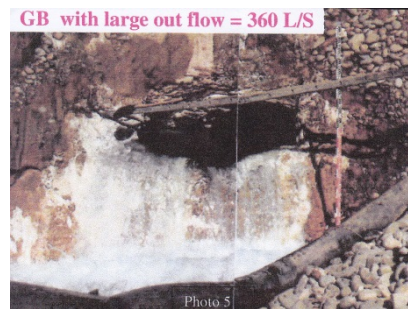
Downstream sinkholes are most likely related to fluctuations in the tail water level of the main dam during operation of the dam and the down-stream regulating reservoir [132]. These sinkholes may be connected to an aquifer on the right bank of the reservoir because before the reservoir was impounded, substantial flows of order of 360 L/sec were encountered from a gypsum layer found during excavation of the tailrace tunnel for the pumped storage scheme; the water had a high sulphate content which was different from the reservoir water (Fig. 7). The karst line also denotes the transition from the interbedded lime-stone-anhydrite/gypsum beds to the less permeable Jeribe limestone (Fig. 8) [12].

Fig. 7: Spring of discharge 360l/sec which is connected to the ground water aquifer connected to the reservoir

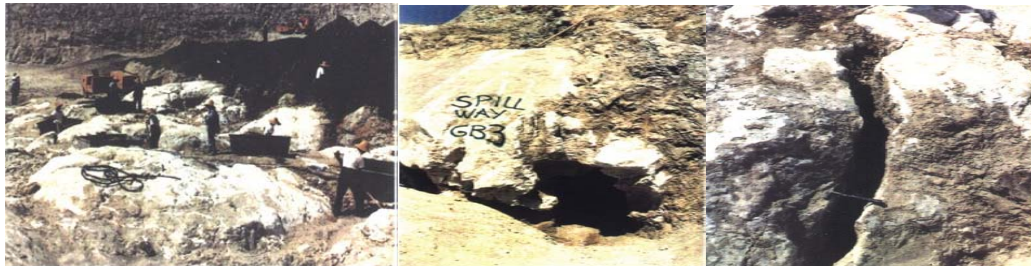
Fig. 8: Karstified gypsum in the foundations of the dam (left and middle), Solution crack (right).

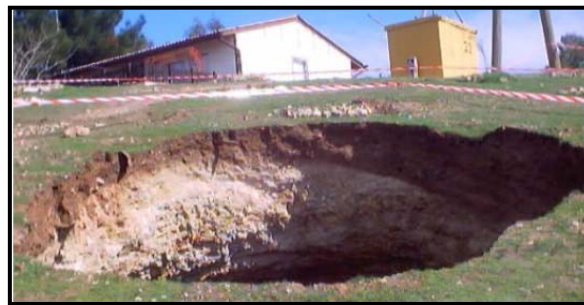
Surface cracking and ground settlement initially developed followed by appearance of sinkholes on the right abutment. Sinkholes on the left flank of the reservoir (in the local tourist village) appeared without warning and developed rapidly with 15 m of settlement and a 15 m diameter depression overnight in February 2003 (Fig.7). The sinkhole was dry, located on a slope on the northern side of a valley feature. The deposits at the surface standing vertically appear to be superficial silty soils, with perhaps bedded marls below. Although the initial sinkhole was filled with 1200 m³ of loose sandy gravel material and fenced off,

but the settlement continued. A further 3000 m³ of material was required to fill the settled surface of the sinkhole in two separate filling operations in May 2003 and October 2004. By March 2005 there were been a smaller settlement of the ground surface of about 0.5 m.

Fig.9: Left photo show the Ground settlement before the full development of the left bank sinkhole.

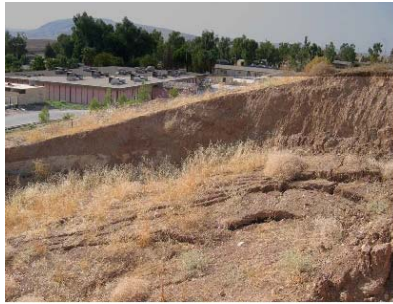
About 100 m up-stream from the dam, on the right abutment of the reservoir, a dipping limestone bed near the margin of the reservoir shows ground settlement. This movement could be partly related to sloping failure and translation of the rock beds as a result of fluctuating reservoir levels and residual high pore pressures in the slope. However, a sinkhole feature seems more likely (Fig.9). Although tested for, no connection has been established between this upstream sinkhole and those downstream [6]. It is believed that in some cases soil failure takes place (Fig. 10), which could be initiated due to over saturation of the soil by rain water. In addition slab failure (Fig. 11) was also recognized, most probably due to fluctuation of the water level in the reservoir.

Fig.10: Soil failure.

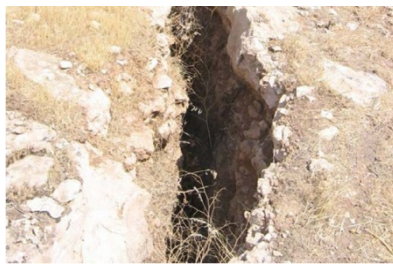
Fig.11: Upstream right abutment, open fissure resulting from slab sliding.

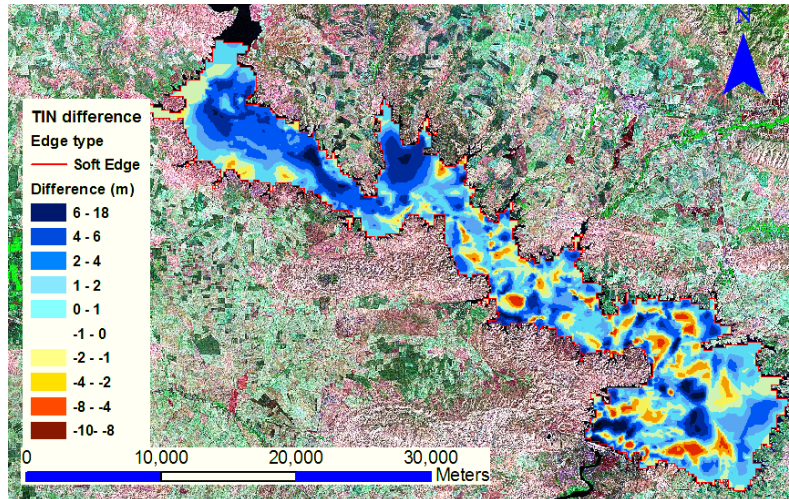
construction to 0.71 m.km^{-1} . The sedimentation rate in the upper section of the reservoir where the River Tigris enters the reservoir was greatest and gradually decreased toward the Mosul dam site. The greatest deposition thickness was 17.6 m in the upper zone of the reservoir. Furthermore, there are many areas like the middle and lower parts of the reservoir that are exposed to erosion (Fig. 12). This is believed to be due to the dissolution of gypsum and limestone beds forming sinkholes that might reach about 20 m in diameter and 9.6 m in depth. The conducted survey also confirms the presence of sinkholes and other karst forms within the reservoir, which are active, and continuously increasing in size, and exerting hazards to the Mosul Dam.

Fig. 12: Holes noticed at the bed of Mosul reservoir [17].
