# **Geophysical Investigation of Structural Failures Using Electrical Resistivity Tomography: A Case Study of Buildings in FUPRE, Nigeria**

## **Abstract**

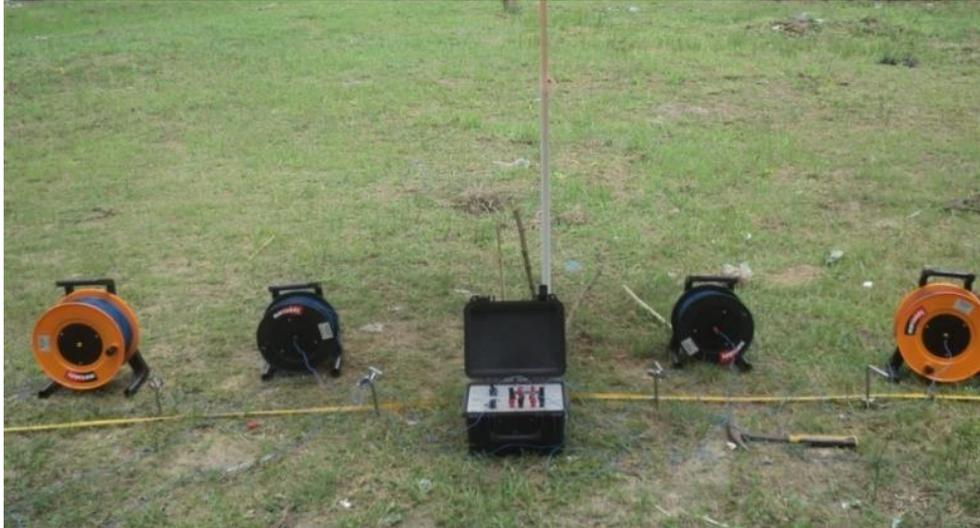
**Figure 2: Instruments arrangement for the data acquisition.**

The Vertical Electrical Soundings (VES) were conducted employing Ohmega Digital Terrameter (Figure 2). Schlumberger electrode configuration was employed for the data acquisition (Figure 3). Two current electrodes (AB) with a maximum separation of 40m were placed linearly at the same mid-point with two potential electrodes (MN) but at different distances from one another. The current electrodes were placed at equal distance,  $s$  from the mid-point of the configuration while the potential electrodes were placed at equal distance but at  $a/2 < s$ . Different spreads of current electrodes AB were achieved, thereby resulting in different probe depths.

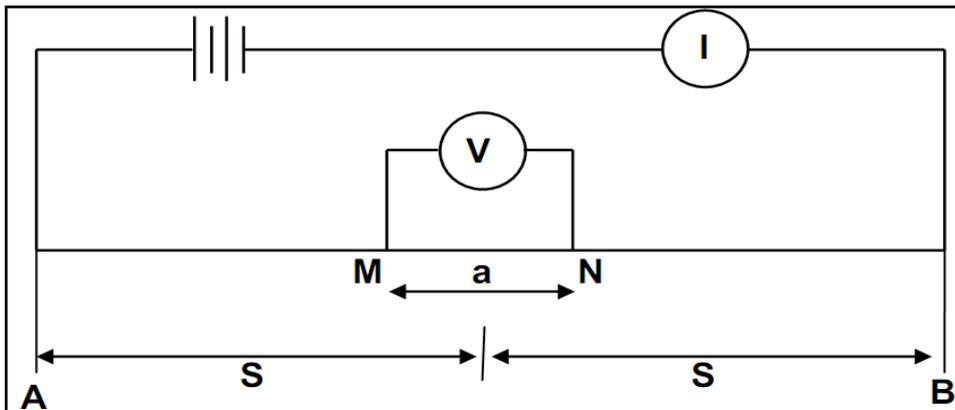
**Figure 3: Schematic of Schlumberger array for data acquisition.**

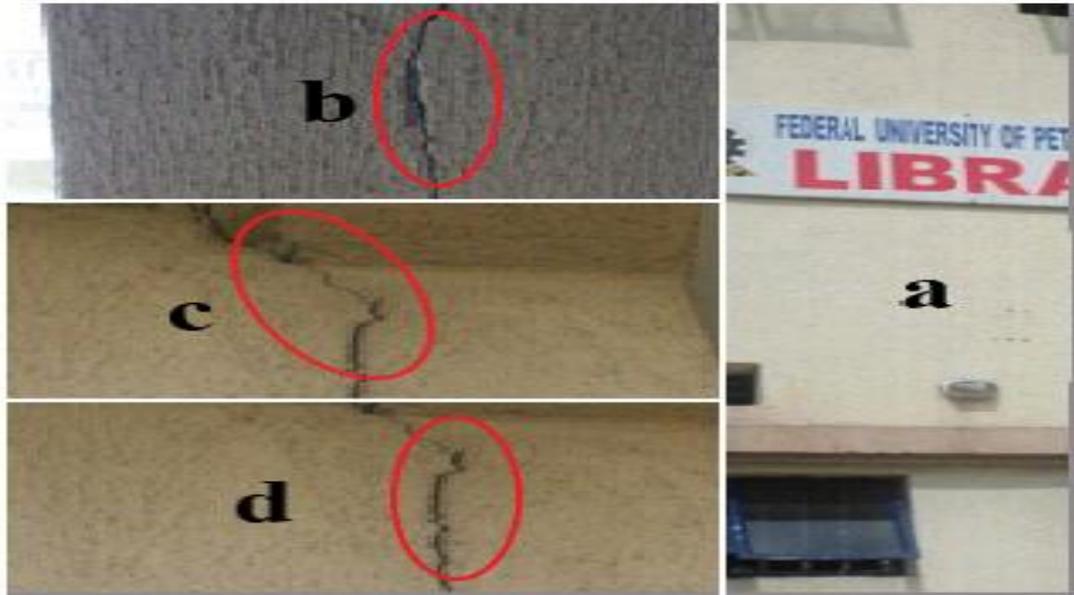
**Figure 4: Library Building, showing the severity of some vertical cracks on parts of the building (a) part of the building under study (b) vertical cracks upstairs (c) and (d) vertical cracks downstairs.**

The buildings under investigation are the Library, Administrative, College of Science and College of Technology Blocks constructed in 2007 (Figures 4 to 7). On the sides of each building, a total of four Vertical Electrical Soundings (VES) traverses were conducted amounting to a total of 16 VES locations.

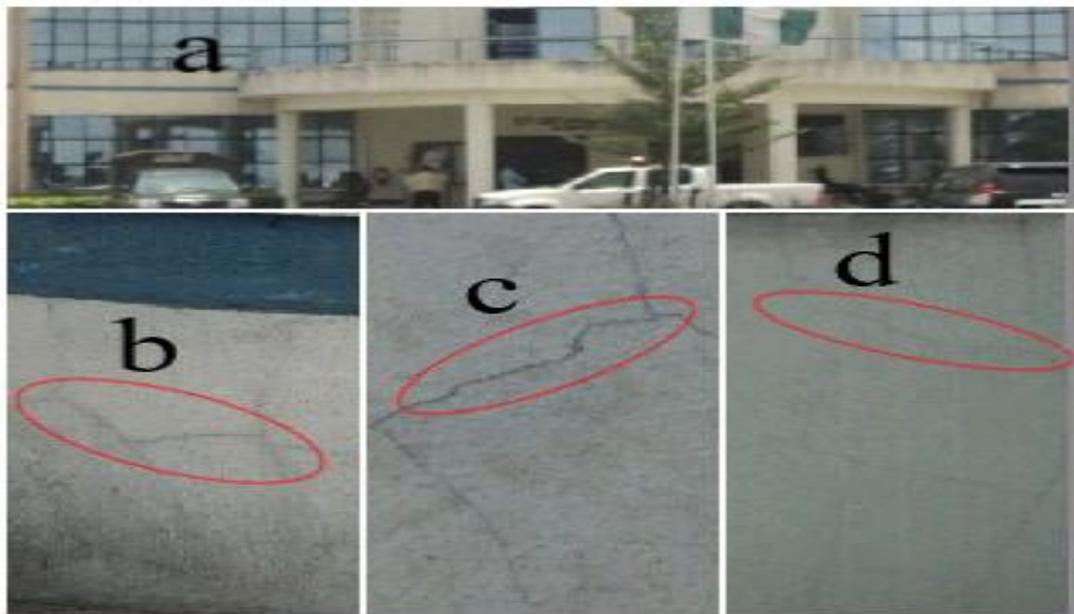
**Figure 5: Administrative Building, showing the severity of some diagonal cracks on parts of the building (a) parts of the building under study (b), (c) and (d) some diagonal cracks.**

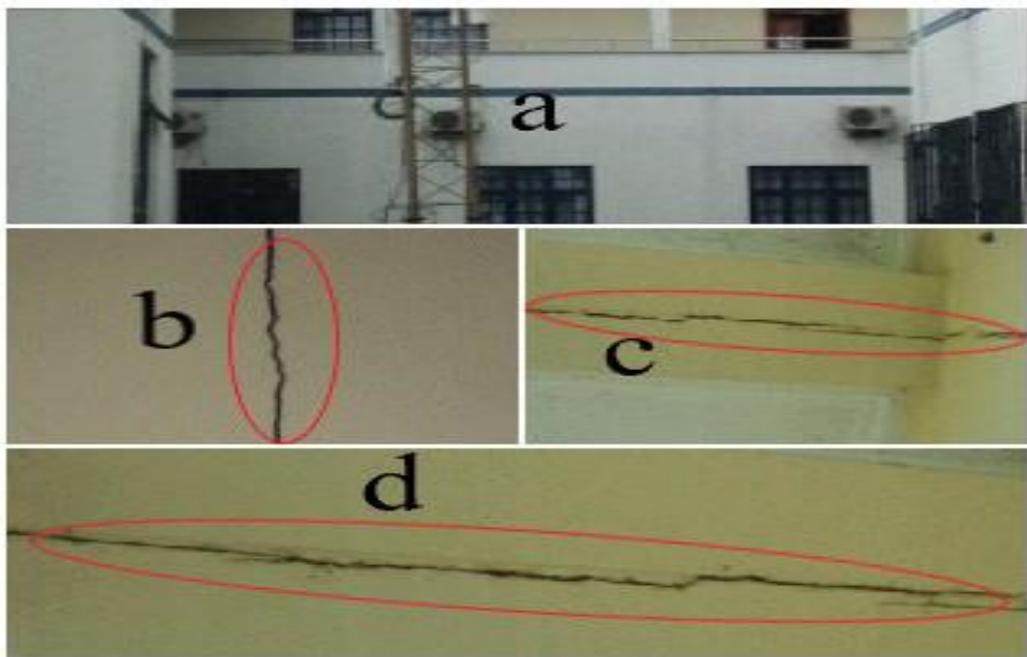
**Figure 6: College of Science Building, showing the severity of vertical and horizontal cracks on parts of the building (a) part of the building under study (b) some vertical crack (c) and (d) some horizontal cracks.**

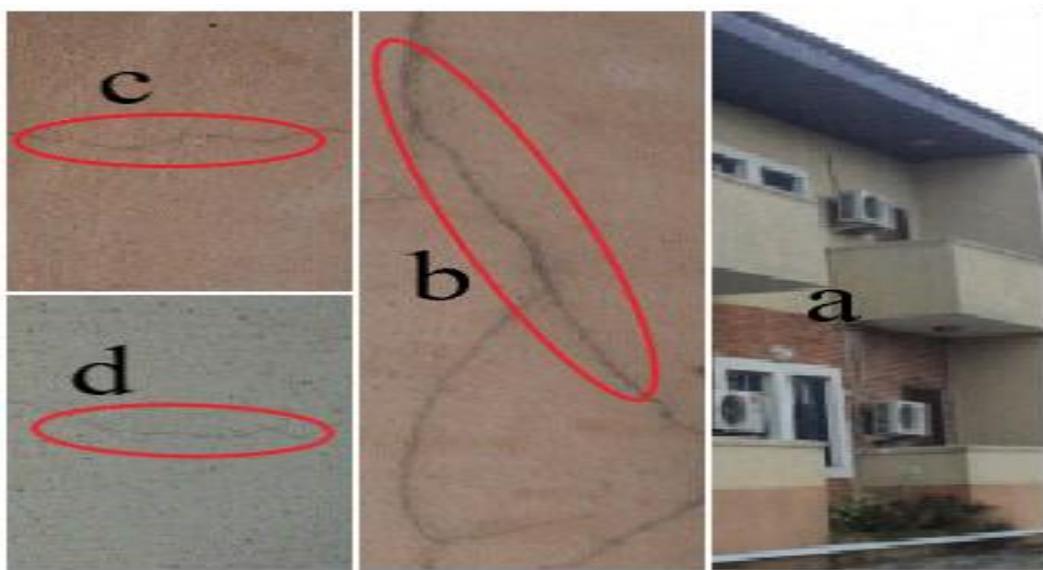
**Figure 7: College of Technology Building, showing the severity of some diagonal and horizontal cracks on parts of the building (a) parts of the building under study (b) diagonal crack (c) and (d) horizontal cracks.**

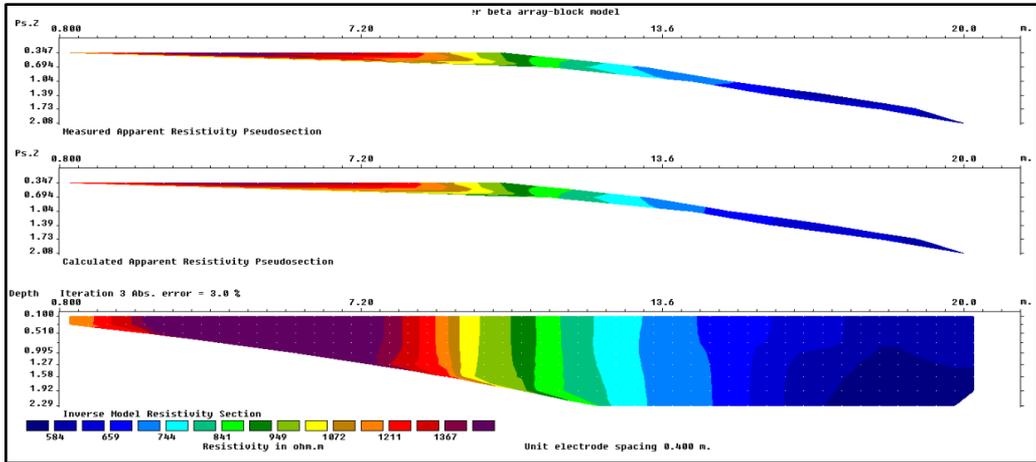
Figure 8: 2D Resistivity tomogram for profile LIB 1.

Figures 8 to 11 show the results for the Library building. Lowest resistivity values between 584 and 659  $\Omega\text{m}$  are observed at LIB 1 (Figure 8) in the deep near-surface layers (from 0.9 to >2.0m) and 660 and 707  $\Omega\text{m}$  at LIB3 (Figure 10) at a depth from 0.1 to 0.5m in the shallow near-surface layer. Soils within these zones are characterized as clayey-sand. Highest resistivities values between 2561 and >2877  $\Omega\text{m}$  are observed at LIB 2 (Figure 9) at depth from 0.5 to 1.0m in the shallow near-surface layer. Soil within this zone is characterized as sand.

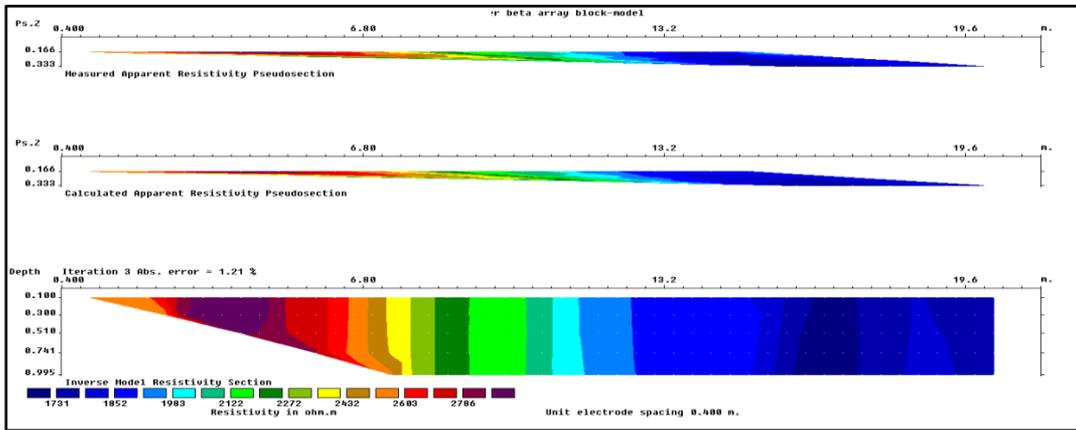
Figure 12: 2D Resistivity tomogram for profile ADM 1.

Figures 12 to 15 show the results for the Administrative Block. Lowest resistivity values between 262 and 394  $\Omega\text{m}$  were observed at ADM 4 (Figure 15) at depths from 0.1 to 0.4m and 406 and 625  $\Omega\text{m}$  at ADM 3 (Figure 14) at depths of from 0.1 to 0.4m. Soils within these shallow near-surface layers are characterized as clayey-sand. Highest resistivities values between 2798 and >2970  $\Omega\text{m}$  are observed at ADM 2 (Figure 13) at depth between 0.1 to 0.4m and 2683 and >2786  $\Omega\text{m}$  at ADM 1 (Figure 12) at depth between 0.3 to 0.5m in the shallow near-surface layers. Soil within these zones is classified as sand.

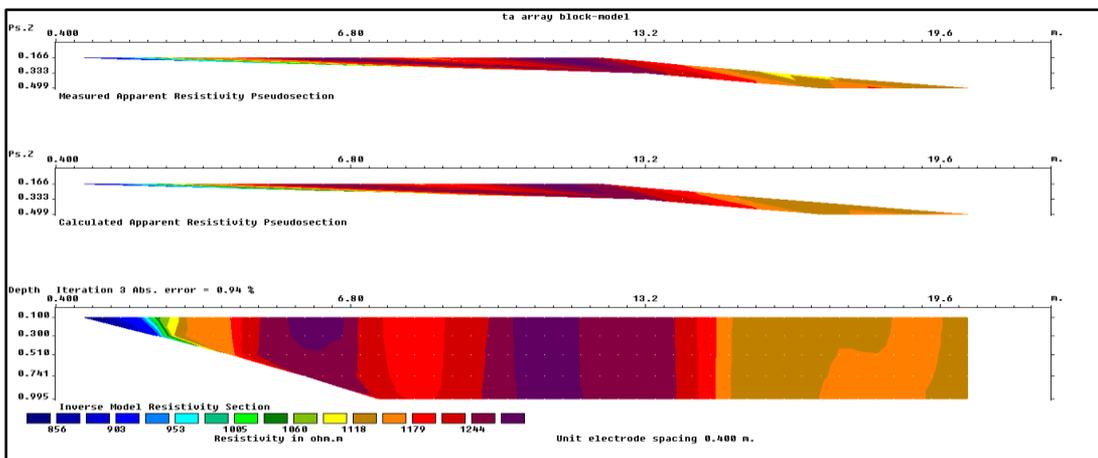
Figure 16: 2D Resistivity tomogram for profile COS 1.

Figures 16 to 19 show the results for the College of Science Block. Lowest resistivity values between 856 and 953  $\Omega\text{m}$  are observed at COS 1 (Figure 16) at depth from 0.1 to 0.3m in the shallow near-surface layer. Soil within this zone is classified as clayey-sand. Highest resistivities values are observed between 2470 and >2957  $\Omega\text{m}$  at COS3 (Figure 18) at depth from 0.1 to 0.5m also within the shallow near-surface layer. Soil within this zone is classified as sand.

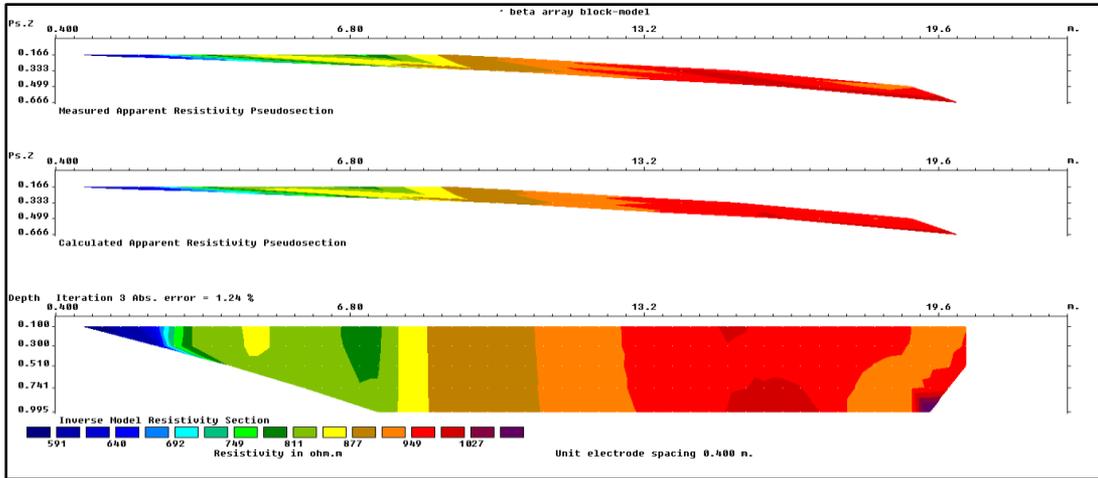
Figure 20: 2D Resistivity tomogram for profile COT 1.

Figures 20 to 23 show the results for the College of Technology Block. Lowest resistivity values between 250 and 399  $\Omega\text{m}$  are observed at COT 3 (Figure 22) at depth from 0.1 to 0.5m at the shallow near-surface layer. Soil within this zone is classified as clayey-sand. Highest resistivities values are observed between 1324 and >1480  $\Omega\text{m}$  at COT 2 (Figure 21) at the deep near-surface layer at depth from 0.7 to >0.99m). Soil within this zone is classified as sand.
