Age Estimation of Alqosh Main Landslide, North Iraq Using Exposure Dating Method

Abstract

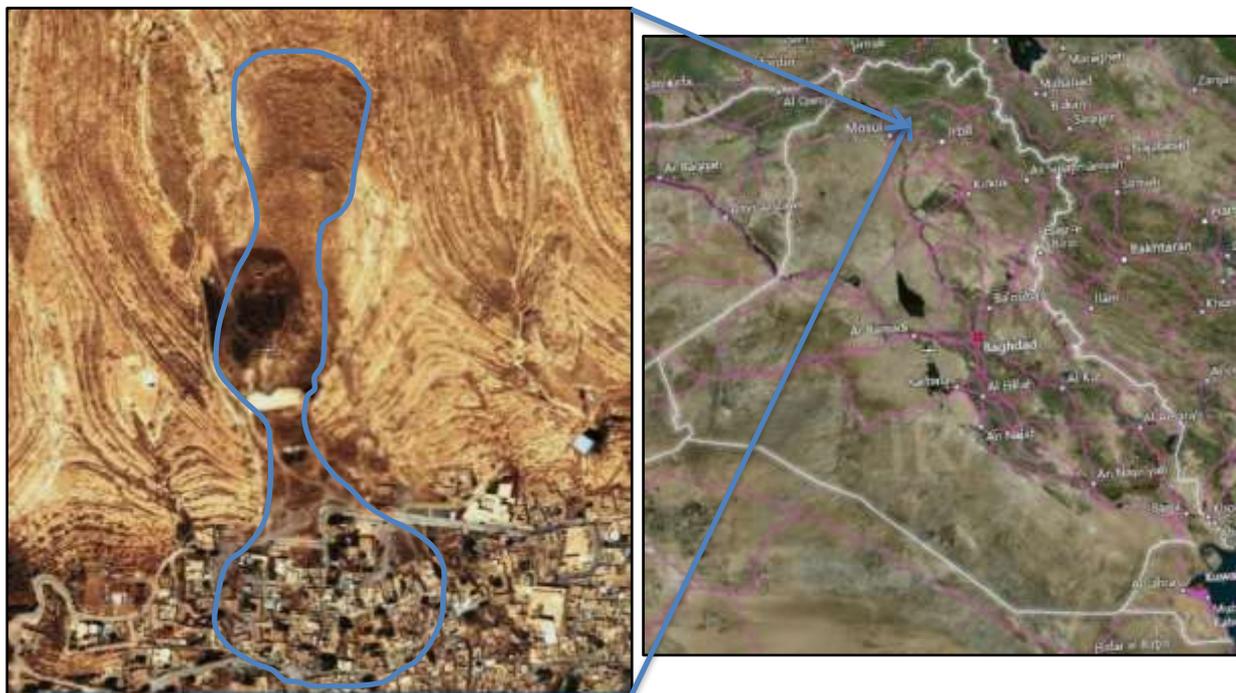
Figure 1: Flash Earth image showing the studied area

The studied area is located in the central northern part of Iraq, about 75 Km northeast of Mosul city (Fig.1), the center of the landslide has the following coordinates; Latitude: 36. 741362, Longitude: 43.094841. The coverage area of the landslide is about 49684 m² (0.5 Km²), the length is 496.84 m, whereas the width ranges from (144.2 – 61. 80) m; in the upper and lower parts, respectively.

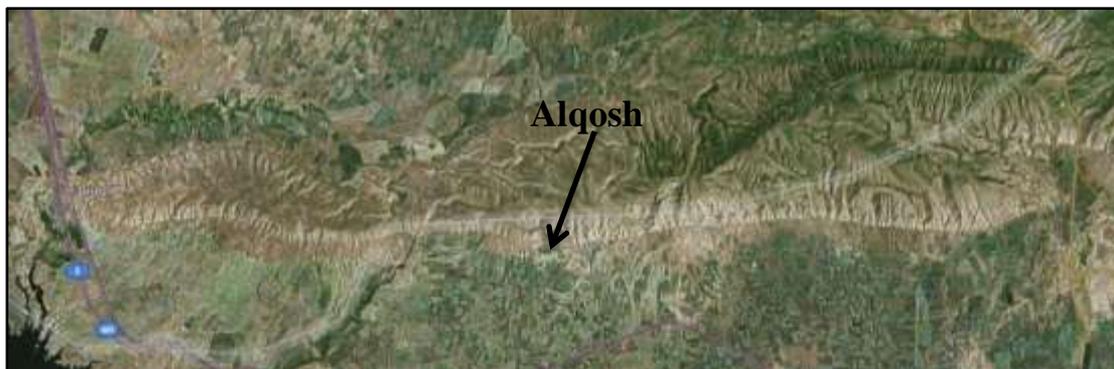
Figure 2: Flash Earth image of Alqosh anticline

The study area is located on the southern limb of Alqosh anticline, which is an E – W trending double plunging anticline. The length is 25.7 Km, whereas the width in the eastern side is 4.95 Km and in the middle part is 1.7 Km; as the narrowest width. The southern limb is very steep; up to 80°, whereas the northern limb is very gentle; not more than 20°; therefore, the anticline shows acute asymmetry (Fig.2).

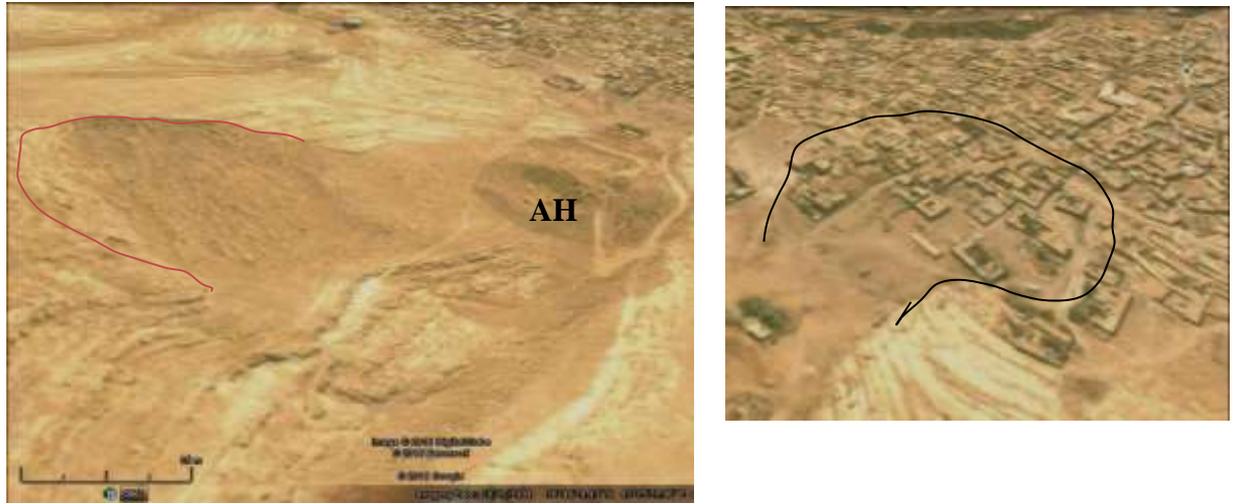
Fig.3: Google Earth image, **Left**) The main scarp (marked by red line); note the fallen blocks on the slope, and the artificial hill (**AH**), **Right**) What remained from the toe area (marked by black) on top of which many houses of Alqosh town are built

A large old landslide occur north of Alqosh town, its toe extends inside the town for about 105 m (Figs. 1, 3 and 4). The coverage area of the landslide area is about 49684 m^2 ($\cdot 0.5 \text{ Km}^2$), the length is 496.84 m, whereas the width ranges from (144.2 - 61.80) m; in the upper and lower parts, respectively. The highest point in the crown is at elevation of 699 m (a.s.l.), whereas the lowest point is at elevation of 553 m (a.s.l.). The height if the cliff in the crown is 43 m, the eastern side cliff has maximum height of 18 m, whereas the western side cliff is 19 m; however, the western cliff is steeper than the eastern one. The length of the scarp is about 120 m. The scarp is still active area for rock fall and toppling with small blocks up to 1.5 m from the well bedded carbonate rocks (Fig. 3).

The toe area of the main old landslide is almost vanished (Figs. 1 and 3 Right). The remaining of the toe area near the outlet of the landslide area from the

The crown area of the main old landslide is almost vanished (Figs. 1, 3, 4 and 10). The remaining scarp is about 43 m in height; due to weathering and erosion factors that were acting on the area since the sliding had occurred. However, the crown area is still an active erosion area as indicated by recent toppled blocks (Fig.3) and few rock fall blocks with other small slides in the area (Fig.5).

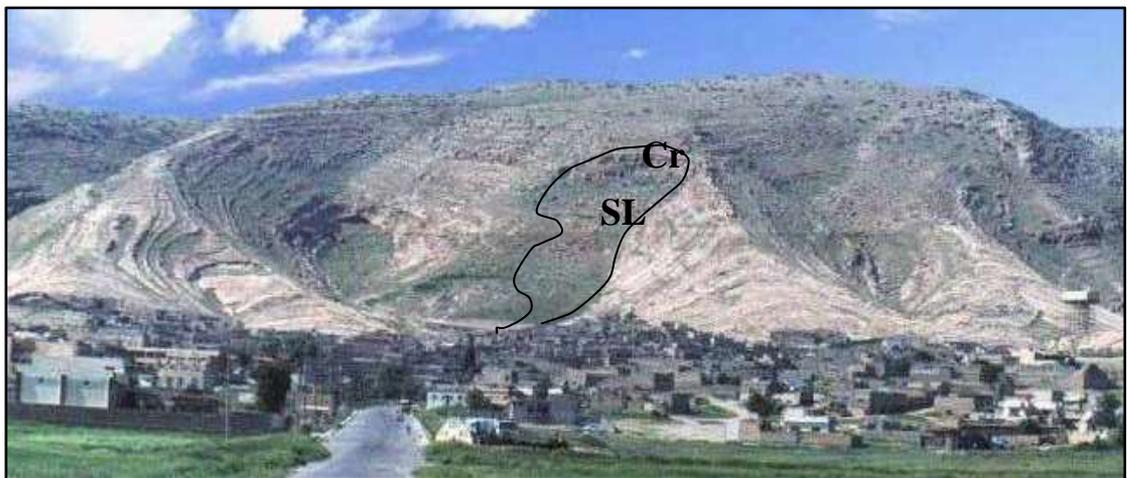
Fig.4: General view of Alqosh main landslide, limited by black line.
Cr: Crown area. **SL**: Small landslide

Although the landslide is very old; but the shear plane along which the slide had occurred is still visible (Fig.4), as indicated by the even surface of the plane; limited by two side scarps. However, some fallen blocks and small landslides have occurred and still can be see, especially in the uppermost part of the shear plane (Fig. 5).

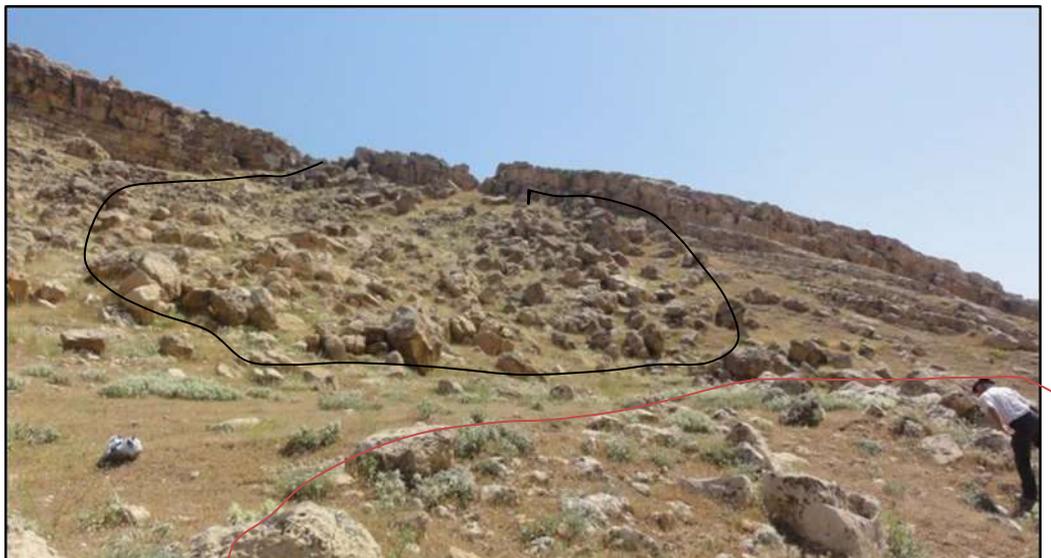
Fig.5: A small landslide (limited by black line) from the crown area of the main landslide. Note another very old slid mass (marked by red line)

From the field check, it was found that after occurring of the main old landslide; many other small slides had occurred from the same crown area (Fig.5), but the slid masses are very small as compared with the mass of the main slide (Figs.1, 3 and 4). The block sizes of the younger slides are also smaller than those of the main slide, the maximum observed size is less than 2 m (Fig. 5). Another slid

mass occur few meters below the small one. It is not possible to decide if it is the upper limits of the main landslide mass or another small old slide (Fig.5).

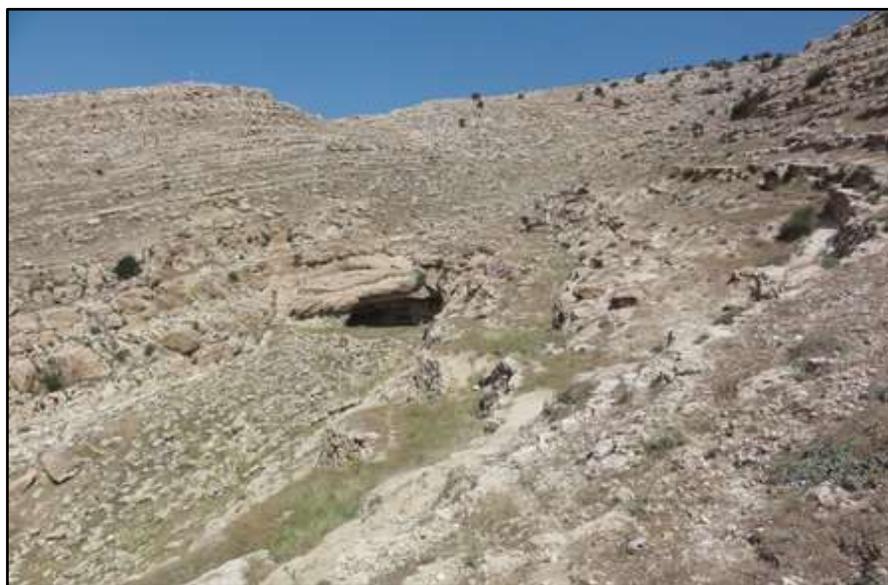
Fig.6: Note the smashed surface of the shear plane of the main slide

The shear plane along which the main slide had occurred is still obvious although very old (Fig. 6), it can be seen it is smoothed and smashed surface; as compared to other natural rough surfaces. The bedding planes can be seen only along the sides of the shear plane not within it (Fig.6).

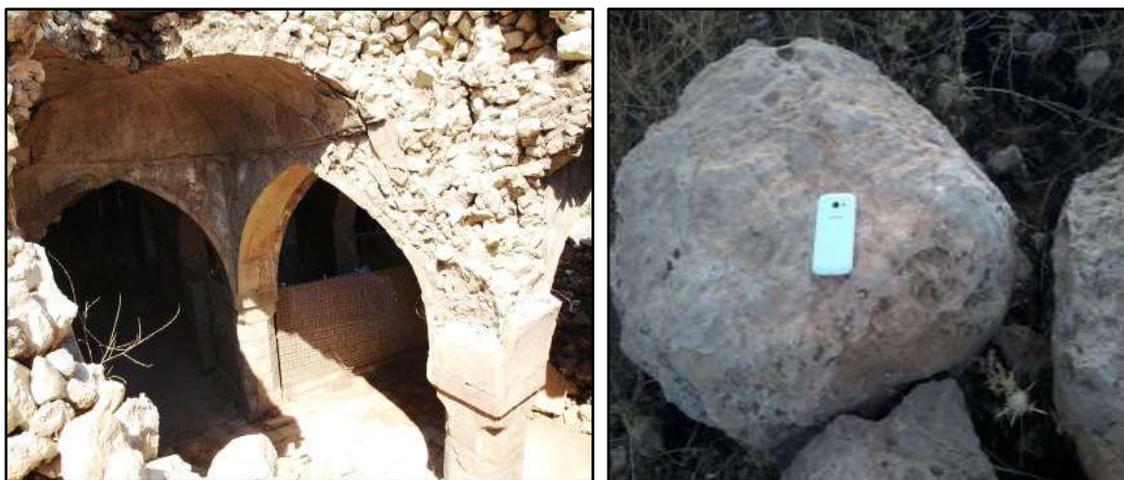
Fig. 7: **Left**) A collapsed old typical home in Alqosh town. Note the used rock in the building, all of them belong to the Pila Spi Formation. **Right**) A boulder derived from the Pila Spi Formation in the toe area; note the roundness of the boulder indicating long rolled distance and being very old; as a block

mountain is used as a residential area that forms the oldest part of Alqosh town. However, the original area of Alqosh town was in the valley where the landslide had occurred. Old people in Alqosh town and a historian from Alqosh (Mr. Lateef Polla) still remember the presence of large blocks of limestone in the toe area (Fig. 7 Right). The residences of the town have used those blocks in building of their houses during the beginning of the last century and may be older (Fig.7 Left). The remained blocks in the toe area are very rare, since majority of them are parted into smaller pieces and being used in building. They belong to the Pila Spi Formation and range in size from ($< 0.5 - \cdot 1.0$) m³.

The toe area of the landslide is within Alqosh town, which means the town is built on the toe area. The bulge shape of the toe is still partly clear (Figs. 1 and 3), although it is covered by the built houses during the long history of Alqosh town that returns back to about 1000 years B.C. Moreover, the old people still remember the existence of large strange blocks in the upper part of the town (the toe area), which were either removed during the beginning of the last century or were break down and were used for construction of the old houses (Fig. 7).

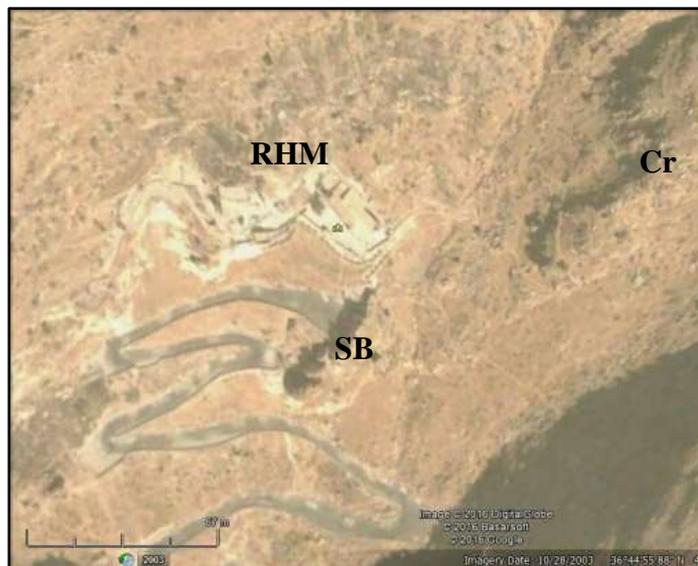
Fig.8: Google Earth image showing Rabban Hurmuz Monastery (RHM).

Note the large slid block (SB) and the crown (Cr)

6.4.1. Landslide of Rabban Hurmuz Monastery: A large landslide had hit the monastery of Rabban Hurmuz (Fig. 8 and 9), the slid mass is very clear; located few tens of meters southeast of the monastery; as well the crown area. The landslide is well known and documented in the archive of the monastery and the living monks there remember the event as passed from the previously living monks; it had happened in the year 1640. By comparing the crown area, shear plane, slid mass and toe area of both landslides (Alqosh and Rabban Hurmuz) to estimate the age of the former one; it was not possible to achieve an obvious idea. This is attributed to the fact that landslide of Alqosh is very old than that of Rabban Hurmuz.

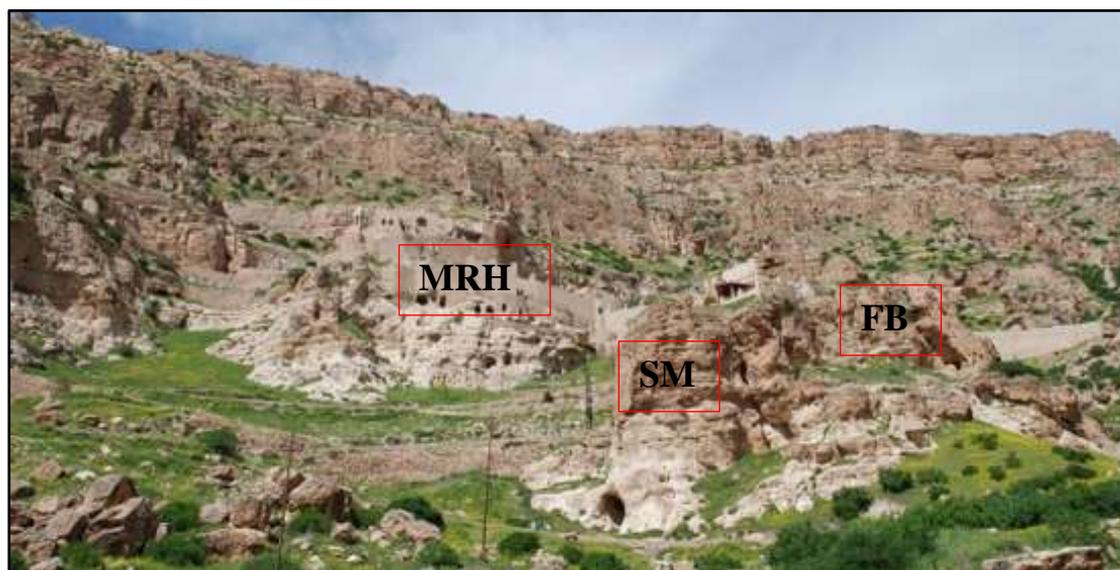
Fig.9: Monastery of Rabban Hurmuz (MRH).

Note the main slid mass (SM) and other fallen blocks (FB)

The status of the slid mass and those of individual blocks in both landslides of Alqosh (Figs. 1, 3, 6 and 7), and that of Rabban Hurmuz (Fig. 9) is compared, as the weathering traces is concerned to estimate the age of the former landslide. Moreover, the blocks of the main landslide of Alqosh and more recently toppled and/ or fallen blocks (Fig.12) are compared for the same reason. It is very clear that those of Alqosh landslide are older from that of Rabban Hurmuz.

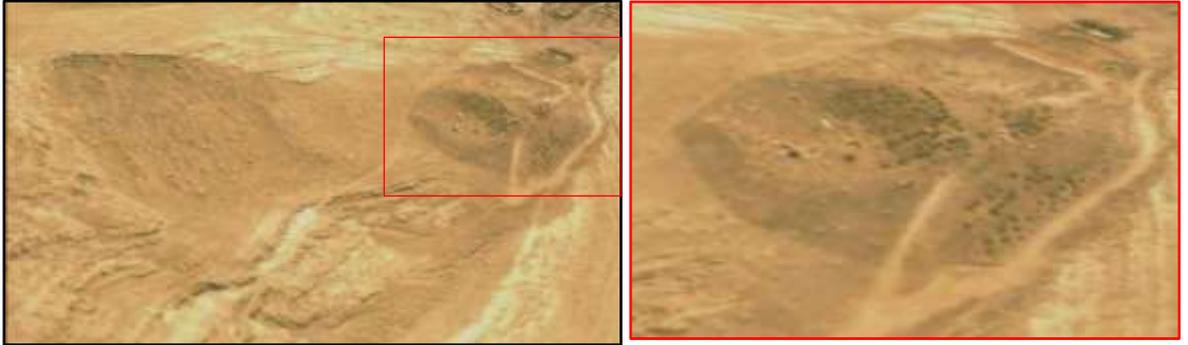
Fig.10: Google Earth image facing NE showing the artificial hill

In the lower part of the landslide area, an artificial hill exists that is built by soil accumulation (Fig.10). The hill was built before some (900 – 1000) years B.C. [11 and 12] and was used as a watching tower during Assyrian Dynasty. Nowadays, it is used as agricultural field after being flattened (Fig.10; enlarged caption).

6.5.1. Artificial Hill: An artificial hill exists in the lower part of the landslide area (Fig.10) on the shear plane; therefore it is younger than the landslide. The hill was built before some (900 – 1000) years B.C. [11 and 12] and was used as a watching tower during Assyrian Dynasty. The dating depends on a found coin in the hill, which was examined in France and was found to be during the dynasty of Assyrian King Sargon (Mr. Lateef Polla, personal communication, 2016). The nowadays height of the hill is about 25 m; but as it was used as a watching tower; then the original height is believed to be higher.

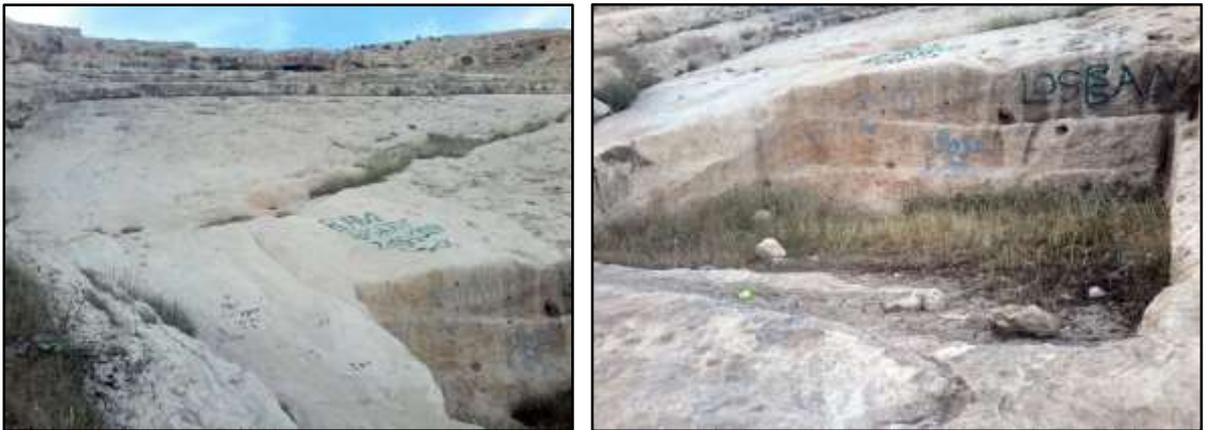
Fig.11: **Left**) Location of the Seen goddess temple, **Right**) The sacrificing location for the goddess

Goddess Seen; the god of moon, was an Assyrian goddess its temple was built in the landslide area (Fig. 11 **Left**) with the sacrificing place (Fig.11 **Right**). The age of the temple is estimated to be about 3000 years [11 and 12].

6.5.2. Goddess Seen Temple and Sacrificing location: The god of moon was an Assyrian goddess, it was built on the shear plane of the landslide (Fig. 11); therefore, it is younger than the landslide. The nearby sacrificing location is also clear; nearby the temple and on the shear plane of the landslide too.

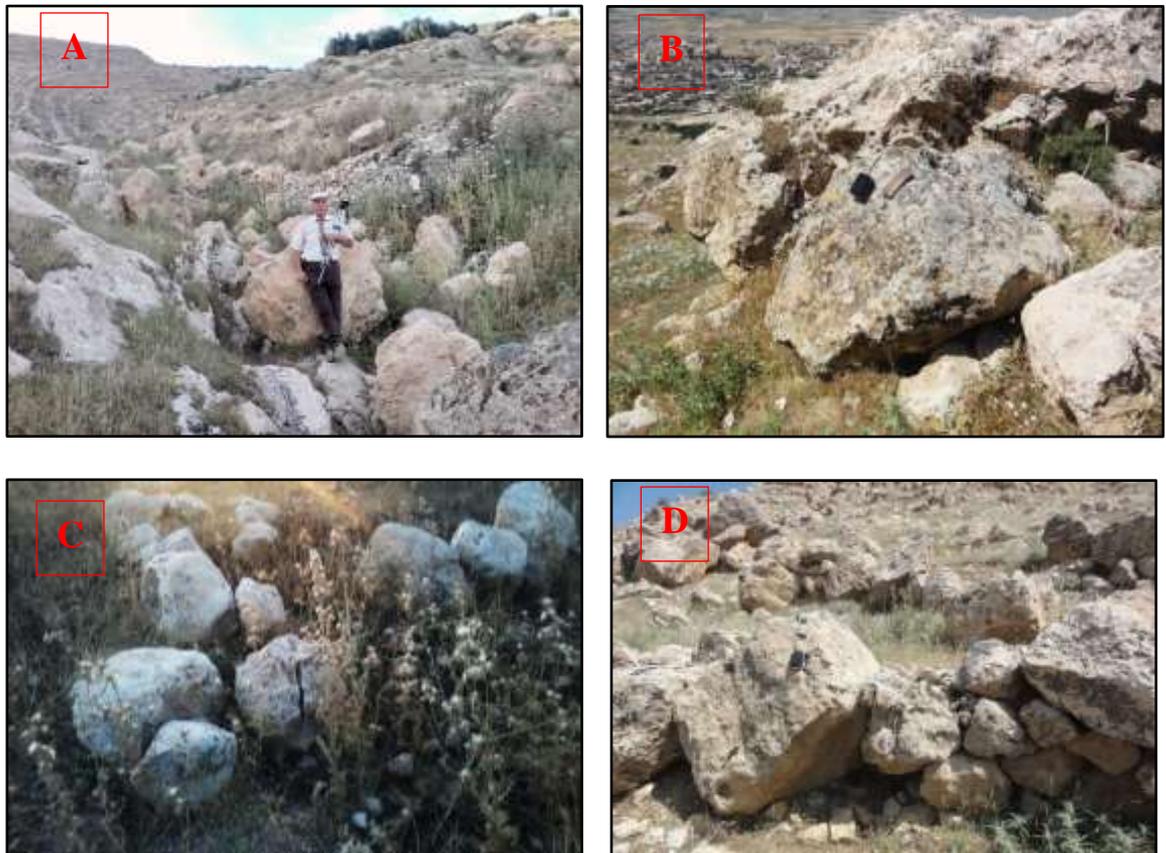
Fig.12: **A)** Compare the status of the old block and a recent one just behind Mr. Lateef Polla, **B)** Blocks of the main Alqosh landslide, note their weathering status, **C)** Blocks of the toe area, almost rounded due to very long time weathering and erosion processes acting on them, **D)** Blocks of the main slide

6.4.2. Limestone Blocks: Different limestone blocks of the Pila Spi Formation were thoroughly investigated in the field to recognize the effect of the weathering on the status of the blocks. The investigated blocks were from the toe area, on the shear plane and recently toppled and/ or recent slides (Fig.12). It is clearly visible the age differences between the blocks; due to weathering and erosion effect, but again no age estimation for the fallen blocks was possible.
