Hill slope housing development in Vinikilang, Yola, Nigeria: A geo-disaster risk

Nsikak E. Bassey¹, Abubakar S. Ahmed² and J.M. Ishaku³

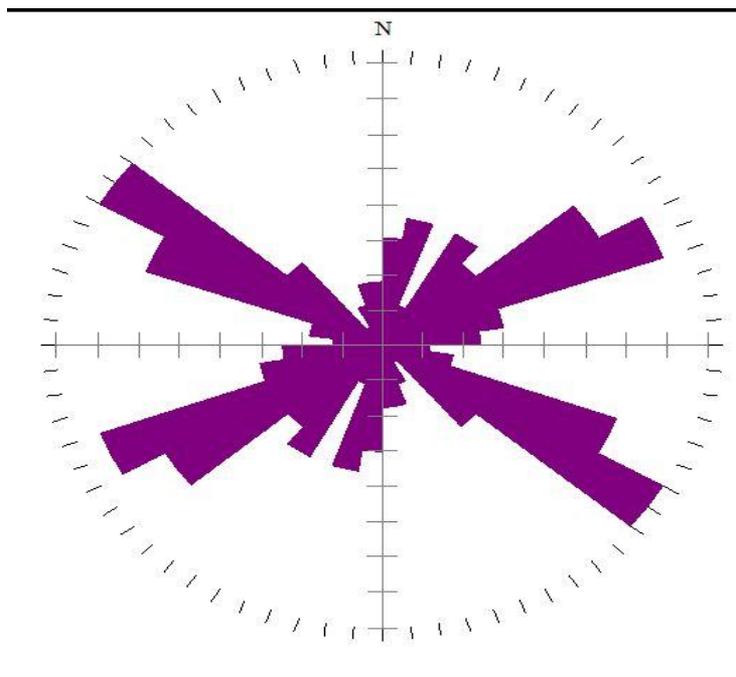
Fig.2 Rose diagram plot of structures (faults, joints and other fractures) in Vinikilang, NE-SW, NW-SE directions are dominant (n=97).

The faults were identified based on features such as striations and slicken sides. A rose plot of the strikes of the structures is presented in Figure 2. Northeast-southwest and northwest-southeast trends are dominant. They constitute part of a conjugate set of lineaments which control the flow direction of the Benue in the area (see: Fig.1). Benkhelil (1986) and Guiraud (1989) observed the occurrence of strike slip faults conjugated around compressive directions of 60° and 50° reverse to thrust faults in the upper Benue Trough. Minor structural directions are N-S, while NNE trend is complimentary. Field photographs show the highly fractured nature of the area (see Photographs 1, 3 and 6). Benkhelil (op cit) showed that Bima Sandstone has the highest density of fractures in the upper Benue trough. He also reported that Bagale hill is an anticlinal structure with a north east axis.
