# Mosul Dam the Full Story: Engineering Problems

Nasrat Adamo<sup>1</sup> and Nadhir Al-Ansari<sup>2</sup>

## Abstract

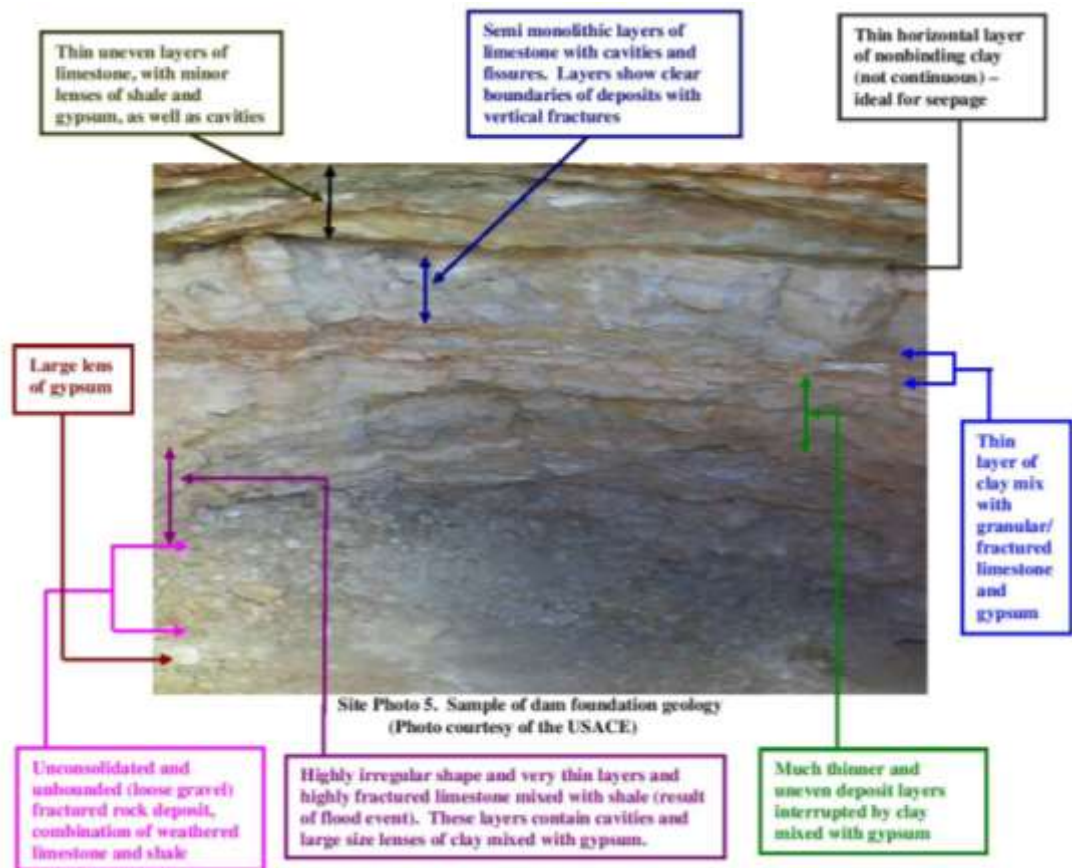
Figure 10: Foundation layers in Mosul Dam foundation (courtesy of USACE)

The sinkholes in the reservoir itself shown in figure (9) were mapped by a recent bathymetric survey which was carried out in 2011 by a Luleå university PhD student [2]. It is considered here that the development of such sinkholes will open new connections with the groundwater aquifer running below and around the dam site causing more problems of dissolution and formation of new sinkholes. The dam foundations itself is very complicated and the combination of gypsum/anhydrite layers with the cavernous limestone give rise to very favorable conditions for seepage and dissolution environment. Figure (10) gives a representative picture of this condition.

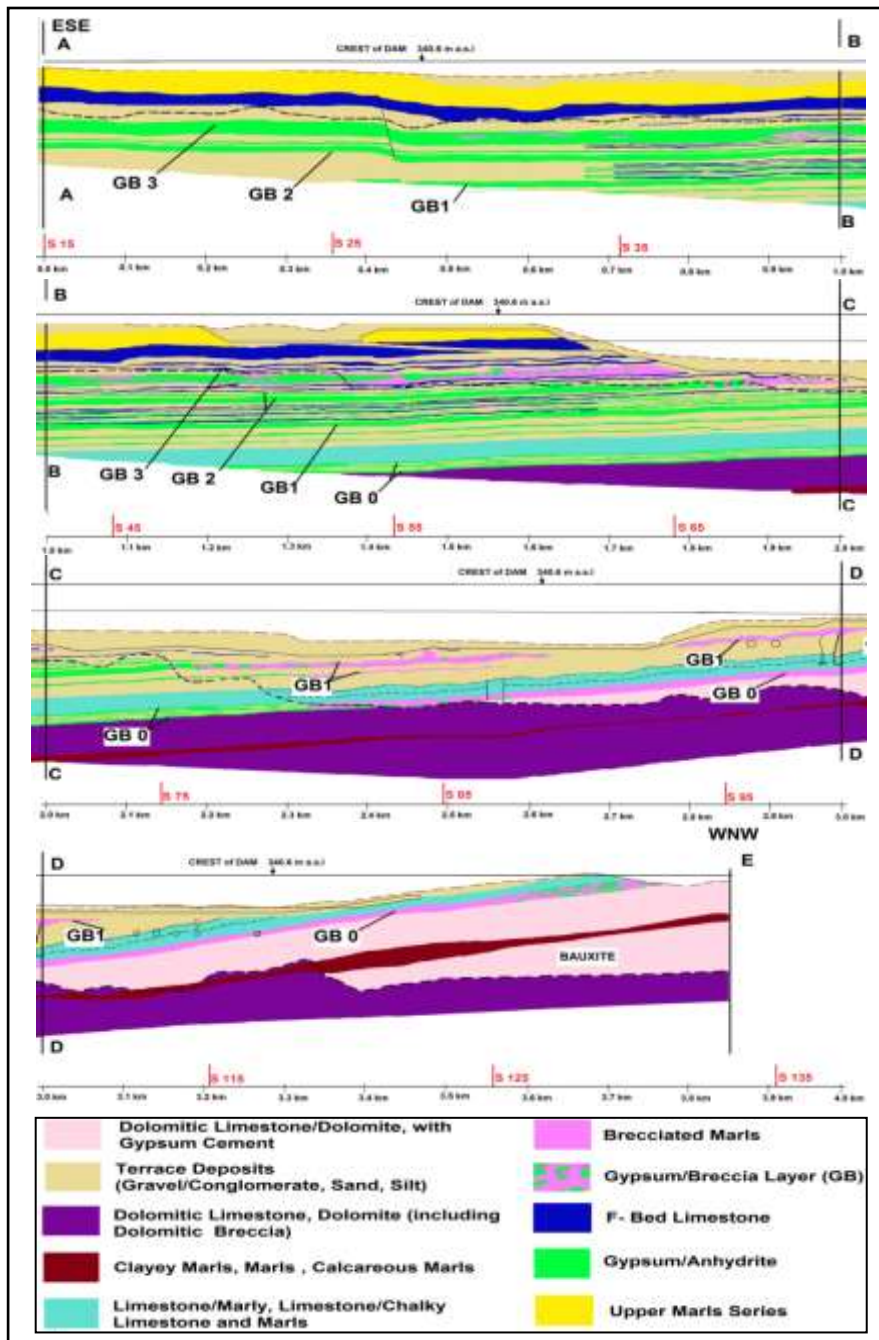
Figure 11: Geological Cross Section along the axis of the dam. (Due to the length of the cross section is segmented here into parts which are stacked on top of each other in this figure).

The existence of highly karstified and jointed limestone layers in the dam foundations gave rise to the formation of highly developed conduits and caverns which form easy conduits to the flow of ground water. This had resulted in the extensive dissolution of gypsum and gypsum anhydrite rocks present above and below these limestone layers. These dynamics caused the collapsing of whole layers of clayey marls into the underneath cavities forming beds composed of brecciated gypsum particles and anhydrite blocks embedded into a loose clayey matrix. Four such layers were discovered during the geological investigations and

were called the (Gypsum-Breccias) layers. These layers had thickness which ranged between (8) meters and (16) meters. The first layer was found at a depth of (80) meters in the river section and it was marked as the (GB0) layer. The other three layers were at higher levels. The last one i.e. the (GB3) was discovered at the foundation of spillway chute ski jump. The (GB) layers proved to be very important due to their erratic behavior during the grouting of the deep grout curtain under the dam. Figure (11) shows the geological cross section under the dam. Figure (12) gives the litho-logical column under the Mosul Dam central part.

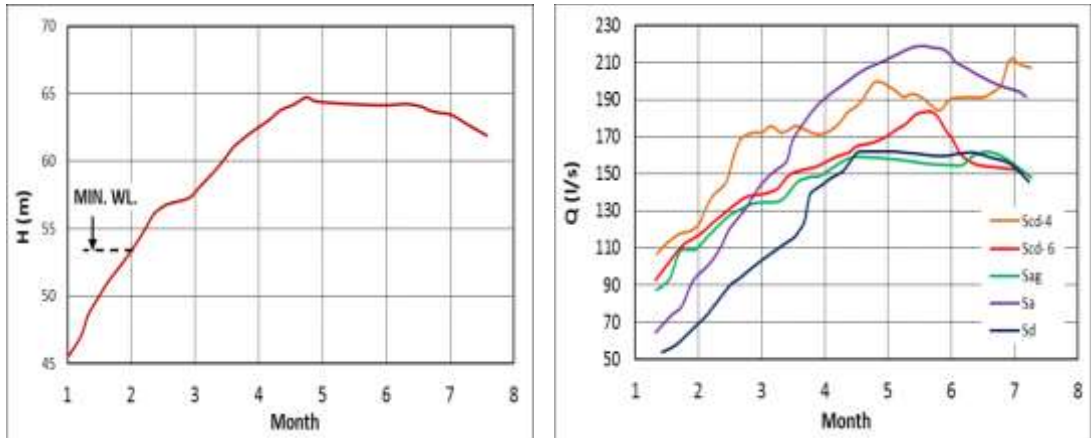
Figure 16: Left, reservoir water level increase      Right, spring discharge variation  
(for the period February-August, 1986)

In winter 1986 as the reservoir level increased for the first time seepage began to appear from six major springs at the left bank downstream of the dam at different elevations along 1.5 km long stretch. Seepage also happened in the deep river section which was discovered from observing the increase of sulfate concentration in the water there. Indications of gypsum mineral leaching from the foundation rocks were evident which raised much concern then. Measurements and sampling of the seepage water were done on the left bank by collecting the water in channels and using weirs. The downstream coffer dam used during diversion was raised and fitted with a measuring weir so to measure and sample the seepage from the deep river section. Water samples were taken at two weeks interval and analyzed for their mineral content to establish the quantities of gypsum and other minerals being leached from the foundations. Results of seepage surveillance from February 10, 1986 to August 16, showed that the recorded seepage through the Main dam foundations and the left bank increased from 500 l/s to 1400 l/s in which water head had increased from 49 m to 65 m. Springs (Sa) and (Sd) in the left bank alone had increased from 150 l/s to 900 l/s (figure 16). The submerged springs at the river channel showed an increased transmissibility by 40% during the same period (from 630 m<sup>3</sup>/day to 880 m<sup>3</sup>/day) [17].

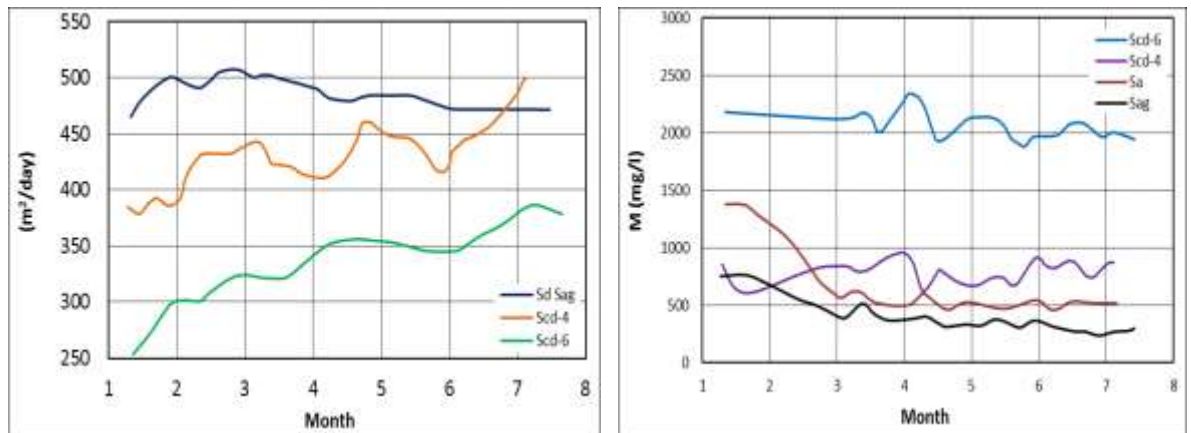
Figure17: Left: Spring transmissibility      Right: Soluble salt concentration  
for the period February-August, 1986.

Dissolution quantities of minerals from Dam foundations were established from the difference in the content of dissolved minerals in seepage water in relation to its content in the reservoir water (amounting to 250 mg/l as average). The total mineral contents of the seepage water by individual spring zones are presented in figure (17). Analysis of these results yielded that 13 000 tons of minerals were leached from the dam foundations at this period and that 70% of this quantity originates from the submerged springs. The dissolution intensity ranged from 42 to 80t /day.

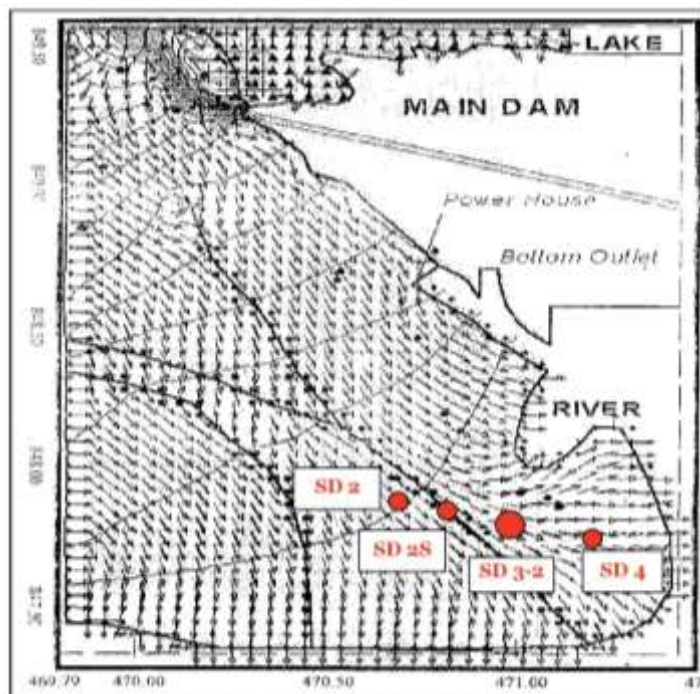
Figure 22: Flow net of ground water flow towards sinkholes

The development of these sinkholes seems to be connected to the dissolution of gypsum in the underground layers due to the activity of Wadi Al malih aquifer on one side and the fluctuation of the tailrace water level resulting from the operation of the re-regulating dam downstream on the other side. The same dynamics was believed to be responsible for the appearance of water spring which was discovered after the washing away of terrace material by water discharging from the spillway at the opposite side of the river. The spring was on the same line of the sinkholes and its water had the same chemical contents of the sinkholes and the aquifer. Figure (22) shows the flow net of ground water flow towards the sinkhole and the discharge of this water into the river.
