# Case Study: Investigation, Analysis and Mitigation of Rock Instability for a Potential Slope Failure in Highly Weathered Granite at Pinto Valley Mine in Arizona

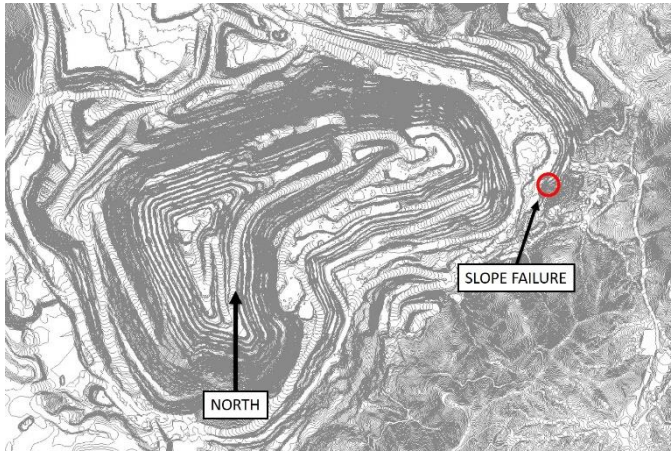
Fig. 1. Pit map showing location of slope failure.

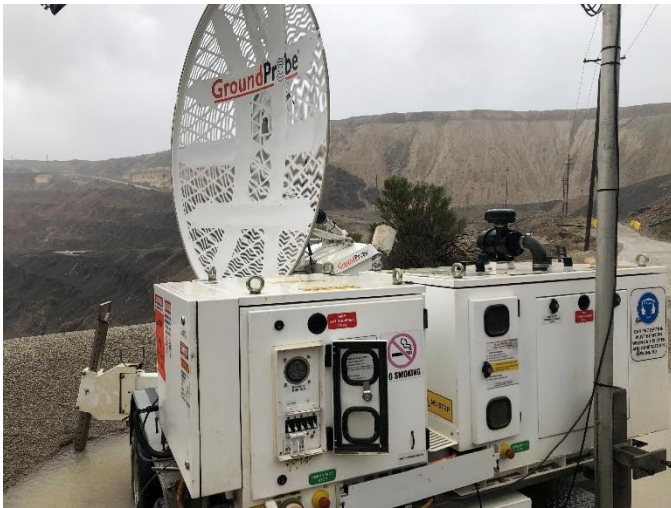
Fig. 1. Groundprobe SSR used to monitor pit high walls

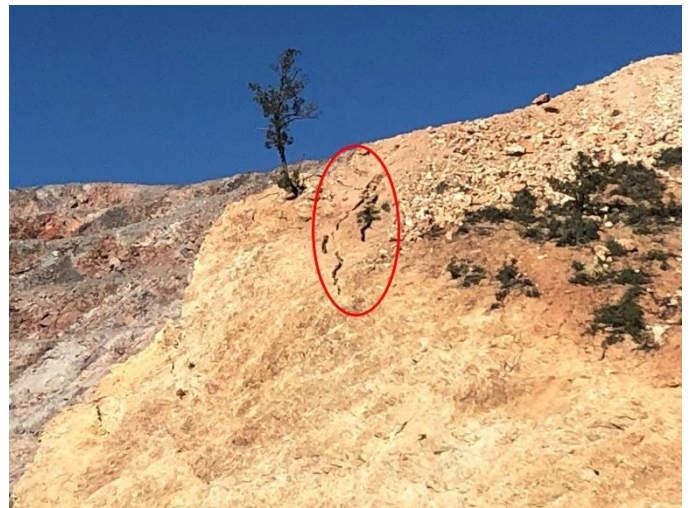
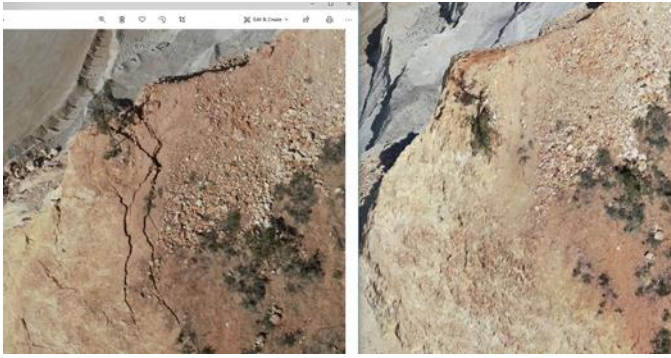
The slope finally failed in the late evening of 30 October 2019. Mining personnel indicated larger amounts of the rockfall began during the previous evening until the slope failed due to being severely weathered and having low rock mass properties. Several alerts were emailed from the SSR indicating urgent and geotechnical issues are in progress. The mine drone was flown above the failure and exhibited all inclusive images. Figure XX shows the drone photo of the failure from above and Figure XX shows the failure close up at the haul road. Figure XX shows the tension cracks at the crest of the benches prior to failure.

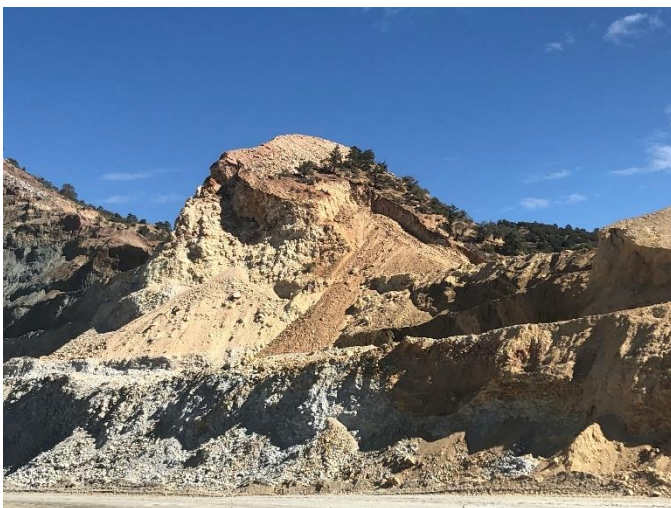
Once the failure reached equilibrium, mining personnel and engineers investigated the area to ensure no further movement would progress. The failure looked to be a circular failure as well as being severely weathered and having low rock mass strength.
