Field Observations of Water and Ice Problems in Railway Tunnels from a Maintenance Perspective

Abstract

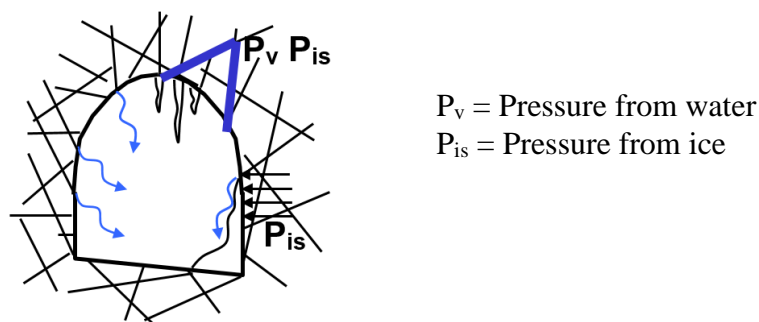
freezing rate (e.g., [2] or [3]), changes in the freezing periods and their duration [4]. If a freezing period has a long duration, or if the freezing rate is rapid, the leaks become frozen. The water freezes and ice formations are created, which act like a plug for the leakage point; it ‘freezes dry’. If instead the leak is subjected to short periods of freezing and thawing, the joint will never become frozen and water will continue to leak, resulting in growing ice formations. Another factor in ice growth is that the leakage water transfers heat from inside the rock mass to the cold tunnel wall. The heat content of the water prevents the rock from freezing despite the freezing tunnel air temperatures. As a result the leak will continue causing ice formations to grow where the water meets the cold tunnel air. Ice developing in joints and cracks can exert a pressure on the joint or crack surface (P_{is}), which leads to frost shattering of rock and shotcrete (Figure 3).

Figure 3: Ice loads (P_{is}) arising when leakage occurs in the frost zone [5]

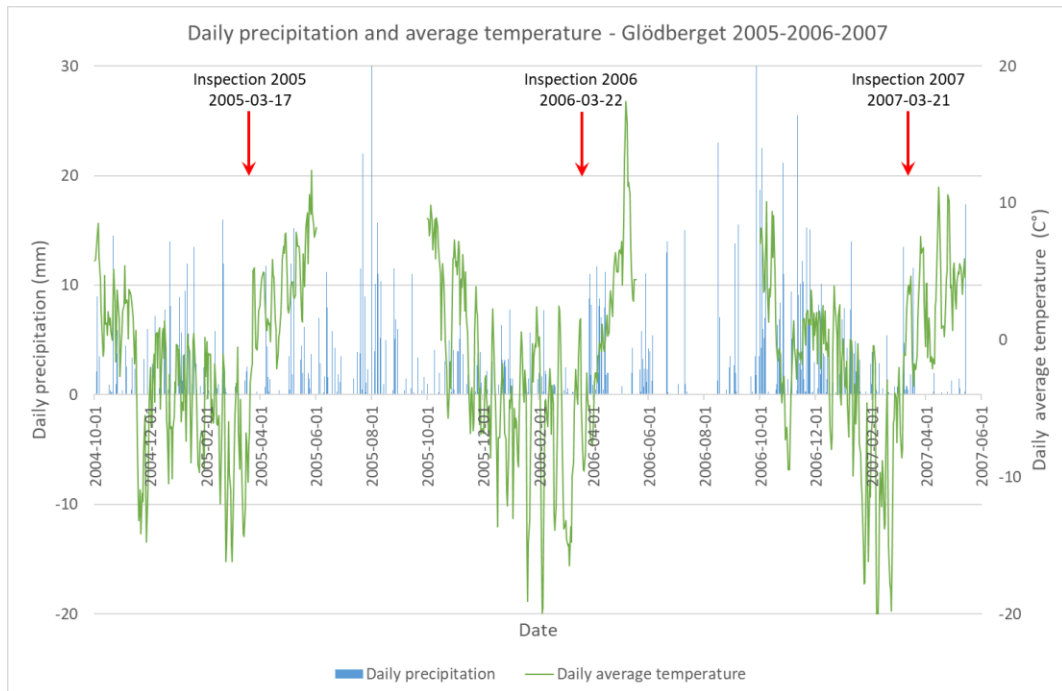
The photos in Figure 22 also show the difference in moisture conditions on the tunnel wall. During the 2007 inspection, the shotcrete was much moister than in the two previous years, which can partly be explained by the fact that the temperature had fluctuated around 0°C for about a week before the inspection (Figure 23). This may have caused warmer outside air to penetrate the tunnel, thawing the rock mass nearest the tunnel wall and causing the leak to become active again.

Figure 23: Daily average for precipitation and temperature for the Glödsberget tunnel over three years
