Mystery of Mosul Dam the most Dangerous Dam in the World: Karstification and sinkholes

Abstract

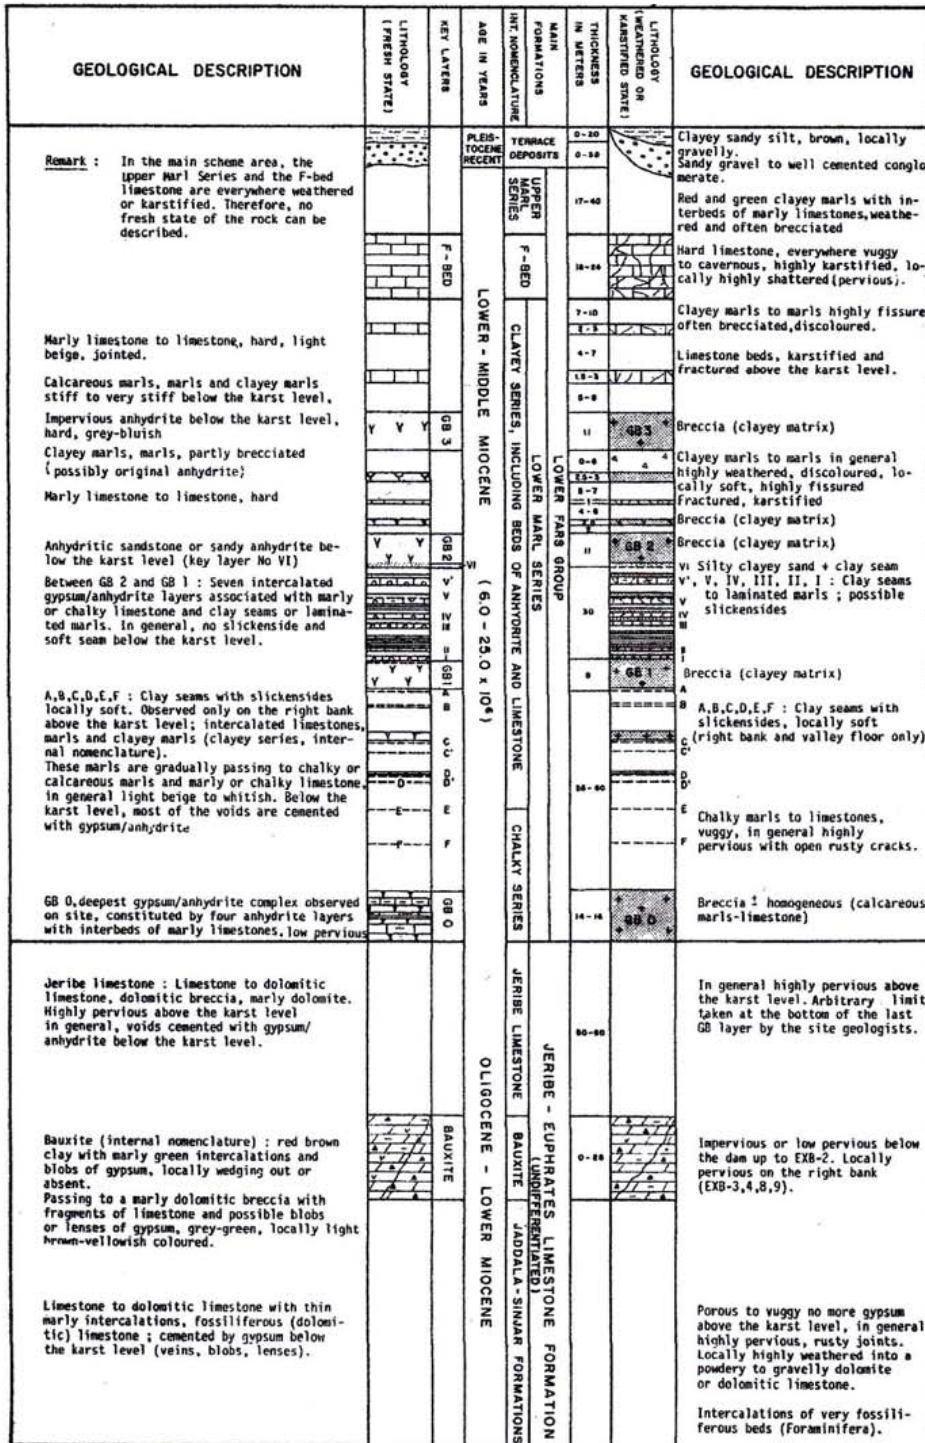
The right (west) abutment is located in the steeply dipping Fatha Formation within Butmah East anticline with SE plunge being in the reservoir north of the dam, whereas the left (east) abutment is located on gently dipping beds of the Fatha Formation, which is overlain by fine clastics of the Injana Formation. These differences in lithology as well the dip amount and direction along both abutments as well upstream and downstream of the dam have certainly affected on the hydraulic pressure and increased the dissolution ability of the gypsum and limestone beds, along the abutments and the foundations, which are already karstified in nearby areas. Consequently, more gypsum, anhydrite and limestone were dissolved and karst openings are continuously increased, as the exerted hydraulic pressure is continuous. Figure 2 show the detailed description of the beds at Mosul Dam site.

Fig. 2: Lithological column of beds at Mosul Dam site [7].

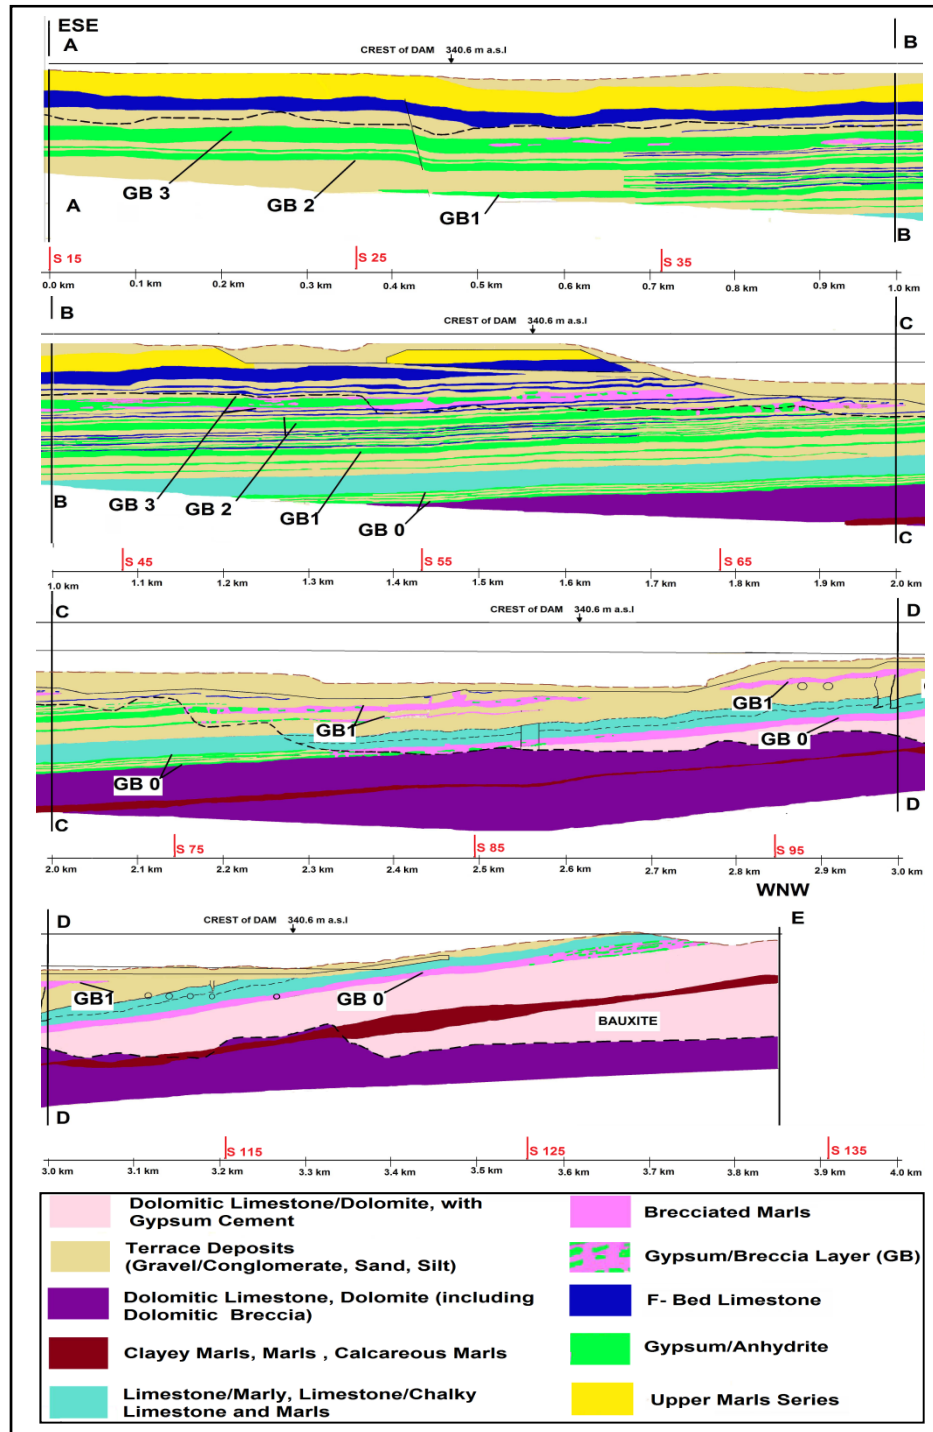
It should be mentioned however, that karstic limestone and the development of solution cavities within the gypsum and anhydrite layers are the main geological features under the foundation of the dam. The bore holes data indicated that four significant gypsum units were identified during design and construction varying in thickness from 8 to 16m and identified as GB0 (Gypsum Breccia 0), GB1, GB2, and GB3 in ascending order (Fig.3) [7].

Fig. 3: Geologic cross section along the axis of the dam.

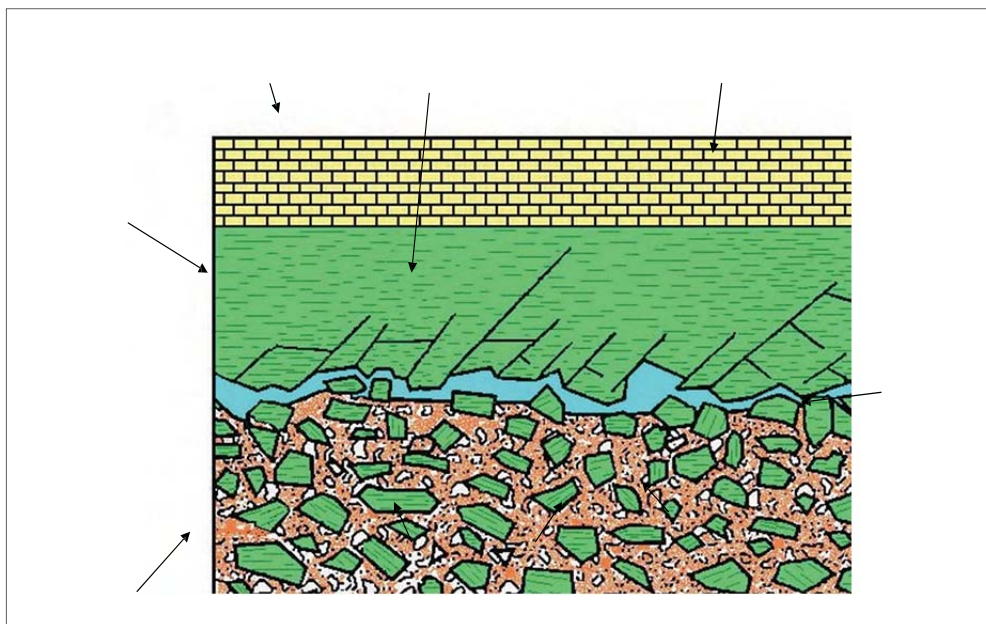
At Mosul dam site, major dissolution occurs at the “karstic line”, where anhydrite converts to gypsum and this unit is subsequently dissolved and eroded by seepage (Fig. 4). This phenomenon of evaporites dissolution by groundwater and the void is generally filled with collapse breccias from the overlying beds (Fig. 5) [11].

Fig. 5: Development of breccia within a layer of gypsum [11].
