## **Dam Safety and Earthquakes**

### **Abstract**

**Keywords:** Earthquakes, Seismicity, Epicentral Distance, Focal Distance, Peak Horizontal Acceleration, Pseudo-static Analysis, Dynamic Analysis, Maximum Credible Earthquake, Safety Evaluation Earthquake, Maximum Design Earthquake.

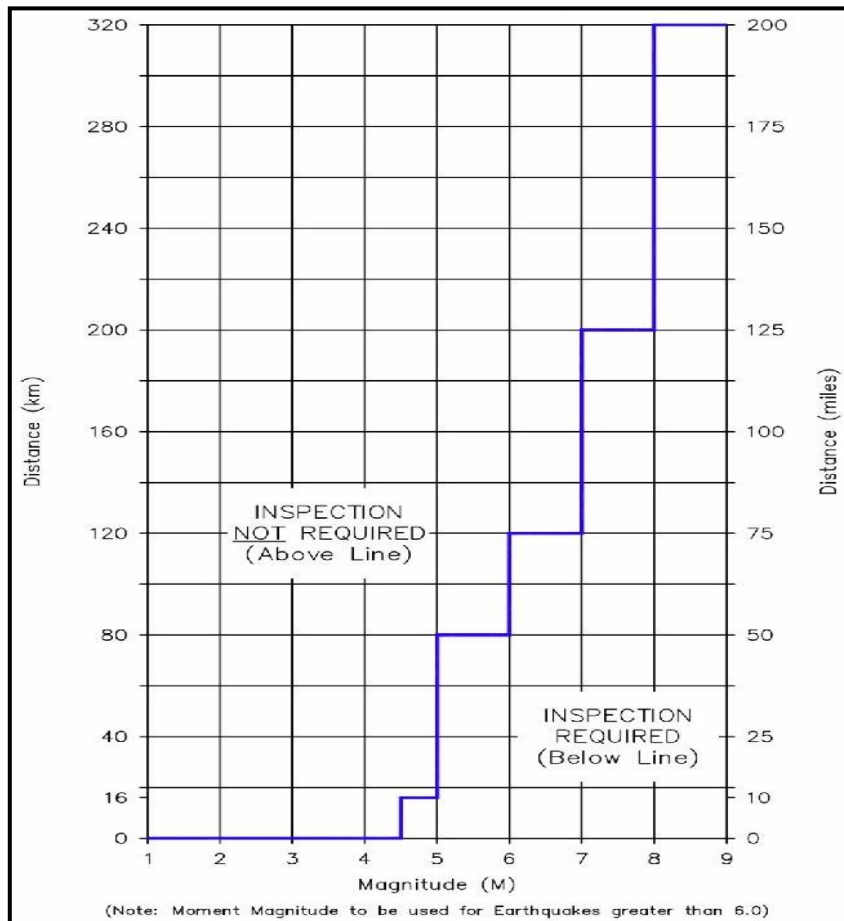
**Figure 4: Earthquake Inspection Criteria – Simplified Model [47].**

1. The following criteria presented by USACE and known by “Earthquake Inspection Criteria Simplified Model” are listed below and illustrated by Figure 4 allow operations managers to assess the immediate need for site inspections and evaluations based on earthquake magnitude and proximity to an earthquake epicenter. If the magnitude and distance fall within the specified ranges, project operation personnel will conduct an inspection and check all the seismic instruments and alarms, if any are present at the project. If no seismic instruments are located at the project, then earthquake magnitude and epicenter data can be obtained from regional or international seismological centers such as; The Global Seismographic Network (GSN), The International Seismological Centre (ISC) or The European Mediterranean Seismological Centre (EMSC).

2. If any of the seismic alarms indicate a (PGA) of 0.05g or greater, or if damage is identified, then the inspection results performed by the project staff will be reported immediately to the designated personnel within the next higher engineering authority who will carry out themselves a more comprehensive inspection. The USACE criteria, aforementioned, for the need or otherwise to carry out the inspection is stipulated in the following ranges and illustrated in Figure 4:

- Magnitude 4.5 through 4.9 within 16 km (10 mi).
  - Magnitude 5.0 through 5.9 within 80 km (50 mi).
  - Magnitude 6.0 through 6.9 within 120 km (75 mi).

- Magnitude 7.0 through 7.9 within 200 km (125 mi).
- Magnitude 8.0 or greater within 320 km (200 mi).

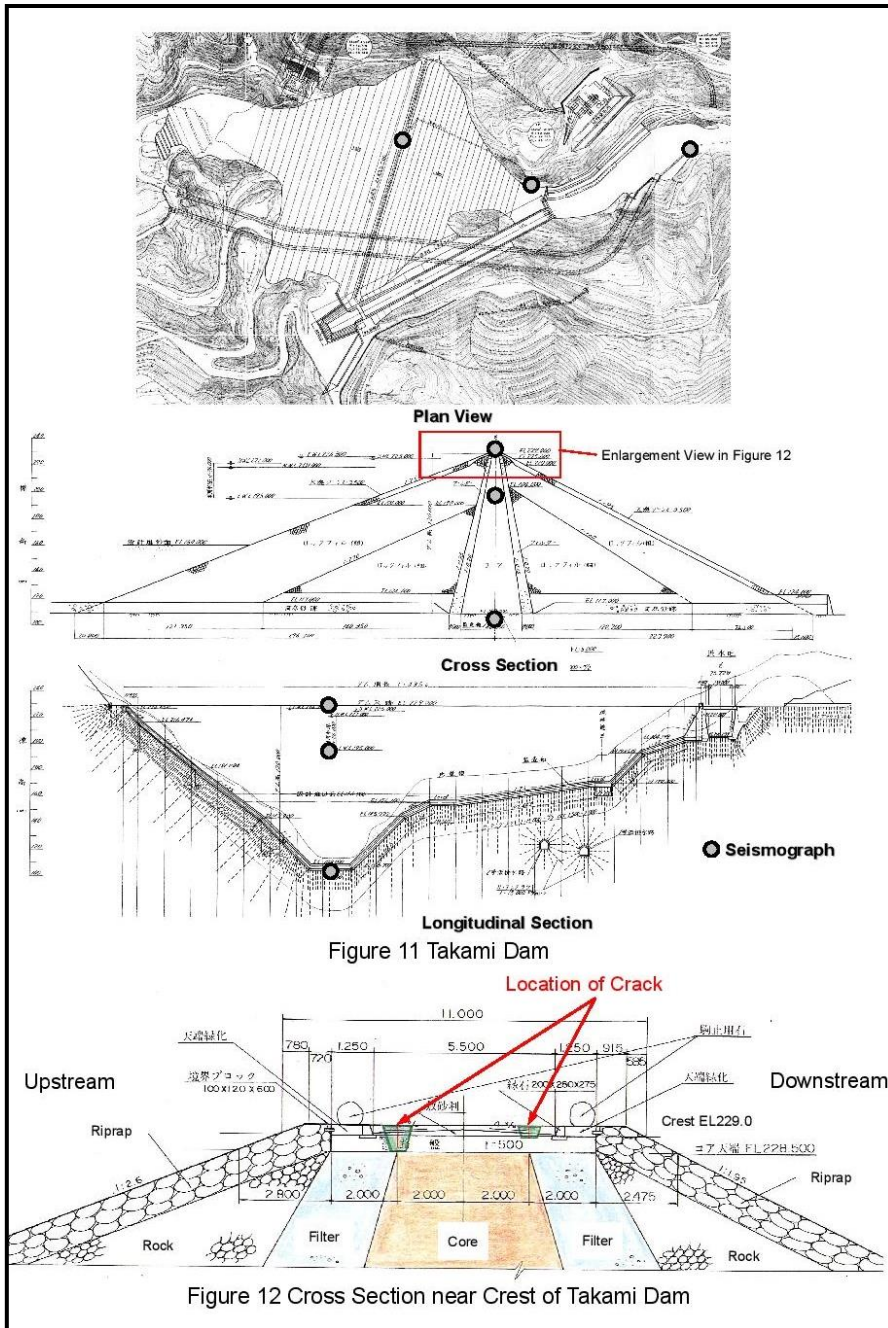
Figure 5: Takami dam and location of cracks at the Crest [49].

dam, refer Figure 5. The cracks were up to 160m long in the dam axis direction. The maximum width of the cracks at the surface was 50mm. An exploratory pit at the locations of the widest crack was then excavated to measure the depth of the crack. The results confirmed that the cracks remained within the crest protective layer with a thickness of about 90cm without reaching the core zone. The excavated pit was filled in immediately after the survey, and to prevent seepage by rainfall from expanding the cracks to the core, the entire cracked area was covered with impervious sheets. One follow-up survey of the crack depth at the crest was carried out later on as a check. The results confirmed that as in the case of the previous survey, none of the cracks extended beyond the protective layer. The locations of the cracks inside the protective layer were repaired by backfilling them with identical material, refer Figure 6. During the backfilling, density measurements inside the protective layer were done to control compaction so that the density would be the same as that before damage [49]. In case the cracks penetrate into the core, it is suggested to excavate a trench deep enough to expose the top of the impervious core, the trench to be further dug for 0.5m depths in the impervious material of the core. The side slopes of the trench are kept at 0.5:1 and bottom width be kept as 1.0m. The trench in impervious core is to be filled with water and allows water to seep through. If, at all, any sign of wetness or oozing is found. The trench is back filled with mixture of impervious soil and 2% to 3% of low-grade bentonite to be laid and compacted with hand- held pneumatic tampers at 2% of optimum moisture content and up to a depth of 1.5m. The upper 1.5m layer over core material is backfilled with semi-pervious type of soil with compaction by pneumatic tamper. The crest is reinstated to its original shape, and riprap is then re-laid as per designed section. After refilling the trench, 3m c/c holes be drilled and grouted with clay bentonite slurry at a low pressure if warranted, Figure 7 [50].

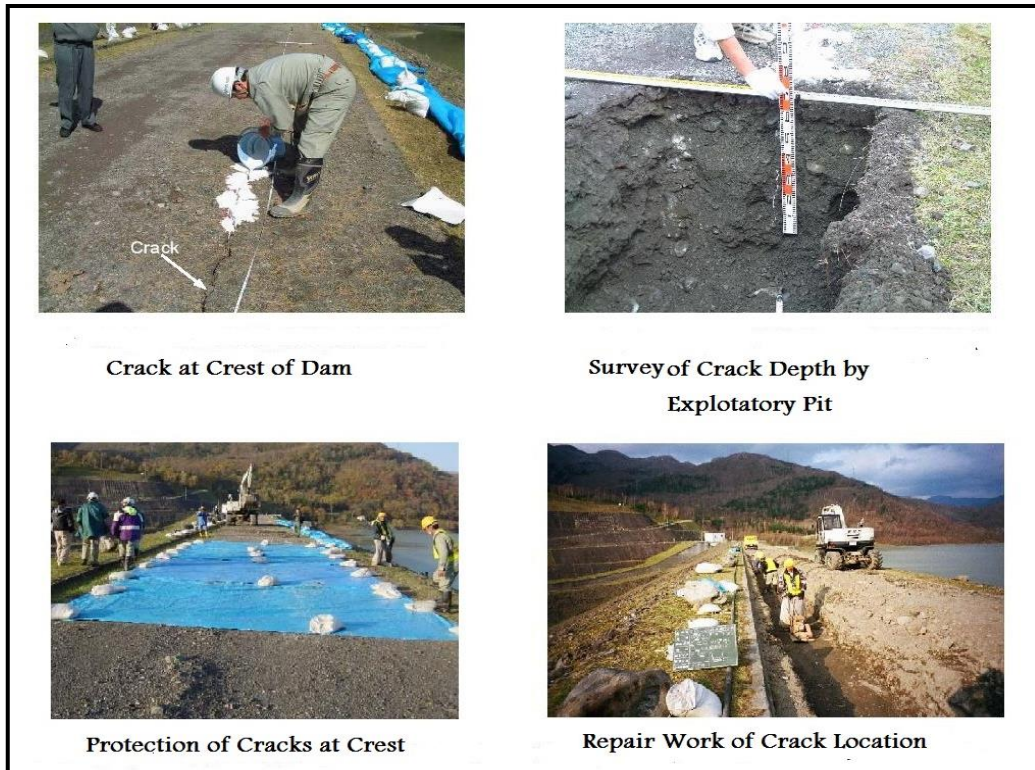
**Figure 6: Preparation for Filling the Crack on the Crest of Takami dam [49].**

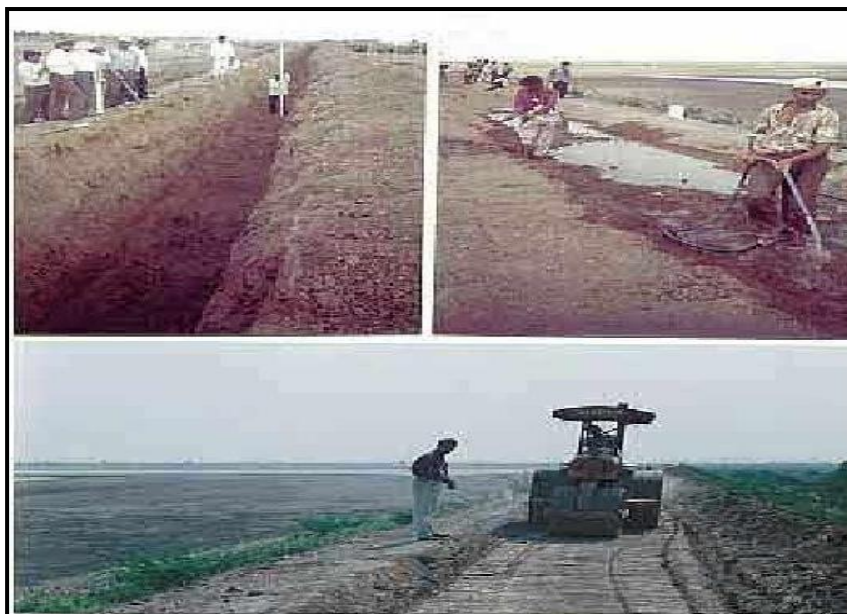
**Figure 7: Treatment of longitudinal deep crack at Dam Crest [50].**

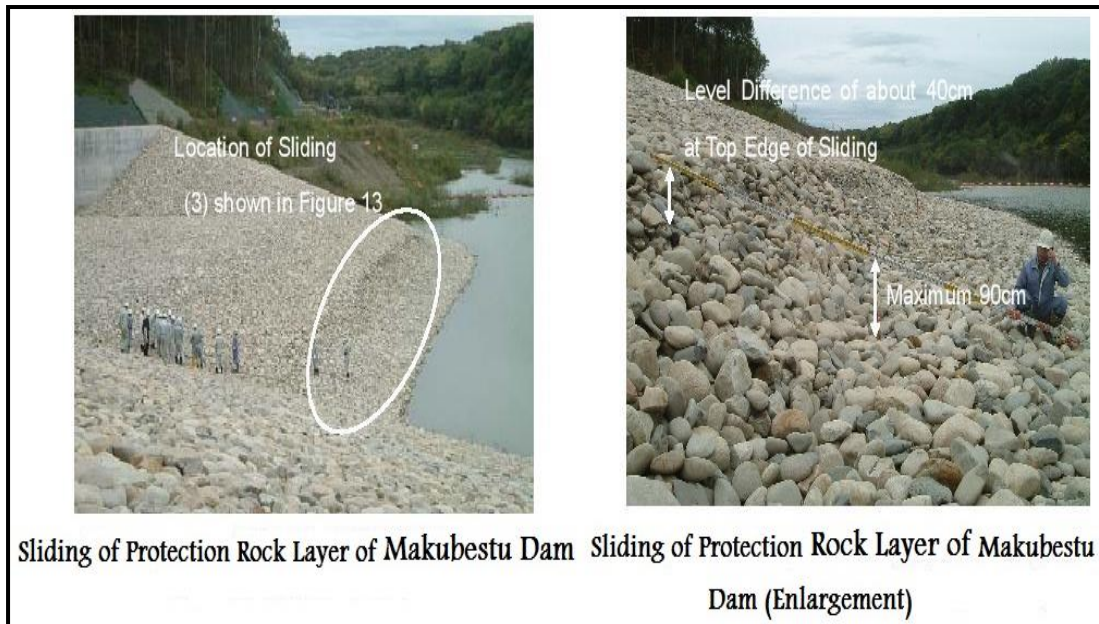
Figure 9: (Upper) Layer of Makubetsu Dam and location of slides. (Lower) views of slides [49].

The case at the Makubetsu Dam, an earth fill dam in Japan, with a height of 26.9m, completed in 2004, may serve as an example. In this case, the maximum accelerations of 173.1gal (dam axis direction) and 251.6gal (stream direction) were recorded in the dam foundation and at the crest, respectively. The epicentral distance of the dam was 140.6km. The sliding of the protective rock layer on the earth blanket placed on the left and right bank slopes upstream of the dam body occurred at two locations; on the left bank, length of the first was 20m, while length of the second was 23m, these are indicated by numbers 1 and 2 in Figure 8. In addition to two more locations on the right bank, the first was 80m long and the second was 30m long, and indicated by the numbers 3 and 4, respectively, in the same Figure 8. The topmost end of the sliding was directly above the water level during the earthquake. The location of the maximum sliding is near the spillway on the right bank side, and the maximum settlement of approximately 90cm was confirmed by the shape of the slope, and a level difference of about 40cm was formed at the top edges of the deformation, refer Figure 8. Close up of photos of the sliding are shown in Figure 9. After the earthquake, the dam management performed an excavation survey confirming that the sliding was limited to the protective rock layer (approximately 2m) and did not extend to the interior of the earth's blanket. And the part of the protective rock layer, that became thinner because of the sliding, was thickened by placing more rock materials to temporarily repair the sliding. The pore water pressure inside the dam body rose slightly at almost all parts of the upstream side zone, and it had almost peaked at the time of the survey. The values obtained later by a regular inspection were stabilized, and almost no abrupt change was found. The seepage was increased slightly due to the earthquake, but it stabilized later. The dam body displacement in the upstream- downstream direction near the center of the crest is approximately 2cm on the upstream side, and the settlement is about 3cm.

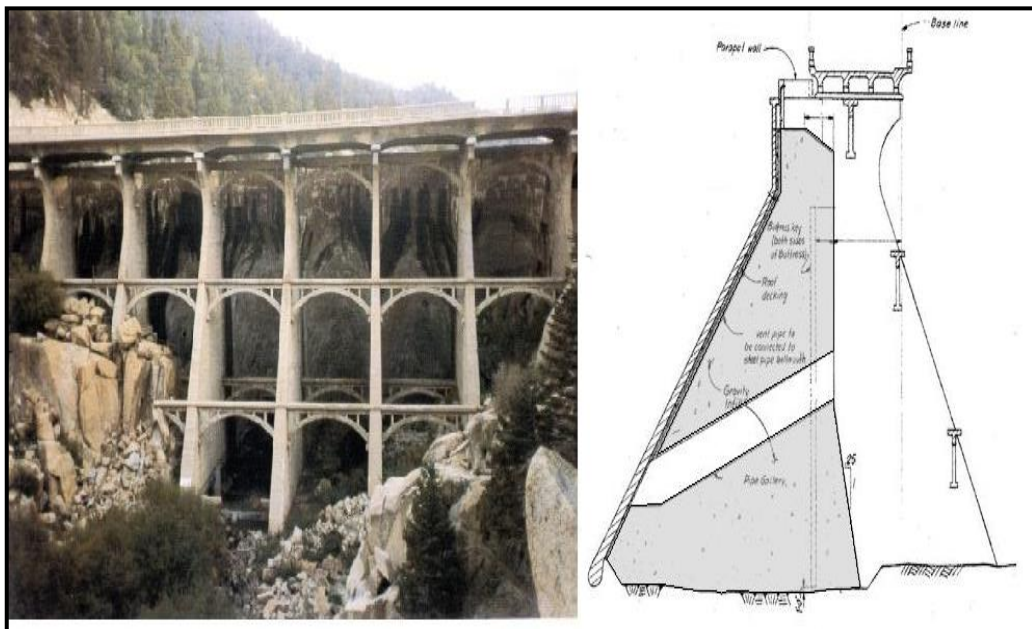
**Figure 10: Bear Valley Dam (a) multiple arch dam. (b) Shaded area Shows concrete infill between arches to improve seismic stability [52].**

The Bear Valley Dam is located in the San Bernardino Mountains about 80 miles east of Los Angeles. It was the first concrete multiple arch dam to be upgraded to improve its seismic performance. The dam was completed in 1912 as a 92 foot (28m) high, 360 foot (110m) long multiple arch dam. In the 1980s, there were concerns over the structural adequacy of the dam with respect to severe earthquake shaking as well as overtopping. Two MCEs were considered for the dam rehabilitation. The most critical shaking was determined to be a M=8.3 earthquake caused by a rupture on the San Andreas Fault; 10 miles away with a PHGA of 0.45g and a bracketed duration of 35 seconds (duration between the first and last peaks of 0.5g or greater). The structural strengthening was accomplished by infilling the arch bays with conventional mass concrete in order to convert the multiple arch to basically a gravity dam. The downstream slope was formed at 0.25V:1.0 H except for the uppermost 47 feet which was vertical (refer Figures 10a and 10b) [52]. The

modification which also included grouting between the old and new concrete to assure monolithic behavior was completed in 1989. On June 28, 1992, the M=7.4 Landers Earthquake occurred about 28 miles from the strengthened structure. Then one day later, the closer M=6.6 Big Bear Earthquake occurred about 11 miles from the dam on an unnamed fault reportedly in response to the rupture on the Landers Fault. At the Big Bear Lake Civic Center about 2.4 miles from the dam, a strong motion instrument recorded a peak of 0.57g horizontally and 0.21g vertically during the Big Bear Earthquake. This recording is about 5 miles closer to the causative fault than the dam. Thus, the estimated PHGA at the dam was between 0.4 to 0.5g. A thorough inspection after the earthquake indicated that the dam had not been damaged. The only damage was a slight displacement of the highway bridge at the crest of the dam. The bridge has since been removed from the dam and relocated downstream.

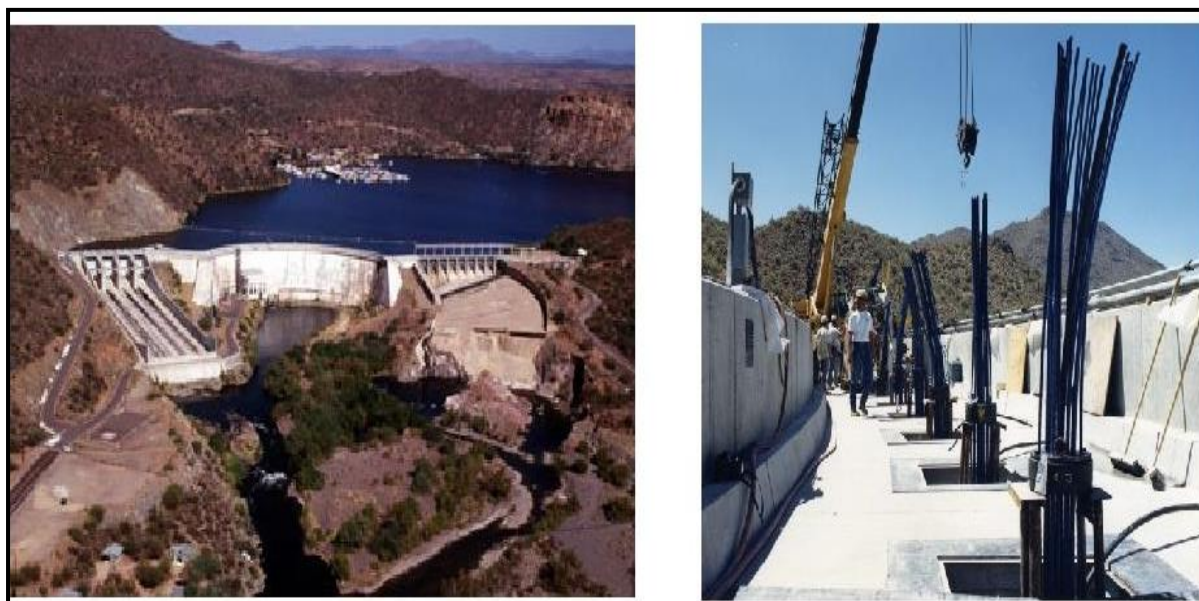
**Figure: 11: (a) Stewart Mountain Dam, (b) Post-tensioned cables installed to increase frictional resistant along lift lines [52].**

This Dam is located on the Salt River east of Mesa, Arizona. The concrete structure includes thin arch dam, two thrust blocks, three gravity sections, and one spillway, Figure 11. The arch has a 212 foot (65m) structural height, an 8 foot (2.4m) crest thickness, a 34 foot (10m) base thickness, and a 583 foot (178m) crest length. Construction was completed in March 1930. Concrete placement proceeded without cooling in 5 foot (1.5m) high blocks. Lack of cleaning horizontal construction joints before subsequent placements produced weak layers of laitance at every lift surface,

thus resulting in planes with little or no bond. The combination of weak horizontal planes and vertical contraction joints basically produced independent concrete blocks. Alkali-aggregate reaction within the concrete has permanently displaced the arch dam crest 6 inches upstream and 3 inches upward. This reaction has apparently stopped due to depletion of the alkalis in the cement and is no longer a major concern. A structural analysis indicated large inertia forces near the crest that are produced in the 3D linear elastic modal-superposition time-history analysis with mass-less foundation and (Westergaard Added Mass) using the MCE of Richter magnitude  $M=6.75$  at 9.3 miles (15 km) occurring on the Sugarloaf Fault. Predicted horizontal site accelerations are approximately 0.34g upstream/ downstream, 0.258g cross stream, and 0.19g vertical using attenuation curves developed by Seed and Idriss. The study determined at times, that during the design earthquake, the upstream inertia force tended to pull portions of the upper arch dam horizontally apart along the vertical joints. Concrete blocks in these areas may thus be without much side support from the natural arching action of an arch dam. The arch dam was believed not to perform dynamically as a monolithic unit as originally intended, because of the unbonded horizontal lift surfaces. This situation is acceptable for static loadings because of the horizontal arching action transferring loads along the arches and 'wedging' the structure in the canyon. The cantilevers still act as cantilevers because of the transfer of load across the lift surfaces from friction, but this situation was determined to be not acceptable for dynamic loadings. Large inertia forces induced in the upstream direction of the dam during an earthquake were greater than the static reservoir load. It was felt that individual concrete blocks moving in the upstream direction without arching action would break the frictional resistance along unbonded lift surfaces causing instability. A progressive failure of the top central section of the dam was postulated. The dam was modified in 1991 with post-tensioned cables adding the necessary normal force across these horizontal planes to increase the frictional resistance for stability. The cable installation consisted of 62 epoxy-coated post-tensioned cables varying from 75 to 240 feet (23 to 73m) in length, inclined between vertical and  $8^{\circ} 40'$  off vertical. It is believed that this modification was the first time an arch dam had been post-tensioned [52].
