## **Dam Safety Problems Related to Seepage**

### **Abstract**

**Keywords:** Seepage, Internal Erosion, Piping, Sloughing, Hydraulic Fracturing, Filters, Chimney Drain, Drainage, Uplift.

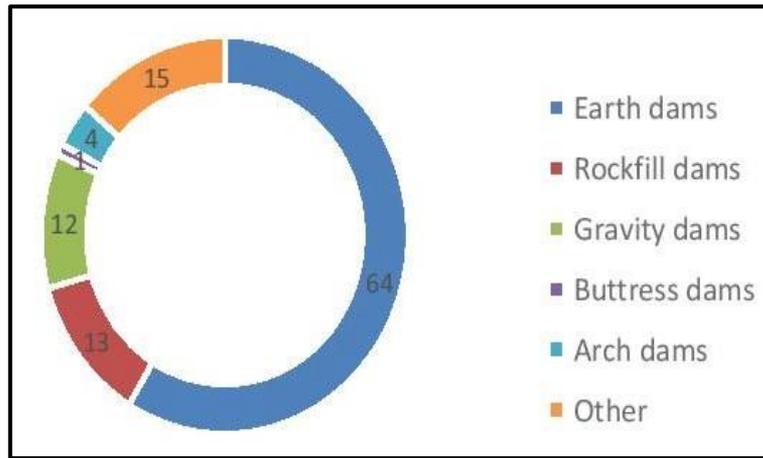
The majority of existing dams today are embankment dams totaling 77% of all dams in the world, of these 64% are earth fill and 13% rockfill dams concrete dams and other type dams make up the remaining 32, refer Figure 1 [2].

**Figure 1: Percentage of all types of dams in the world, excluding China [2].**

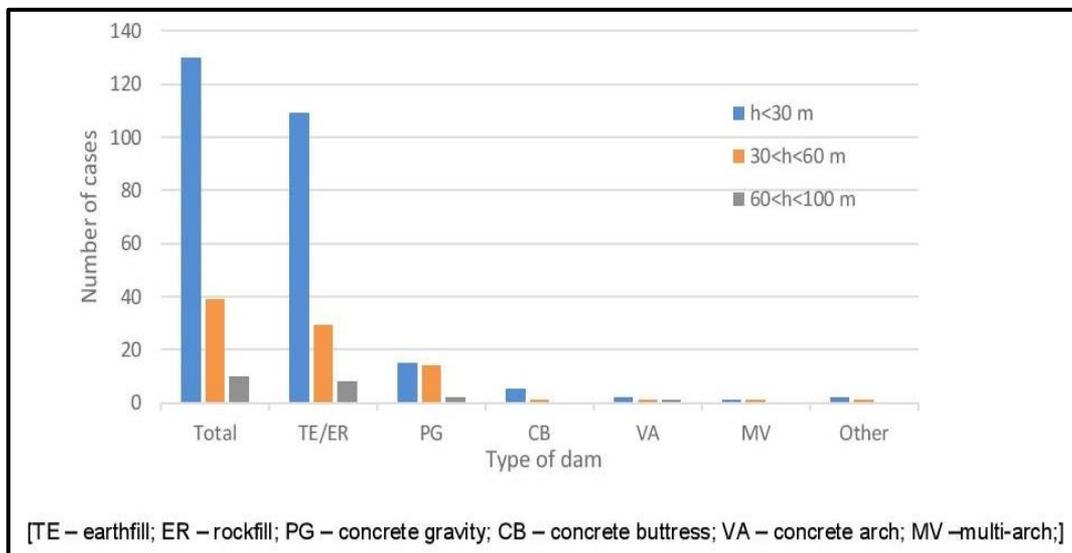
It follows that the number of failure cases in embankment dams hydraulic exceeds by far the failure cases in the other ones, which can be observed from Figure 2.

**Figure 2: Number of failures by types and height of dams, excluding China [3].**

The bias in the above statistics towards embankment dams with 77% failures can be explained by the fact that the majority of dams constructed so far are embankment dams compared to concrete dams. Moreover, earth fill dams are more sensitive to hydraulic problems than the concrete dam due to the nature of their

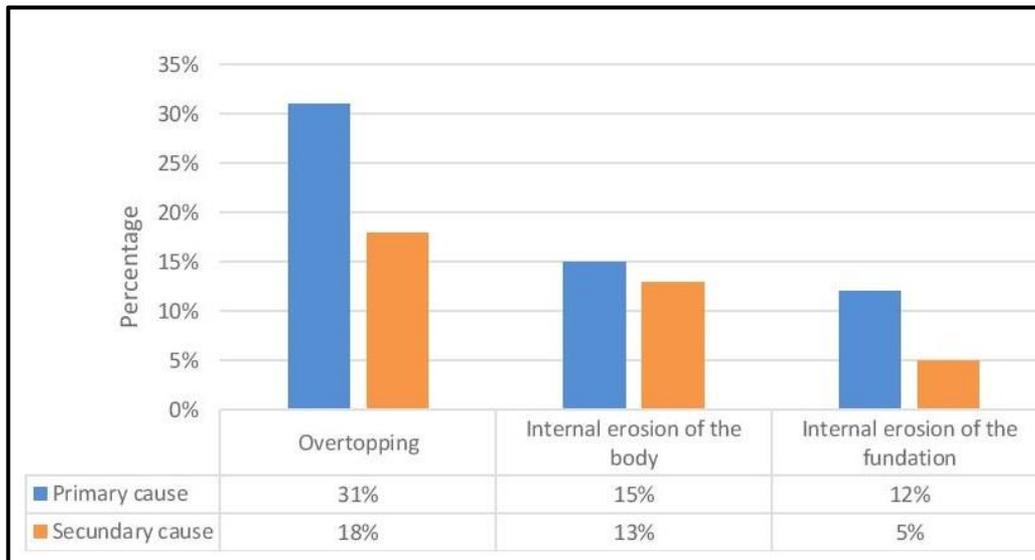
The most common hydraulic problems that have caused dam accidents (failures and incidents) up to 1995 are shown in Figure 3. This is based on an (ICOLD) report published in 1995 under the title “Dam Failures-Statistical Analysis (Bulletin 99)”.

**Figure 3: Causes of failures in embankment dams [3].**

Internal erosion is one of the most common modes of embankment dam failures, which is caused by extreme conditions of seepage. Inspecting the statistics shown in Figure 3, shows that the total number of all dam failures and incidents by the internal erosion amount to 40%, adding together failures in the foundation and body of dams. In order to give a good insight of this mode of failures, its causes and forms, elaboration may be necessary, and some details are presented in the following:

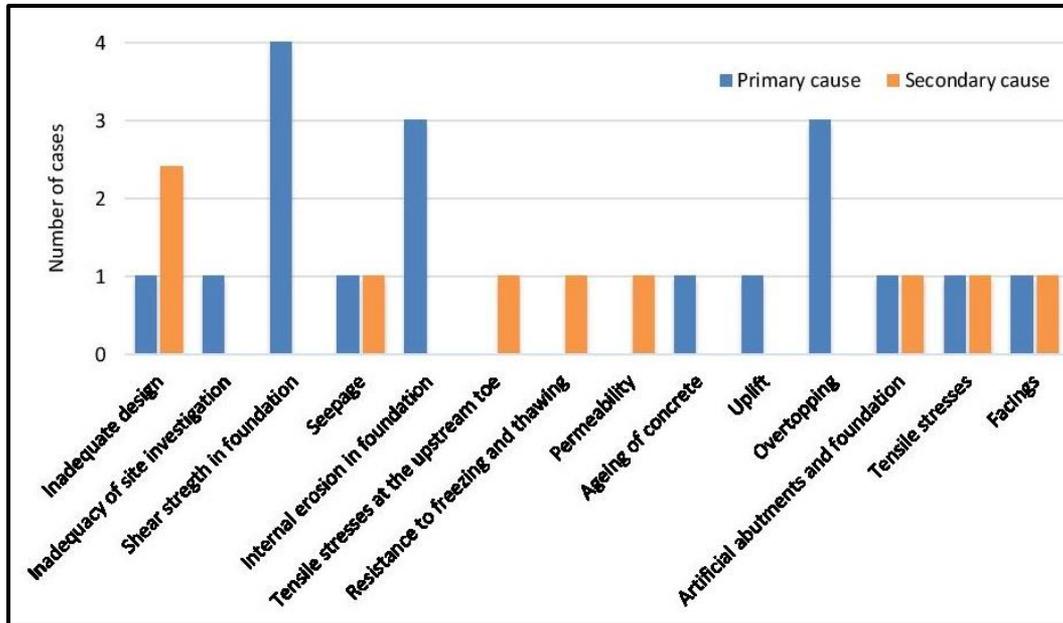
The main causes of failure in concrete dams, according to “Bulletin 99” ICOLD (1995) are summarized as shown in Figure 4 and Table 2 [5].

Figure 4: Main causes of failure of concrete dams.

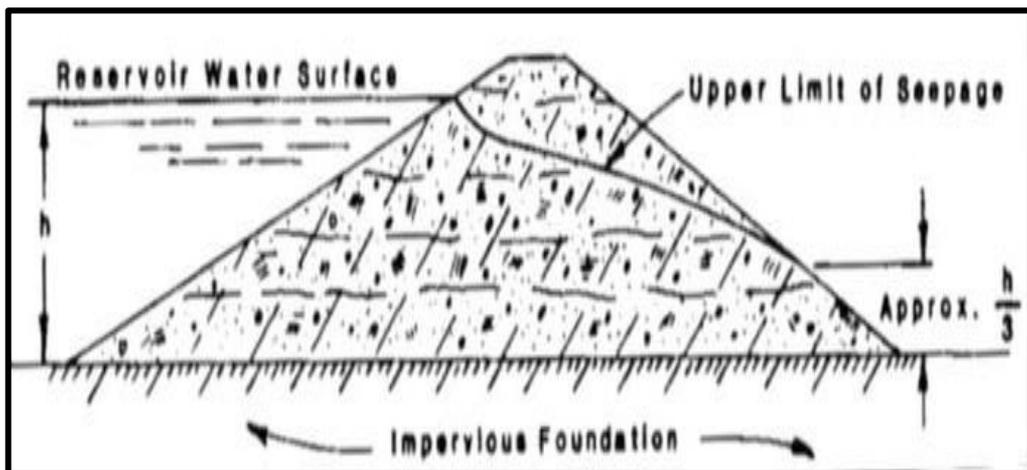
For the simplest case of a homogenous dam on an impermeable foundation, the picture of seepage through the dam body, without using any measure to lower the phreatic surface is as given in Figure 5.

**Figure 5: Homogenous dam showing phreatic surface of seepage.**

In this type of dams, there is the danger of sloughing in the downstream slope and internal erosion leading to failure when the water level in the reservoir is high and pore pressure is also high. The same thing will happen as a result from the rapid draw of the reservoir and the upstream slope is saturated. Both slopes may have to be made very flat to avoid such conditions, or to add filters at the toe, or lay a drainage layer or drainage blanket within the base at the downstream, as shown in Figure 6 and Figure 7.

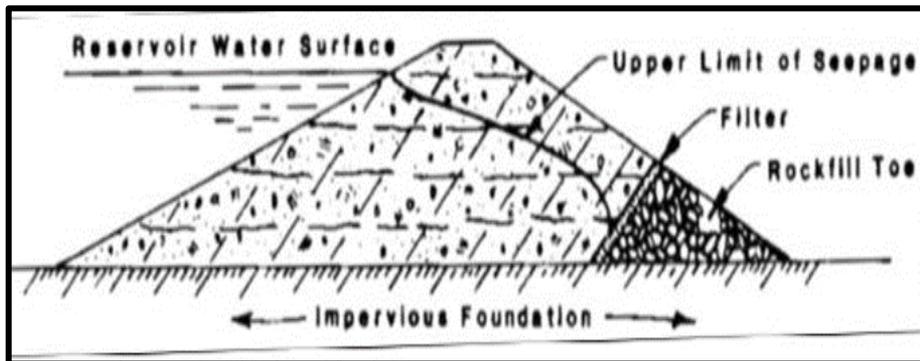
**Figure 6: Using Rockfill toe and filters.**

Homogenous type of dams is built normally from low permeability materials to reduce seepage as much as possible in addition to having good strength parameters, which make them able to develop a maximum practical shear strength under compression and maintain most of it after the filling of the reservoir. They are designed to maintain fairly stable conditions under all operation modes. The use of such dams, however, is limited to small dams; therefore, the need to build larger and higher dams led to the development of zoned earth fill dams. In homogenous dams the seepage phreatic surface daylight in the downstream face at a height of about one third of the hydraulic head on the dam; refer back to Figure 5. If toe drainage is used such as in Figure 6, then the phreatic surface is lowered, and a safer condition of stability is obtained. Another arrangement for lowering the phreatic surface may still be obtained by installing a drainage blanket as in Figure 7, and when the chimney drain is added to the drainage blanket then this arrangement looks like Figure 8.

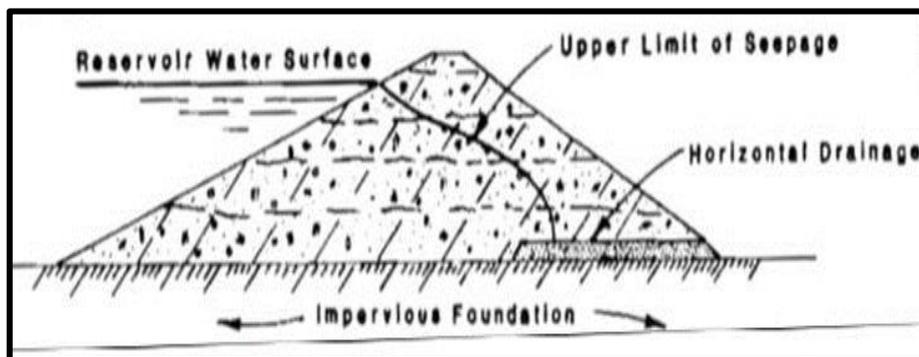
**Figure 7: Using horizontal drainage blanket.**

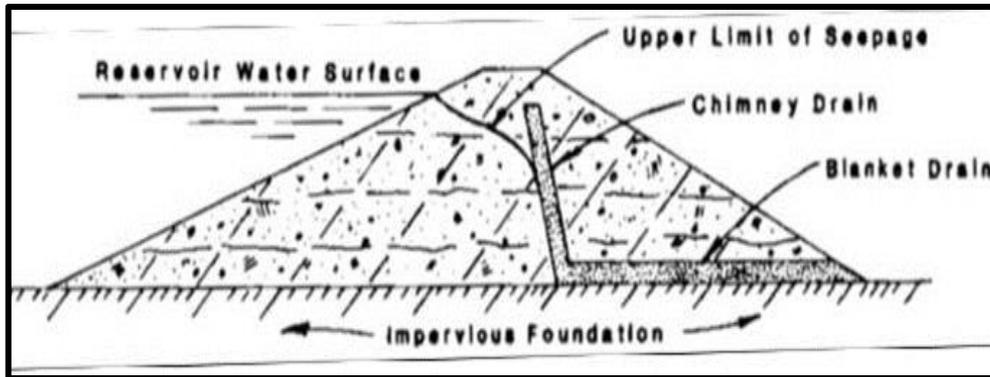
The last alternative is to add chimney drain within the dam to intercept the phreatic surface inside its body, and relieve seepage water afterwards from the downstream in a safe way as in Figure 8.

**Figure 8: Using chimney drain.**

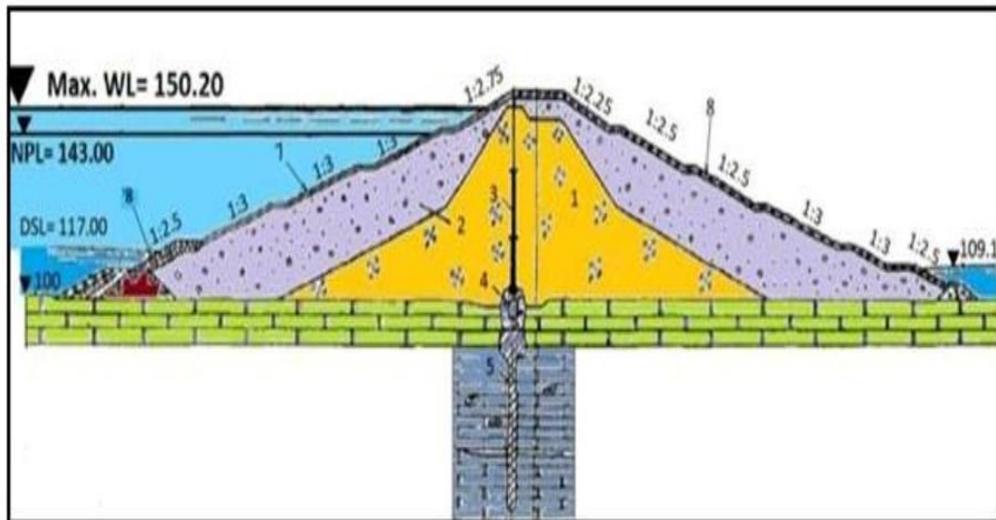
The need for constructing large dams has led to development of zoned fill dams; where different types of soil materials may be used and placed in such a way to protect from seepage. First of all, an impermeable core in the middle, which can be of clay, or a diaphragm (concrete or asphaltic concrete), will act as the main defense against seepage. On the upstream and downstream sides of the core, filter zones should be also designed and added to secure against any residual seepage or leaks through cracks in the core resulting from earthquakes, settlement or hydraulic fracturing. Seepage water is then collected and removed in one of the safe ways as indicated previously. It can be said, therefore, that the design philosophy has changed to controlling seepage and lowering the saturation of the phreatic surface and minimizing seepage quantities by incorporating filters and drainage elements, thus permitting steeper slopes and consequently higher dams. The extra safety drawn from using filters can also help in selecting semi impermeable soils and diaphragm for the core provided that the filter's arrangement and design fulfil the safe exit of the seepage water. One such case can be cited from the construction of Haditha Dam in Iraq, where dolomite fill is used for the central core with asphaltic concrete diaphragm, which is followed by the deep grout curtain in the foundation, refer to Figure 9 [6].

**Figure 9: Cross section of Haditha Dam showing dolomite core and asphaltic concrete diaphragm.**

In this Project, the permeability of the dolomite core varied between  $1.1 \times 10^{-3}$  and  $3.1 \times 10^{-5}$  cm/sec which makes it permeable to semi-permeable. While permeability of the asphaltic concrete diaphragm is below  $1.0 \times 10^{-7}$  cm/sec. Controlling seepage through the foundations of the dam, being an embankment or concrete dam, is important to prevent the foundation material from piping and washing away, which could result in structural failure due to loss of support. At the same time, it is important to control seepage in order to reduce uplift pressure.

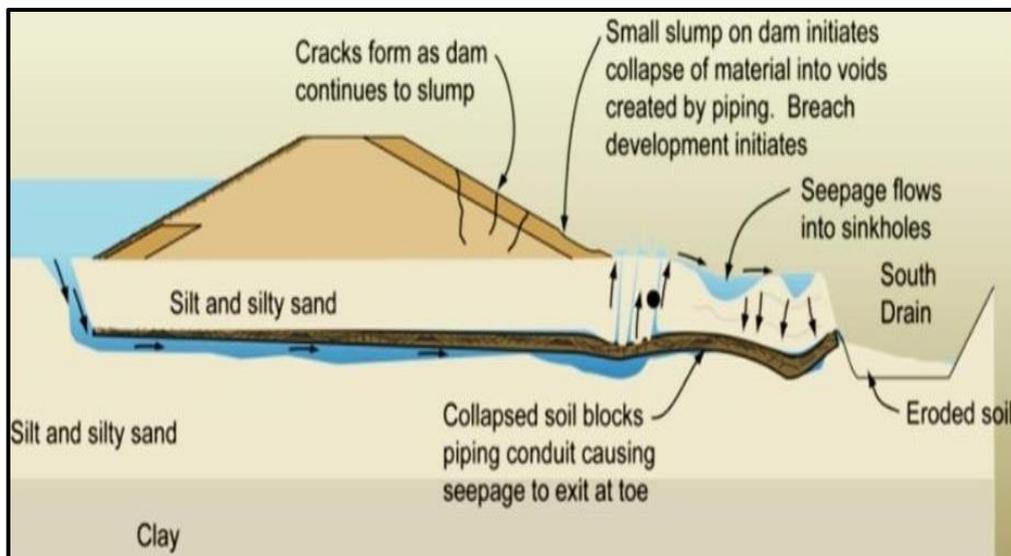
Measures that can be taken vary according to each case from using impervious upstream blankets, and/or grout curtains or diaphragms and cutoff trenches under the dam itself. These measures will reduce uplift, lengthen the seepage path and reduce the exit gradient of the seepage water at the dam toe preventing the formation of boils, which are signs of internal erosion in the foundation material [7]. Seepage problems remain the same for both permeable foundations of silts or clays as for rock foundations, which contains solution channel, rock jointing and cavities. Figure 10 represents a case of under seepage of an earth fill dam on silt and silty sand foundation.

**Figure 10: Piping through dam foundations.**

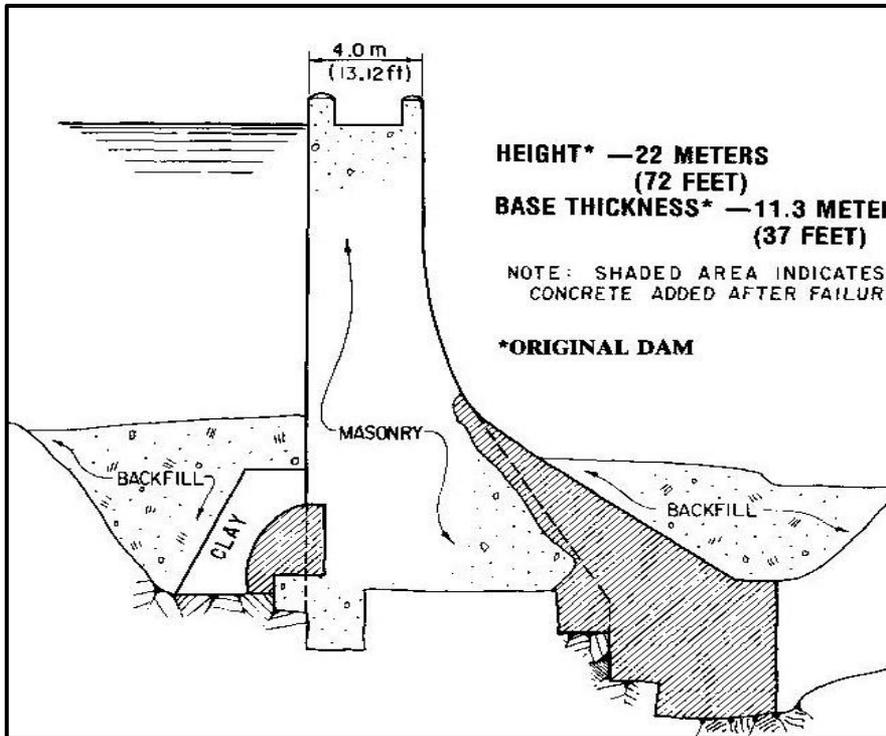
The original design was to have a height of about 20 meters with a crest thickness of about 4 meters. This thickness was to be carried down to a level about 4.3 meters below the top of the dam where the downstream face was to begin a concave circular curve extending down to the toe resulting in base thickness of about 11.3 meters. Construction was started in 1878, subsequently, a decision was carried out to increase the height about 2 meters without altering the other dimensions of the dam disregarding the "middle third principle" which states that on any horizontal plane within a gravity dam, the resultant of forces should act within the middle third. This is to ensure that the stress would be compressive at all points on that plane otherwise tensile cracks may be formed. Late in 1881, the work was completed, and the impoundment was started. Leakage soon appeared, totaling approximately 57 liters per second. About a year later, two cracks were discovered in the dam. As a safeguard, the allowable operational levels of the reservoir were lowered. On March 14, 1884, with the reservoir level about 2.7 meters below the maximum, a 137-meter long section of the mass slipped abruptly on its base and moved downstream as much as 380 millimeters. This was accompanied by a rapid increase in leakage to about 108 liters per second, but no remedial measures were taken. In the fall of 1885, about 1.5 years after this mishap, the reservoir was drained and many cracks in the upstream face were discovered, with one break extending 91 meters horizontally. Evidently, cracking had also severed the dam from its cutoff wall, which extended into the foundation at the heel. This crack at the base was then covered by a longitudinal block of masonry, which in turn was sealed with puddled clay. The downstream toe was extended outward and downward by addition of a masonry mass which roughly doubled the dam's base thickness. It gave a flatter slope to the lower downstream face, keying into the original mass at about mid height. The cracks in the old masonry were grouted, and drains were installed. The remedial program was finished in September 1889, Figure 11.

**Figure 11: Bouzey Dam profile after modification and remedial program.**

In November 1889, reservoir impoundment was begun. When the water level reached maximum, the crest deflection was nearly 25 millimeters at some points. On April 27, 1895, the entire top part of the dam - a mass roughly 10 meters high and 183 meters long - broke away and loosed a torrent of water upon the village of Bouzey. Continuing its rush down the valley of L'Avière River, the flood left several other villages in ruins. Among factors related to the failure, water pressures inside and under the dam were undoubtedly contributory. The sandstone foundation was cracked, and the cutoff at the heel was not extended adequately into the rock. Both of these conditions could allow water under the structure. Faulty masonry joints could permit similar leakage at higher elevations. Detrimental hydrostatic pressures, therefore, could have developed easily. Such pressures, if applied in the upper parts of the dam where structural thickness was marginal, may have been a primary source of trouble. Yet the weakening of the dam appeared to be progressive. Failure did not occur as soon as the reservoir was full, but instead, many months passed before the signs of distress were discovered. After the repairs had been completed in 1889, an even longer period ensued before the collapse, even though the storage levels were kept high. Investigators of the disaster wondered whether other, more subtle, forces of destruction were at work. In the search for a cause of failure, the mortar used to bond the masonry was an outstanding suspect. There is apparently no question that its quality was inferior. If the preparation of lime mortar was done carelessly, as was alleged in this case, some of the lime may have

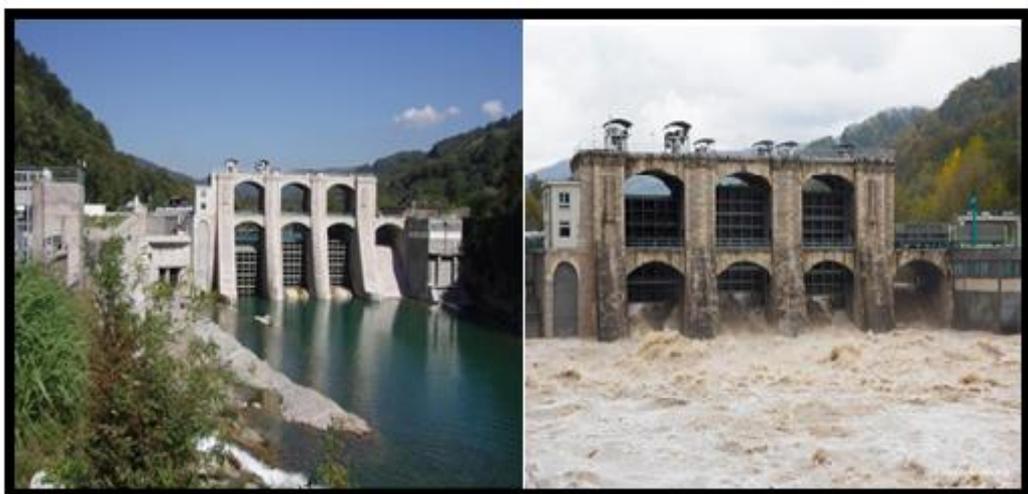
One case which highlights the problems created by seepage water seeping into concrete dam body and result in costly remedial works, is that of Ajba Dam. This dam is part of the hydro-power plant Plave on the Soča River in Slovenia, completed in 1940. The dam has structural height of 39m, and crest length of 72m. It may be classified as a combination of a barrage and gravity dam. The retaining structure consists of four massive piers with three large gates. The piers are connected at elevation 111.5m a.s.l. with bridging elements in pairs, one at the upstream and one at the downstream side of the piers. The small bridges are arched shaped and made of reinforced concrete. The foundation level is 92.1m a.s.l. and the roofing structure with the mechanism for opening and closing the gates is at the 120.0m a.s.l. The roofing structure or 'upper deck' is constructed on top of the four extended piers, and it is made of arching girders, fixed with cross girders and reinforced concrete plate. The usual water level is at 106m a.s.l, refer to Figure 12.

**Figure 12: Views of Ajba Dam (212) [10].**

Sixty-five years of exploitation caused extensive damage on concrete: e.g. cracks, corrosion of reinforcement, damages of construction joints and stone blocks, deterioration due to freezing and thawing cycles ... etc. In the concrete elements of the dam most of the damage was caused by the degradation effect of frost cycles of seepage water penetrating through faulty construction joints and cracks. These damages were very severe at locations where constant leakage and wetting of concrete had occurred. Open construction joints and numerous cracks were clearly visible on all sections of the dam. Most of them were initially caused at the time of construction due to the technology used in construction. At these cracks, leakage was observed where the width of cracks was up to 3mm. It was necessary to seal the open joints and cracks to stop seepage water and re-establish integrity of each construction elements and prevent further degradation of the concrete and the reinforcement.

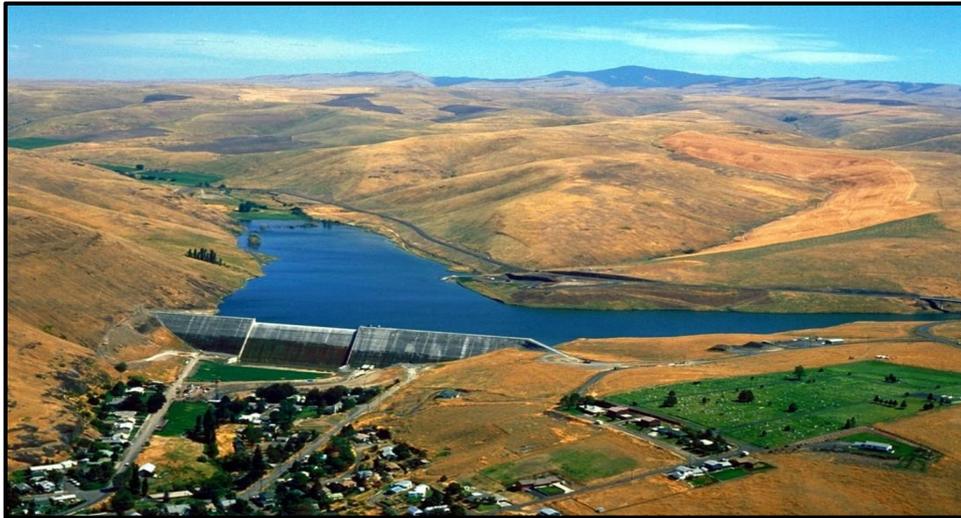
included injecting grout through bores drilled from top to bottom. The initial rate of leakage was 33 cubic meters per second. After remediation, the leakage was less than 11 cubic meters per second. Concern over the dam's safety has continued ever since, especially with the memory of the 1903 flash flood [11]. Figure 13 shows a view of this dam.

**Figure 13: View of Willow Creek Dam [12].**

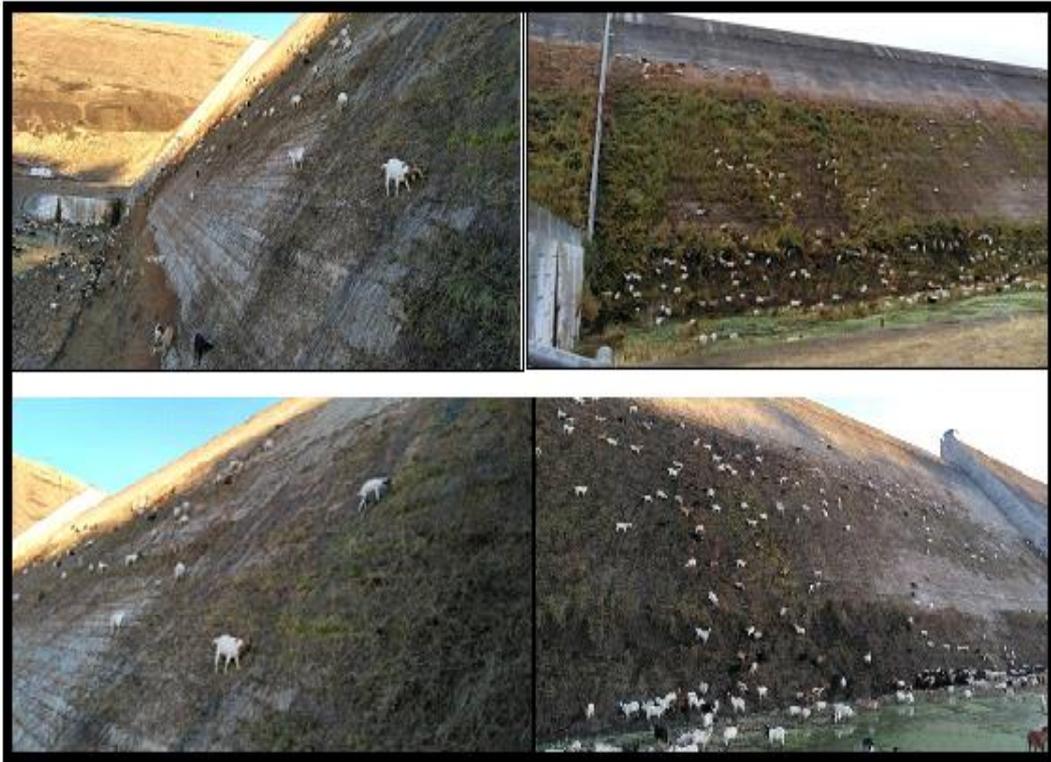
**Figure 14: Leakage signs on the downstream side of the dam, and at the toe observe the heavy vegetation and the grazing goats [13].**

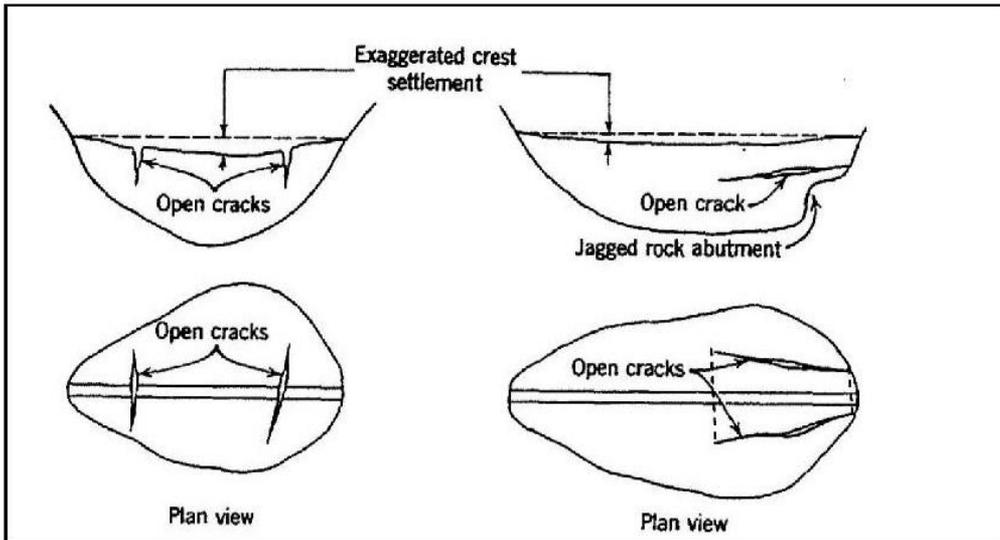
water leading to internal erosion. A good description of cracking in embankment dams was provided by Sherard in his book “Embankment Dams (1963)”, and several figures adapted from that reference are shown in the following Figures 15, 16, 17, 18.

Figure 15: Transverse and longitudinal differential settlement cracks.

All embankment dams will settle to some degree during and after construction. This settlement may not be uniform, and differential settlement should be expected in every dam. When the foundation profile is irregular and the depth of fill varies, differential settlement will occur. When differential settlement is large enough, cracks can form in areas of tensile stress. Typically, these will be transverse cracks that could potentially be continuous across the core and are therefore, of most concerns. Longitudinal cracks may develop due to differing foundation conditions beneath the core and shells and/or due to differences in elastic moduli of the various zones. Longitudinal cracks are generally of lesser concern but could potentially allow reservoir water to access two separate transverse cracks that would not otherwise be continuous from upstream to downstream. Additionally, dams founded on collapsible soil deposits can settle after the reservoir fills. If wetting occurs during first filling, or during a flood event for flood control impoundments, the settlement can be large and dramatic. Earthquakes may be another cause for cracking of the dams resulting from ground shaking and differential settlement that follows. These cracks are not different in their impacts on dams as any other cracks, and if not treated in good time, they may develop into good conduits for seepage

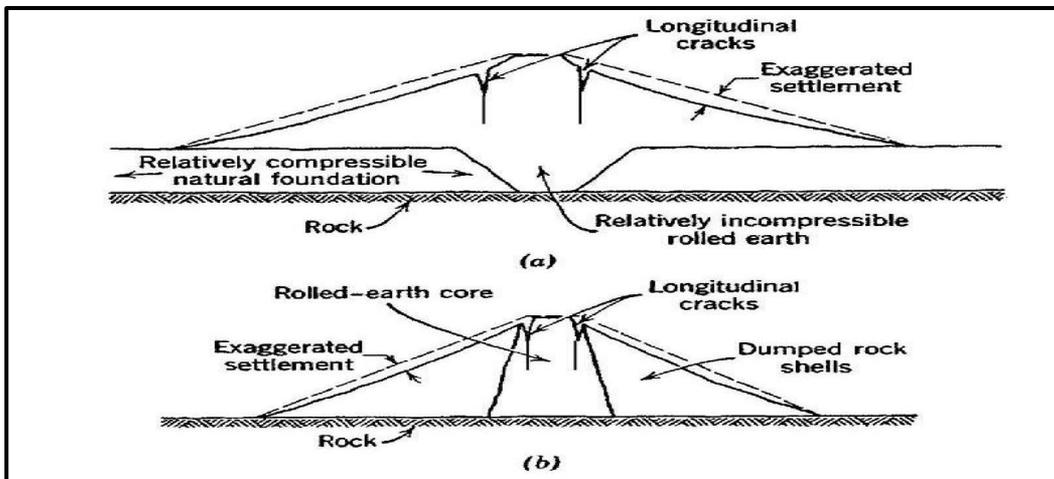
Figure 16: Longitudinal cracks (a) Cracking caused by differential Settlement. (b) Cracking caused by differential settlement between embankment sections of dumped rock and rolled earth.

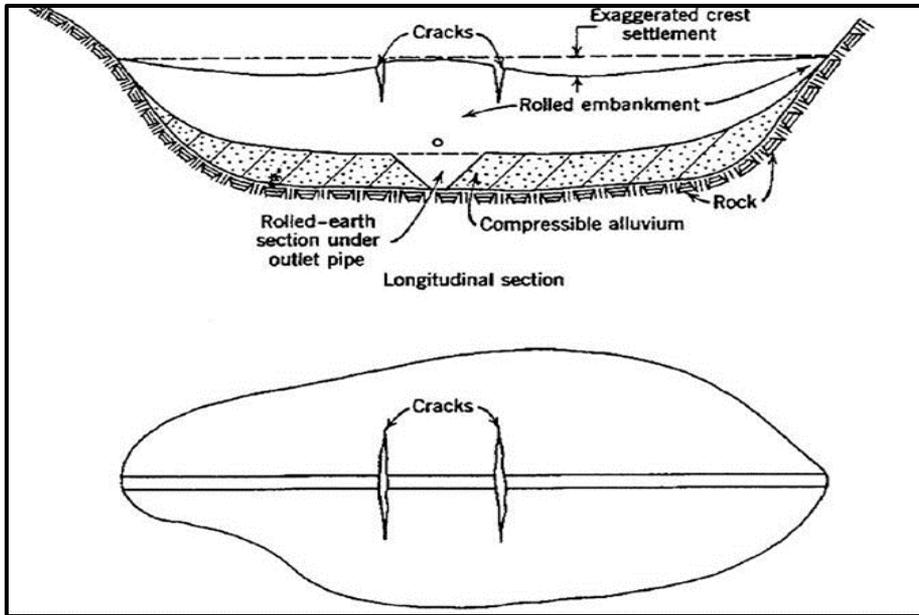
**Figure 17: Cracking due to differential settlement between natural foundation soil and rolled-earth support under outlet pipe (or other discontinuity in the foundation).**

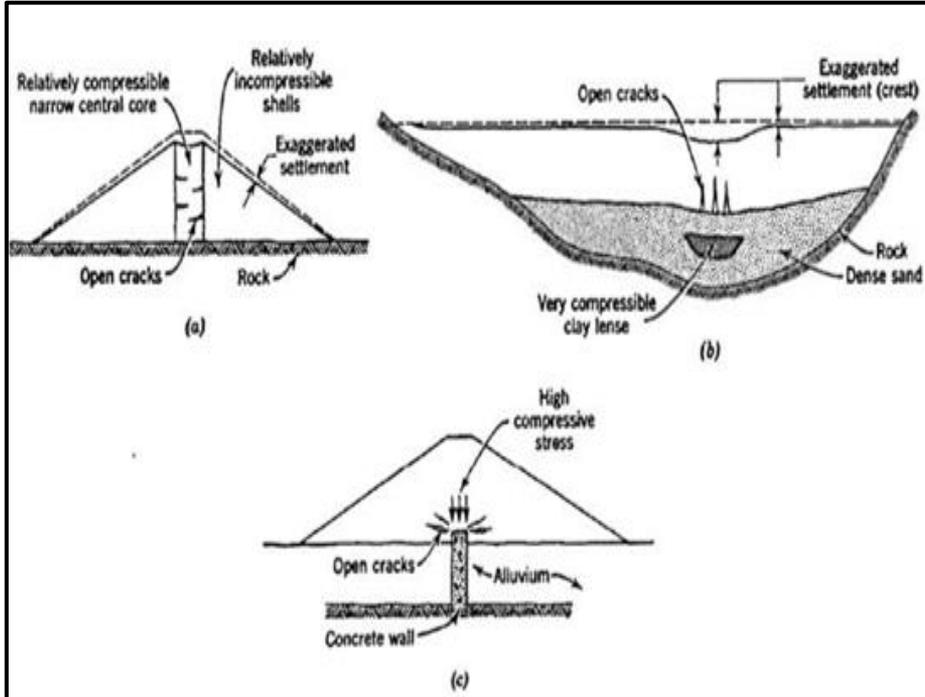
**Figure 18: Internal embankment cracking.**

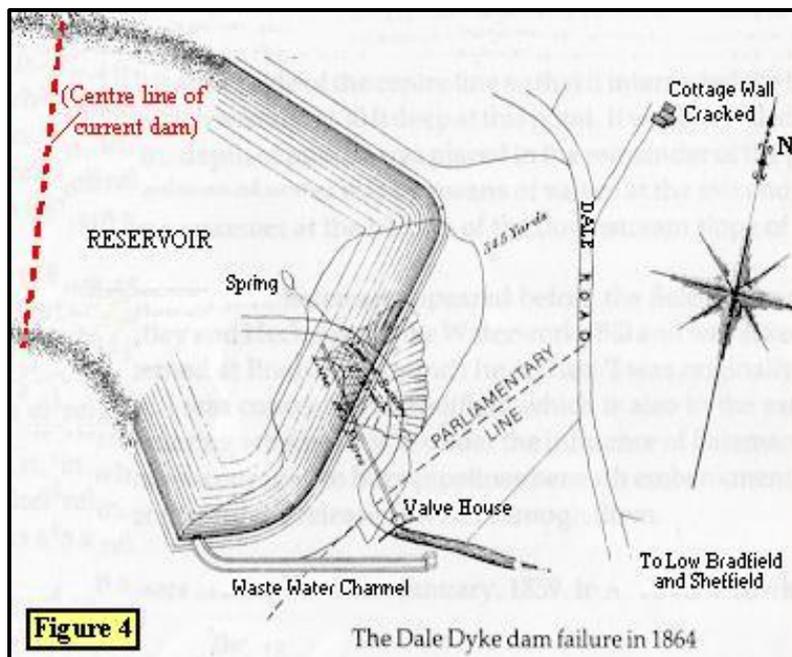
In Figure 19, the red line indicates the site originally chosen for the dam axis; however, it was soon discovered that this line lay in the middle of an old landslide area. The dam center line was consequently, moved about 150 yards upstream at the north end.

**Figure 19: Dale Dike Dam’s layout.**

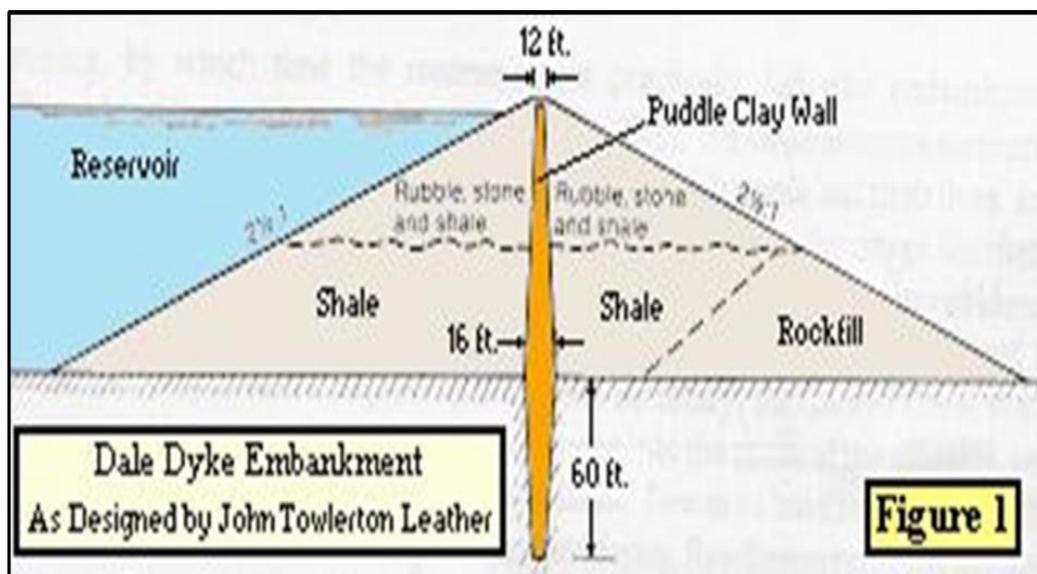
A cross section of the original Dale Dyke Dam as designed by John Towler is shown in Figure 20. The dam had two outer shells with the outside slopes of a (2½:1) which were built from shale in the lower half with rubble stone and shale in the upper half. The central core was made of puddled clay core. The purpose of this puddle clay core was to provide a watertight membrane, essential to make the whole structure leak-free, and thus avoid any gradual erosion of the embankment. To ensure water-tightness, the foundation of this puddle clay core was built on bed-rock (“watertight strata”), and in the case of the Dale Dyke Dam, the engineers had to dig down to the unusually great depth of 60ft to reach solid rock, as indicated in Figure 20.

The puddle clay core of the dam stood 95ft above ground level, it was 16ft wide at the ground level, tapered to 4ft wide at the top, and as already mentioned, was sunk to a maximum depth of 60ft below ground, the crest being 12ft wide and 1254ft long. The dam had two 18” diameter outlet pipes, both sunk in trenches beneath the embankment, and terminating at a “Valve House” at the bottom of the downstream slope of the embankment.

**Figure 20: Cross Section of the deepest section of Dale Dyke dam.**

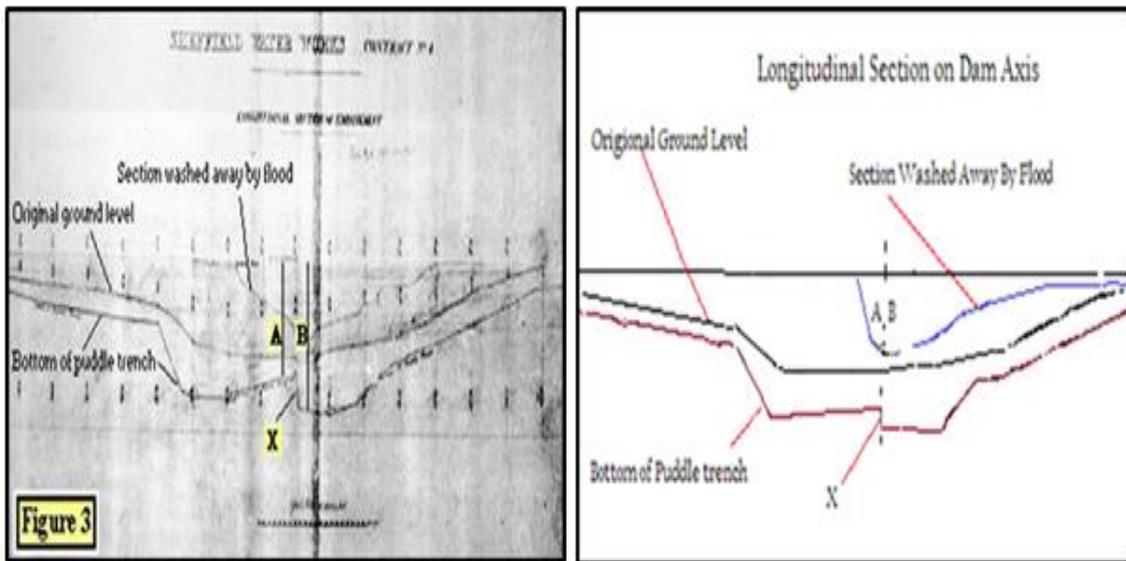
In his search for the original drawings of Dale Dyke Dam, Mr. G. M. Binnie came across the drawing shown in Figure 21a, which is of a longitudinal section on the axis of the original Dale Dyke Dam. It can readily be seen from Figure 21a and Figure 21b, that close to the center of the bottom of the puddle trench (the bed-rock on which the puddle wall was built), there is a very unusual vertical step in the rock formation of 35 feet depth (marked X in the drawing).

**Figure 21: (a) The original drawing showing longitudinal section of the dam along its axis; (b) An illustrating sketch of (a).**

It is also seen that this lies directly beneath the central part of the embankment which was washed away in the flood. It was this that led Binnie to declare: “we need look no further for the basic cause of the accident”: He went on to explain that this abrupt change in the puddle trench “must have caused a rupture in the puddle clay wall, most probably before the core reached its full height”, and that the differential settlement between the greater depth of the puddle wall at (B) compared to that at (A) would have resulted in the clay wall cracking just above this vertical step (marked by X in the drawing). No details of this irregularity in the rock foundation were revealed at the inquest nor in subsequent discussions.

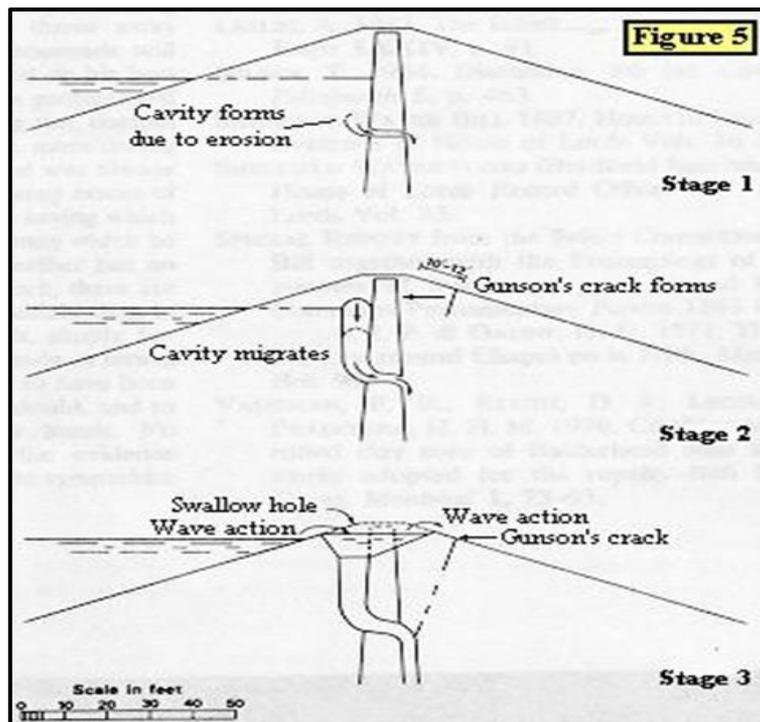
All the evidence points to leakage having taken place due to the puddle wall being ruptured near its base, and this having occurred long before the dam's completion. Having clearly determined this, the postulated sequence of events that would have subsequently occurred leading to the eventual collapse of the dam can now be explained and as illustrated in Figure 22:

**Stage 1:** A cavity forms in the upstream side of the embankment due to erosion caused by leakage through the cracked puddle core.

**Stage 2:** The roof of this cavity progressively caves in resulting in the cavity migrating upwards. As a consequence of the reduced support against the clay core (possibly combined with the undermining of the core by the crack itself), the upper part of the crest leans in the upstream direction (towards the water); thus 'stretching' the outer slope of the embankment, and resulting in a horizontal crack forming a little way down the slope. This was the crack that was discovered earlier on the day that the dam collapsed.

**Stage 3:** When the migrating cavity reached the surface a “swallow hole” was formed very close to the crest with the consequence that the adjacent material slid into it. This is the stage when the waves suddenly started coming over the crest and down the crack [20].

**Figure 22: Stages of failure of Dale Dike Dam.**

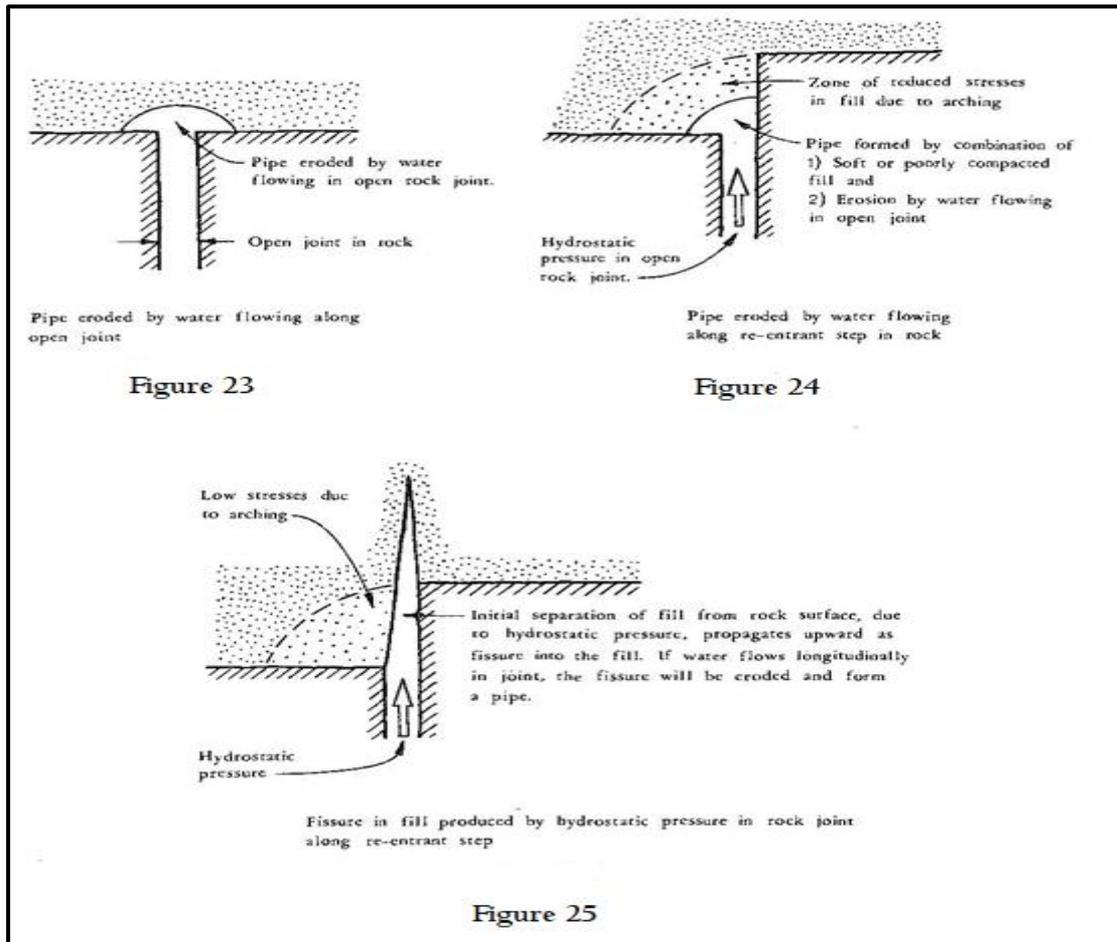
2. The mechanism of erosion under these conditions is illustrated by Figure 23, which shows an idealized joint in the bottom of the key trench. The joint is not sealed by dental concrete or slush grout; consequently, horizontally flowing seepage water under pressure would attack the base of the fill and begin to form a pipe. If the joint occurred at a step in the rock surface, Figure 24, the erosion would occur even more readily because of the reduction of stresses in the re-entrant corner due to arching, and because of the likelihood of poor compaction of the fill in the corner. Furthermore, under high water pressure, the pipe is likely to enlarge by separation of the fill from the rock surface, as illustrated in Figure 23, Figure 24 and Figure 25.

**Figures 23, 24 and 25: Development of internal erosion by arching leading to hydraulic fracturing [21].**

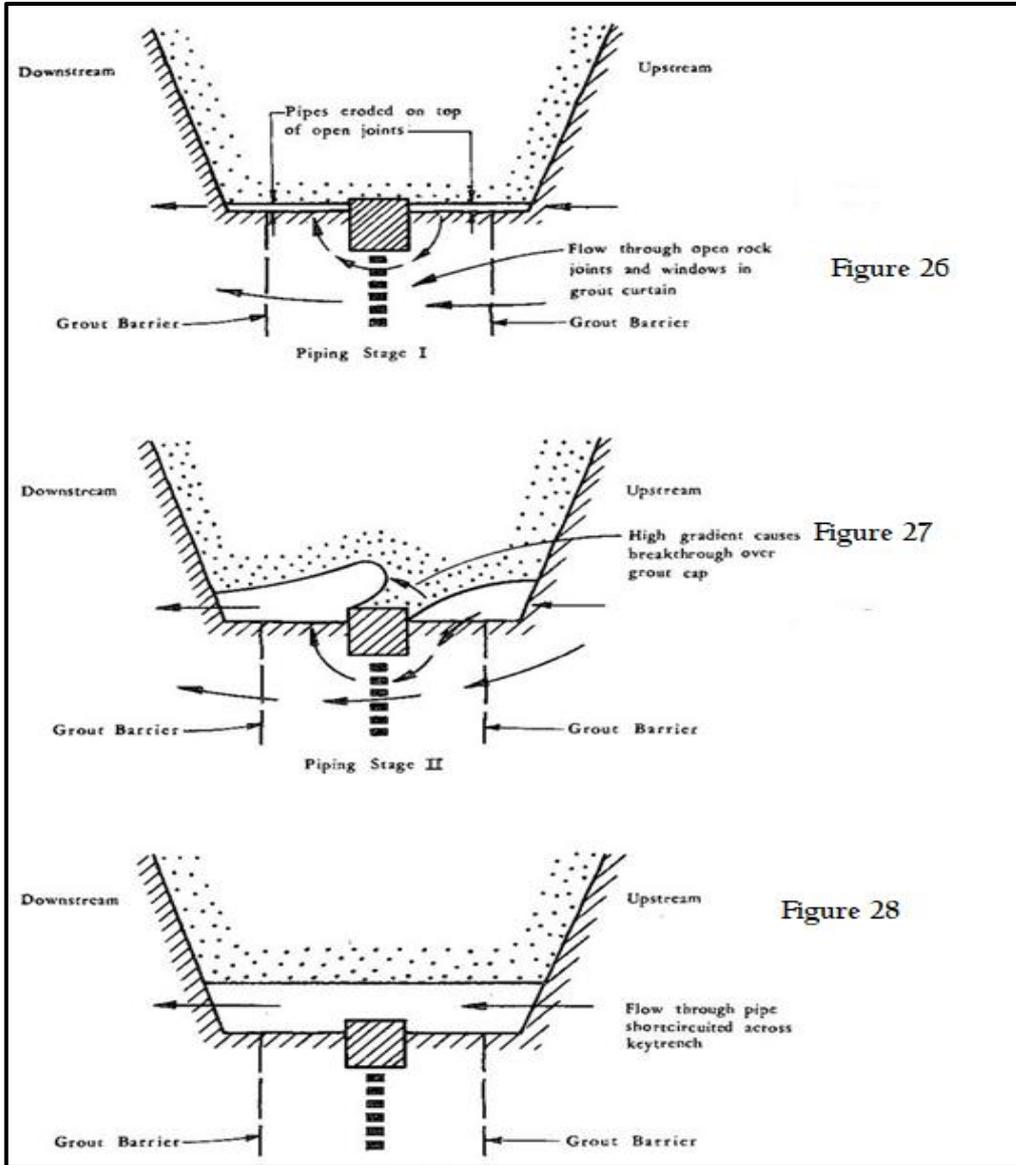
4. Seepage flow as demonstrated by field investigations clearly indicated that openings or windows existed in the grout curtain near the failure section, particularly at shallow depth beneath the grout cap. Even modest seepage beneath the grout cap, can develop into larger cavities upstream and downstream of the grout cap. These cavities may unite under the high hydraulic gradient between them to form a single erosion tunnel, Figures 26, 27 and 28. After this occurs, enlargement of the tunnel is restricted only by the capacity of the adjacent joints to deliver and carry away more of the

**Figures 26, 27 and 28: Seepage flow beneath the grout cap developing into larger cavities upstream and downstream of the grout cap to form single erosion tunnel. Hydraulic fracture of soil around grout cap encourages the formation of erosion tunnel as in stage III.**

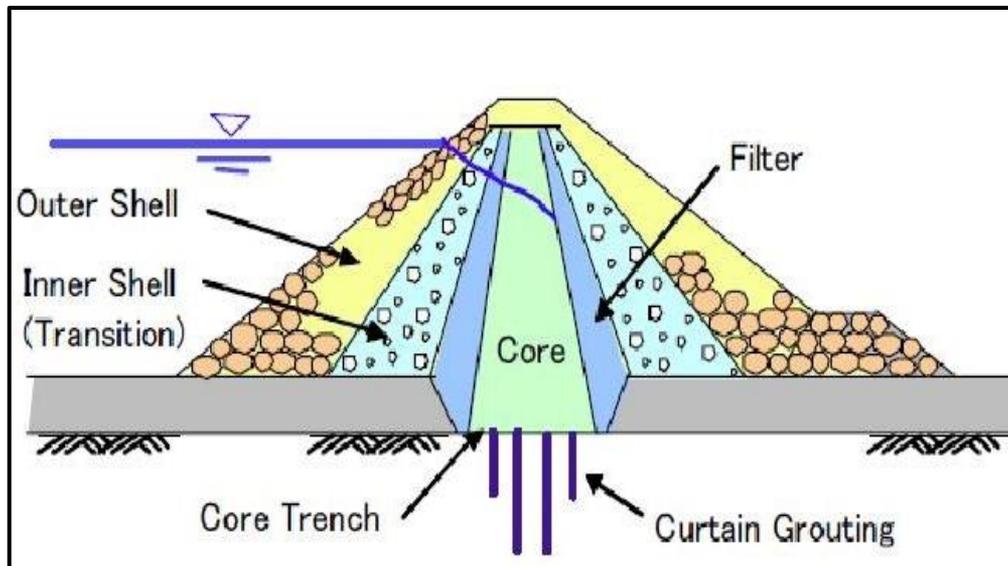
In zoned earth fill dams, the central zone is normally built of low permeability core to reduce seepage through the dam to the minimum possible level. Such cores are usually supported by upstream and downstream outside shells of more pervious material to give weight and stability to the dam under various operation conditions. The shells may vary in composition according to each case from sand-gravel fill, to rockfill, or random fill. Moreover, transition zones of filter materials are included to separate between the core on one side, and the upstream and downstream shells on the other to control seepage and leakage passing through these shells and prevent sediment transport through any cracks in the central impervious core. Additionally, these filters tend to stop any newly formed cracks to dangerous dimensions by filling them in a self-healing process, if such cracks are formed during the life of the dam due to any of the reasons explained previously. Various arrangements to discharge safely the seepage water from the filter zones may be constructed, such that the downstream filter zone is made in the form of chimney drain connected to a drainage layer at the dam base or by adding a toe drain of sufficient height at the toe to collect seepage water directly. Figure 29 and Figure 30 shows such arrangement in a zoned earth fill dam [22].

**Figure 29: Rockfill Dam with clay core and filter zones.**

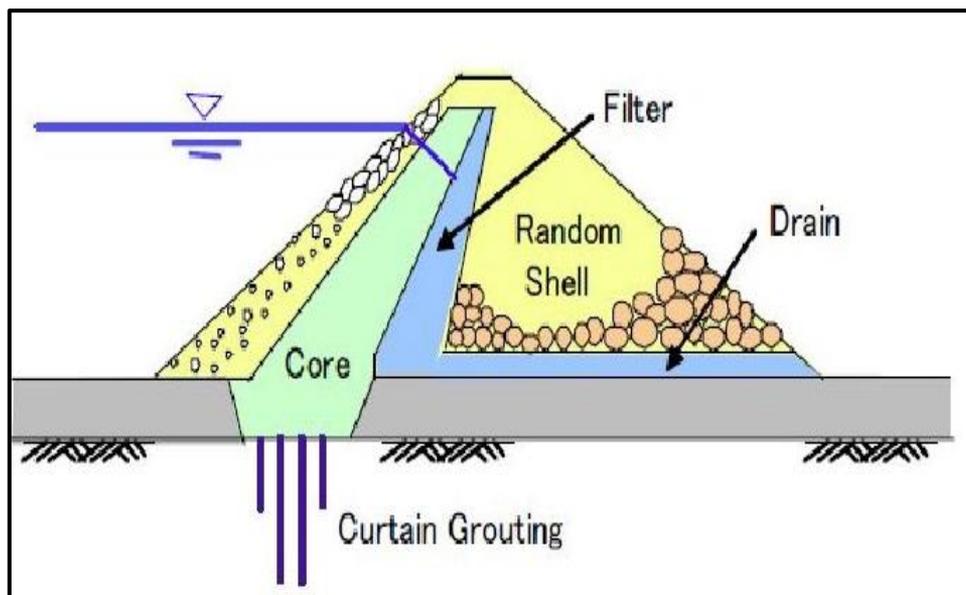
**Figure 30: Rockfill Dam with Chimney filter and drainage layer.**

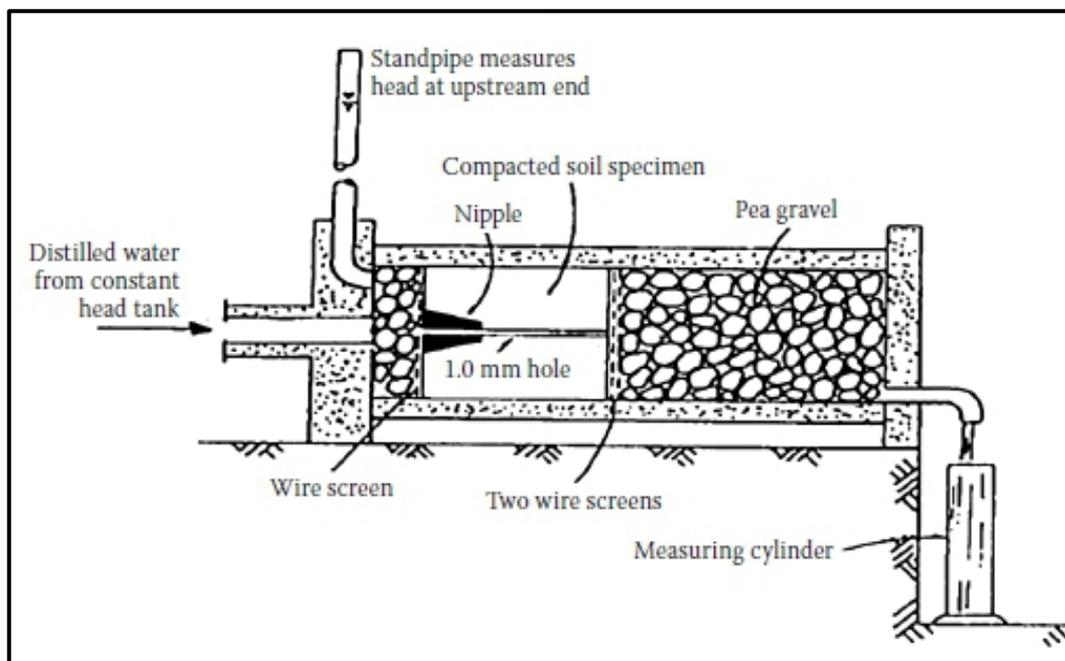
The tests most commonly used for identifying dispersive clays are the crumb test (ASTM D 6572), the double hydrometer test (ASTM D 4221), and the pinhole test (ASTM D 4647) where the pinhole test is a direct measure of the erodibility of soil. Figure 31 shows an arrangement for Pinhole test apparatus.

**Figure 31: Pinhole test apparatus for dispersive clays.**
