## **Dam Safety Problems Related to Seepage**

### **Abstract**

**Keywords:** Seepage, Internal Erosion, Piping, Sloughing, Hydraulic Fracturing, Filters, Chimney Drain, Drainage, Uplift.

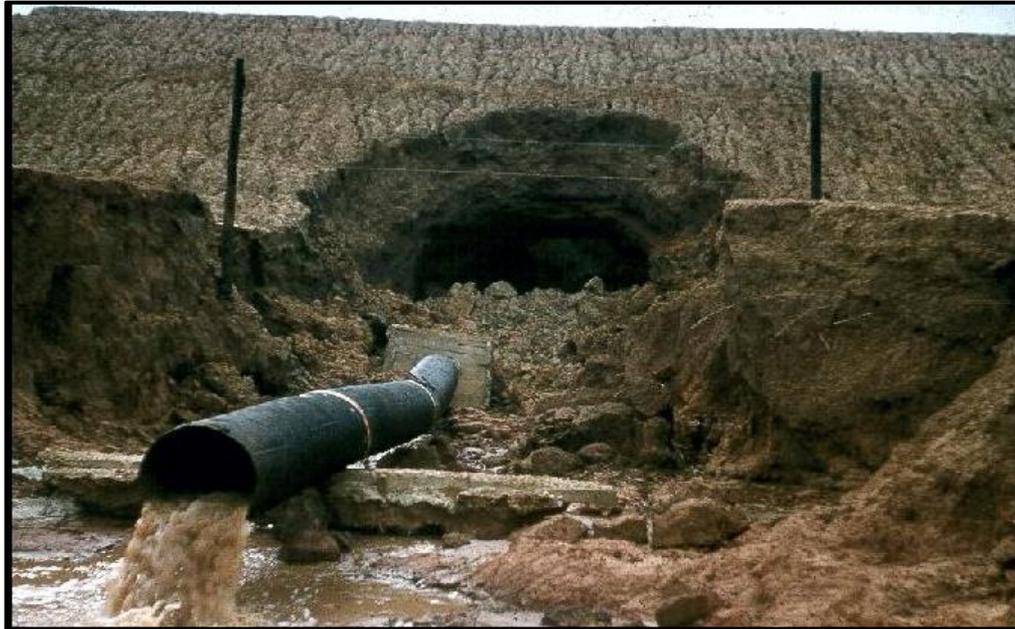
In embankment dams, if the low permeability core, which is normally of clayey soil develops cracks, particularly transverse cracks, from hydraulic fracture, desiccation, or other causes as described already in the previous paragraphs, the integrity of the embankment dam may be at risk. Water flowing through a crack in any soil will erode and enlarge the crack, unless the crack is able to swell closed before erosion occurs. If the crack continues to erode, this can lead to a breaching of the embankment dam. Figure 32 and Figure 33 illustrates failures known to be

associates with highly dispersive clay embankments. Both figures show a small embankment dam that failed when water flowed along a transverse crack in the dam. The transverse crack was caused by hydraulic fracture of the earth fill associated with differential settlement near the conduit. Failures of embankment dams constructed of dispersive clays without appropriate defensive design measures have been common, refer to Figure 32.

**Figure 32: An embankment dam in Mississippi constructed of dispersive clay soil, failed on first filling with low reservoir level. Failure was likely caused by cracks from differential settlement, hydraulic fracture, or poor compaction about the outlet works conduit. The embankment dam had no filter and the clay was dispersive.**

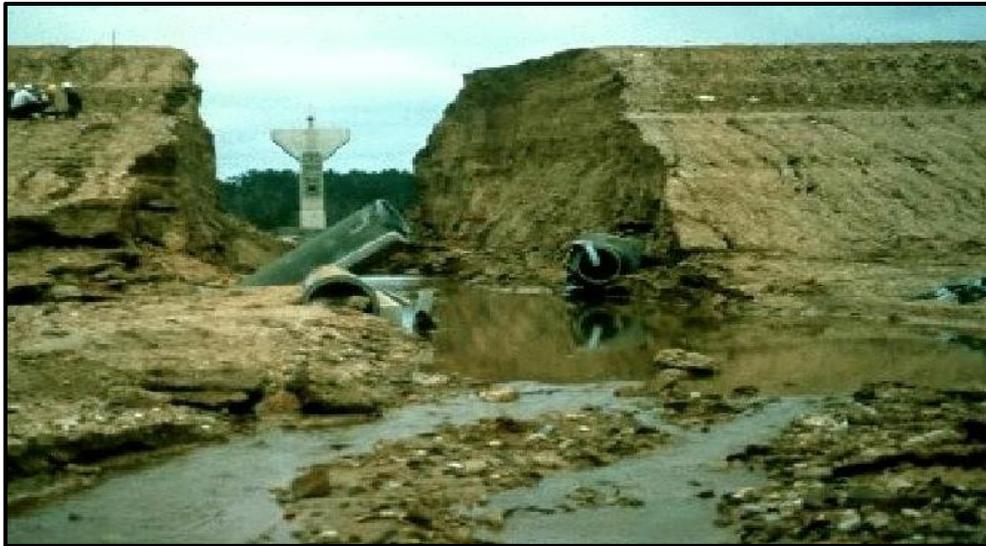
**Figure 33: The embankment dam shown was constructed with dispersive clays, failed on first filling of the dam.**

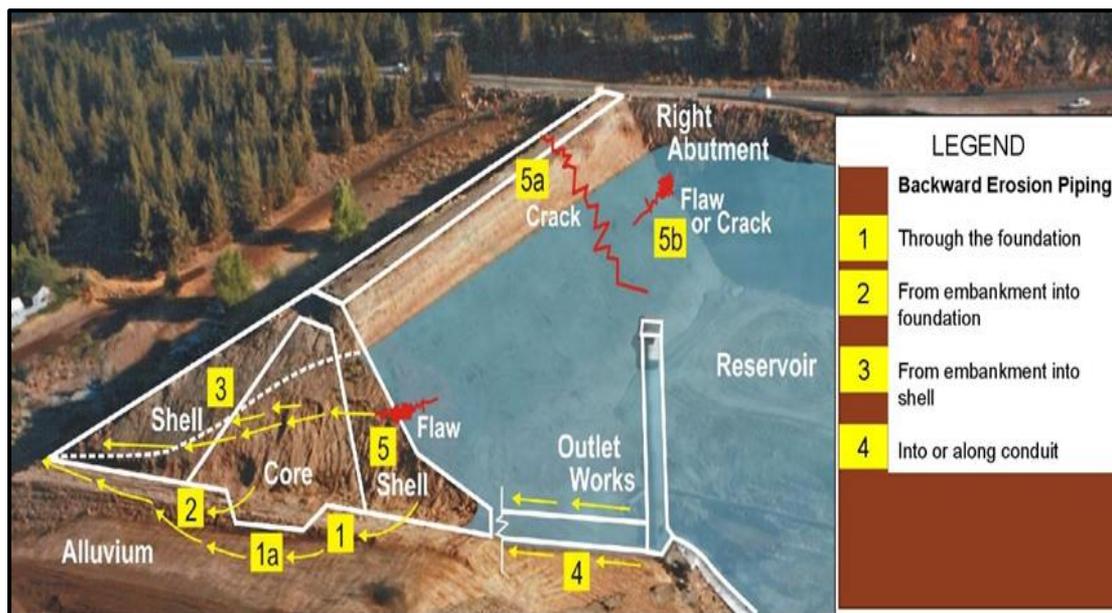
Another form of internal erosion is the backward erosion piping process, which may start at an exit point in the downstream of earth fill structure and progresses backward (upstream) towards the reservoir. In this process, pipes or tunnels are formed in or underneath an earth fill dam or dyke. As seepage water flows through these pipes from the reservoir, it dislodges and washes soil particles from this fill depositing the eroded material at the downstream side of the structure. Figure 34

shows the various modes of backward erosion; note that the yellow arrows in this figure indicate the direction of seepage flow while the backward erosion process occurs in the reversed direction.

**Figure 34: Modes of backward Erosion Piping [29].**

Backward erosion can also develop along conduits of outlet works crossing the foundation of an earth fill dam (Failure mode 4 in Figure 34). Factors that increase the likelihood of internal erosion and backward erosion piping incidents include:

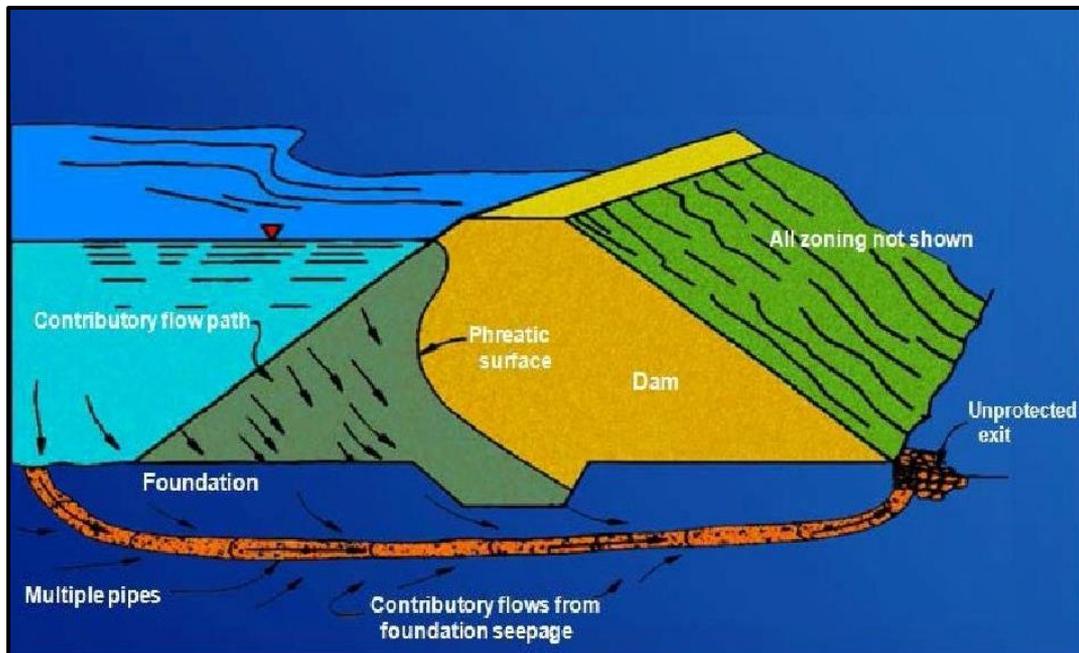
High embankments constructed from cohesionless and /or low-plasticity cores can also be at risk for piping when they are not provided with filter zones within the fill. An illustration of backward erosion piping through foundation (Cases 1 and 2 shown in Figure 34) is illustrated in Figure 35.

**Figure 35: Backward erosion piping showing the fully developed pipe connected from downstream to upstream.**

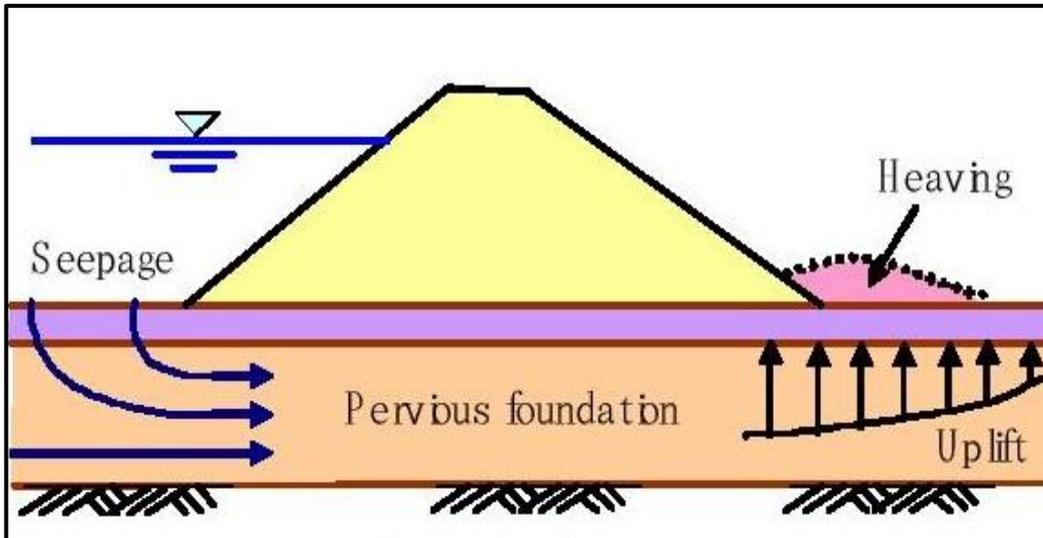
If the remaining head at the toe of the dam exceeds the overburden weight of the overlying layer, and if the upward flow of seepage water is strong enough, then it will breach the confining layer causing what is known as a blowout, whereby sand particles and other finer particles are washed out and deposited around the springs in a conical ring, referred to as a sand boil. Two idealized cases of piping at the toe of an earth dam resulting from excess uplift pressure are shown in Figure 36 and Figure 37.

**Figure 36: The case of dam founded on impermeable layer and permeable layer beneath it (artesian flow) [32].**

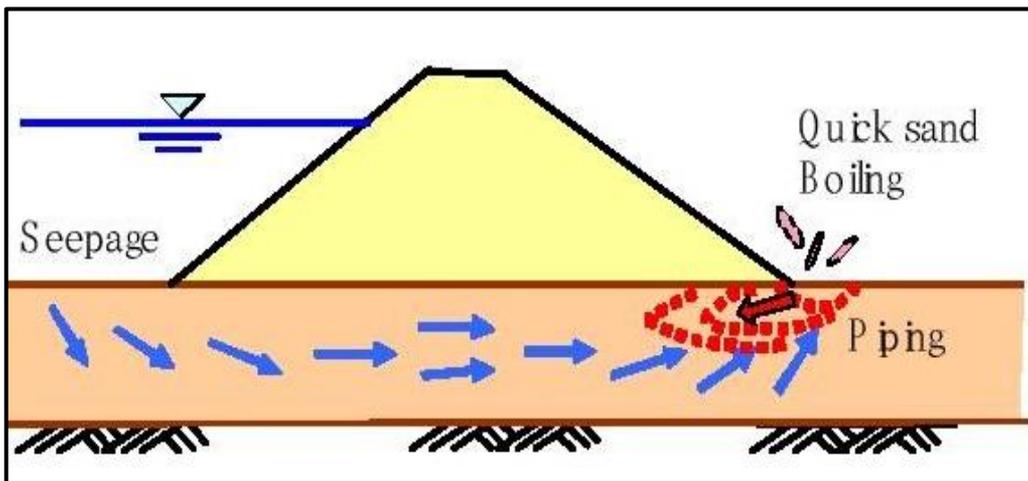
**Figure 37: The case of a dam founded on permeable foundation (free surface flow) [32].**

In case of foundations, consisting of pervious material right from the surface to the impervious layer like rock (refer to Figure 37), relief wells may not be fully effective as the flow is being distributed over the entire length and depth of the foundation. Such relief wells, however, serve their purpose in relieving pressures that may get locked up below some impermeable pockets or where the horizontal permeability differs substantially from the vertical permeability. Hence, they should be generally provided in such cases, especially if the anti-seepage measures used for the dam (cutoffs, or blankets) only have been partially provided.

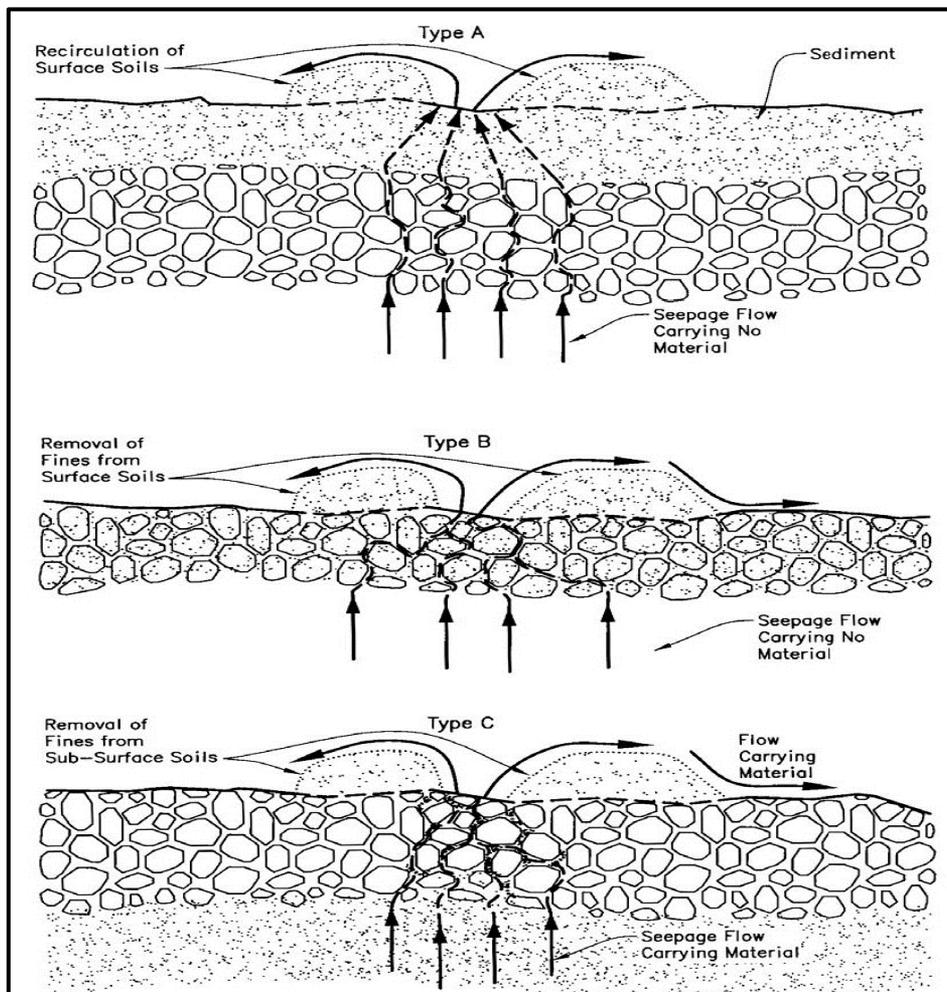
If a sand boil continuously removes material due to an excessive hydraulic gradient, they may eventually lead to piping, collapse or failure of the structure. Figure 38 illustrates various types of sand boils. Type A is indicative of a static condition for the current hydraulic gradient and is not necessarily indicative of an immediate problem developing. However, if the hydraulic gradient could increase during an extreme event, a Type A boil may become a Type B or Type C boil depending on the magnitude of the hydraulic gradient and soil conditions within the foundation or embankment. Type B is a boil that is carrying material, but the material is originating from near surface soils rather than deeper zones. A Type B boil may be

indicative of a more serious problem developing that could warrant corrective action. Type C is indicative of a critical condition, where the present hydraulic gradient is removing subsurface soils. A Type C boil would need immediate action to remedy. Piezometers can be used to monitor downstream foundation uplift pressure and detect unsafe conditions before failure occurs. A key indicator of a potential problem developing is fine soil carried in water draining from a boil. In this case, the water is cloudy rather than clear or it may contain scattered fine particles [33].

**Figure 38: Types of sand boils likely to develop due to uplift at the toe of dam.**

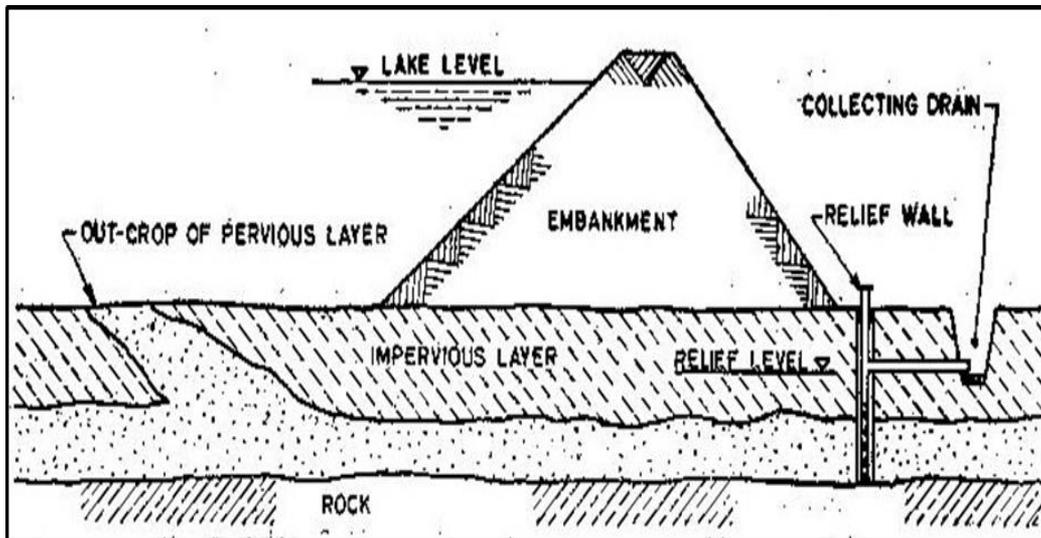
When confined flow conditions are predicted during design or develop during operation then one of the more effective safety precautions may be taken by installing relief wells at the toe of the dam spaced at calculated intervals; such an arrangement may be seen as in Figure 39.

**Figure 39: Typical Arrangement of Relief wells installed at the toe of earth fill dam.**
