Water Resources Projects: Large Storage Dams

Abstract

Several dams were built on Tigris, Euphrates, and Tigris tributaries in Iraq. The construction of dams had been done in the second half of 20th century. Of the most critical issues confronting the large storage dams in Iraq are the liquefactions in Mosul Dam foundations, land sliding and earthquake effects in Darbandikhan Dam, and the essential maintenance and rehabilitation requirements almost for all the dams. Absolutely, large storage dams made Iraq surviving from thirst in several occasions. Unfortunately, after 2003, the attention or will are not exist pertaining the building of new or partially built large dams.

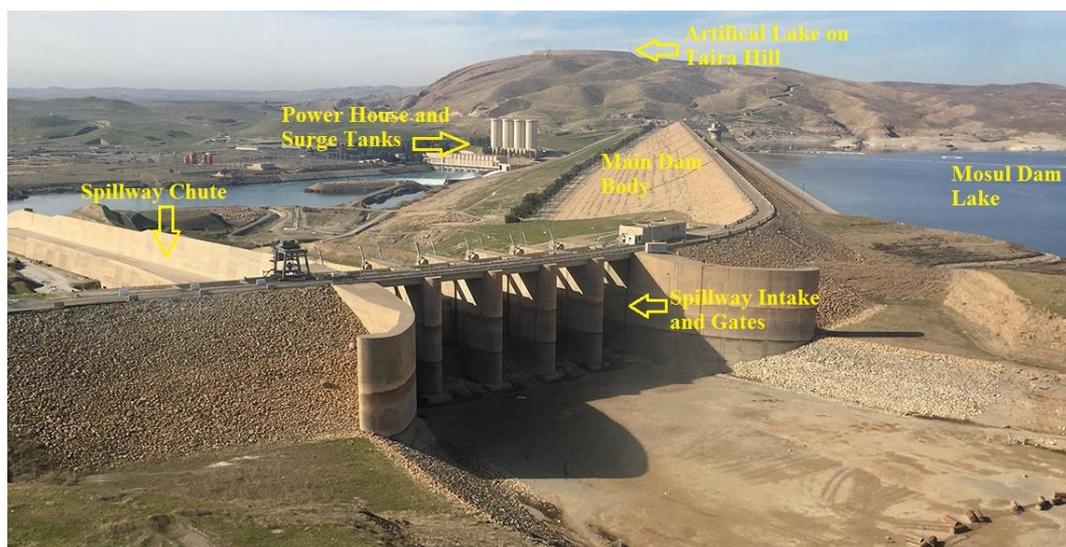
The dam project consists of the main dam with a length of 3600m, it is an earth fill dam with a clay core. The tallest height of the dam is 100m and the operational level is 330m a.s.l. The design storage is 11.11 billion cubic meters. The minimum operational level is 300m a.s.l., below a dead storage equals to 2.95 billion cubic meters, as the live storage is 8.16 billion cubic meters. The dam has a gated spillway on the left side; the spillway maximum discharge is $7400\text{m}^3/\text{s}$ at the maximum flooding level of 338.5m a.s.l. The length of the spillway is 1.013 meters and the width is 50 meters. The flow energy through Flip-bucket end of the spillway which directed the flow 25° of horizon, Figure 1 shows a general view of Mosul Dam [1, 2, 3].

Figure 1: General view of Mosul Dam (Edited by Author). (Source:[4])

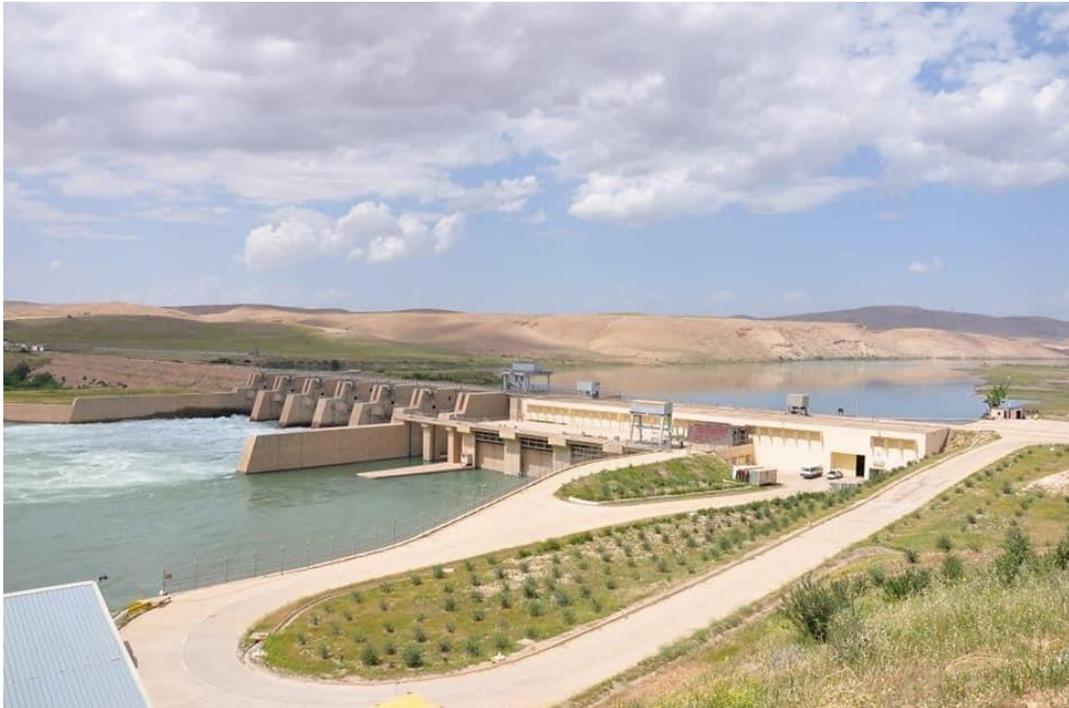
Mosul Dam is a giant project that includes a number of details, such as fuse-plug dam on the left side of the main dam, grouting tunnels, electric transformers, piezometers, as well as infrastructure for control, management, grouting and other services. Beneath the main dam, the grouting blanket had been implemented with 20 lines and depths of (25-10m). Further; the curtain grouting were implemented which consists 5 lines, three of them are vertical, and the two on both sides has inclination of 6° , the curtain grouting varies in depth and reaching up to 150m [5]. Downstream of the main dam and at a distance of 9km, the regulation dam was built on Tigris stream to control the high discharges from power plants and ensure a minimum discharge $330\text{m}^3/\text{s}$. This dam was implemented by Austrian company Allen Union. The length of the regulation dam is 381m and the height is 20m; it is an earth fill dam with storage capacity of 21 million cubic meters. The dam includes tunnels, bottom outlets, spillway and power station that have 4 units of Kaplan turbines with a capacity of 60M [1, 2, 3].

**Figure 2: General view of the Regulation Dam, Mosul Dam project.
(Source:[6]).**

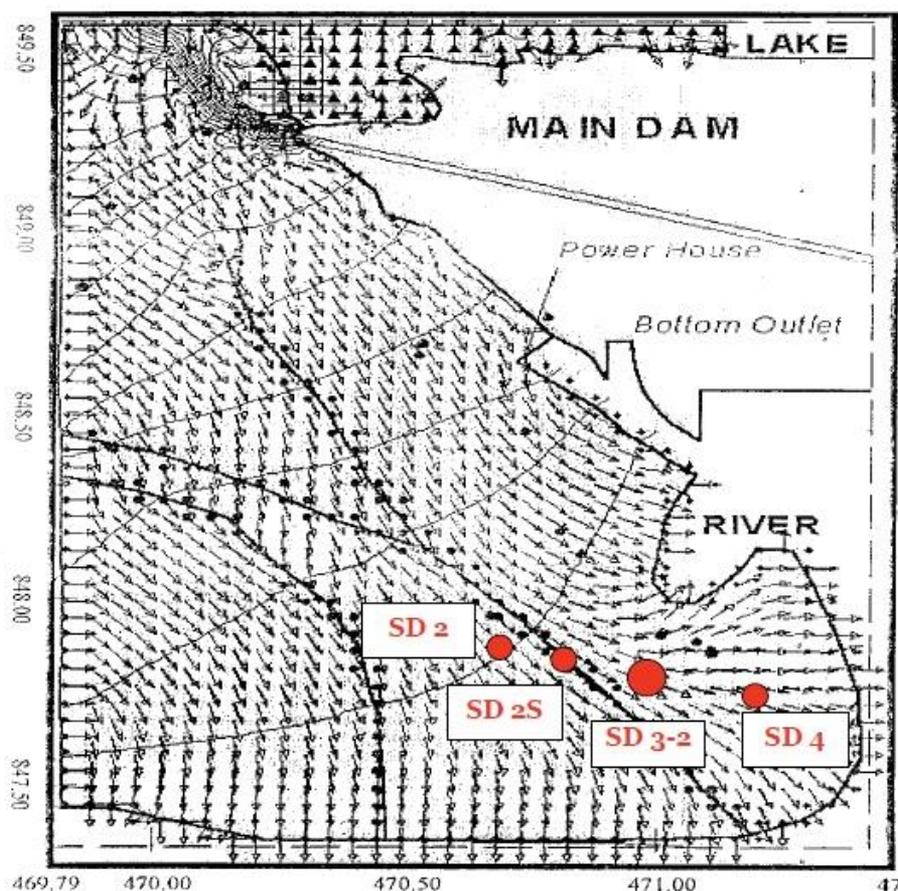
After the opening of Mosul Dam in 1986, the leaks began to appear from the downstream of the dam body at rates higher than the expected. Measurement data for sensors in the dam were periodically discussed with Board of Experts. As a result, they decided that the dam administration to continue the grouting during the service life of the dam. Several sinkholes appeared in the dam site, the first sinkhole occurred in 1986, this was followed by a group of sinkholes that occurred from 1992 to 1998, these sinkholes lying nearly on an axis that parallel to main dam axis. There was also a spring observed in the river stream near the right bank. In February 2003, a large sinkhole occurred suddenly in the left bank near the curtain and the main dam. Also, another one occurred in 2005. Further sinkholes and cavities discovered at the bed of the lake itself and in the surrounding areas. As a result, a Board of Experts had recommended to limit the storage at elevation of 319m a.s.l [1, 5, 7, 8]. Figure 3 shows the locations of sinkholes on the right bank downstream of Mosul Dam.

Figure 3: Locations of sinkholes on the right bank downstream Mosul Dam. (Source:[5]).

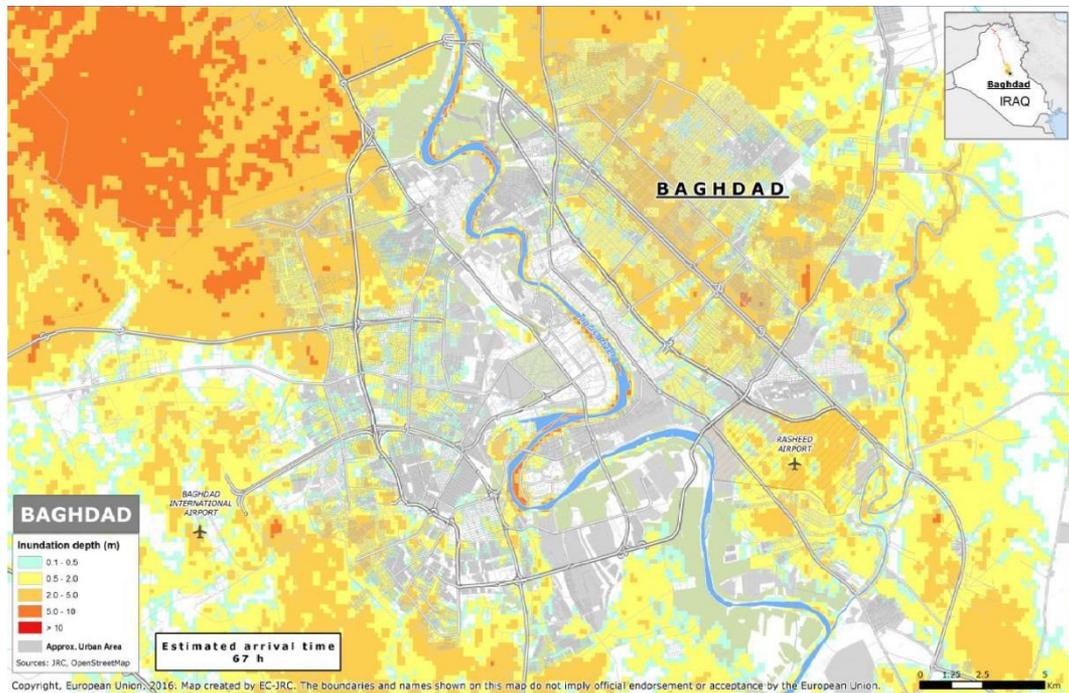
Figures 4: Inundation of Baghdad city for the calculated Mosul Dam break scenarios when storage at elevation of 330m a.s.l. (Source:[9]).

The Ministry of Water Resources after 2003 adopted the option of implementing a middle wall diaphragm, but another alternative adopted later, which is to continue the grouting of the base. After the chaos in 2014 and the occupation of Mosul Dam, the foundations issue spotlighted with an exceptional coverage by global media. This has resulted the signing of a rehabilitation contract with the Italian company Trevi for the work of grouting, training, and maintenance of the dam. The company has continued to carry out the traditional grouting works with the supply of the dam project with modern sensors and rigs; they finalize the works on June 2019 [2, 4]. A number of international organizations have also carried out simulation scenarios of the dam break, in addition to the studies prepared by the consultants who studied the dam at the beginning. Of these studies, it was found that the analysis of the default break of the worst scenario at the storage level 330m a.s.l. will cause wave height of 25m, where the wave reaches the city of Mosul in 1 hour and 40 minutes, and reach the city of Baghdad in 3.5 days. The flood wave has effect on 6 million people, 2 million people with flooded areas to a depth of 2m and 270 thousand people with flooded areas to depths of more than 10m. The most affected city is Mosul [9]. Figures 4 and 5 show the inundation of Mosul and Baghdad cities for the calculated Mosul Dam break scenarios when storage at elevation of 330m a.s.l.

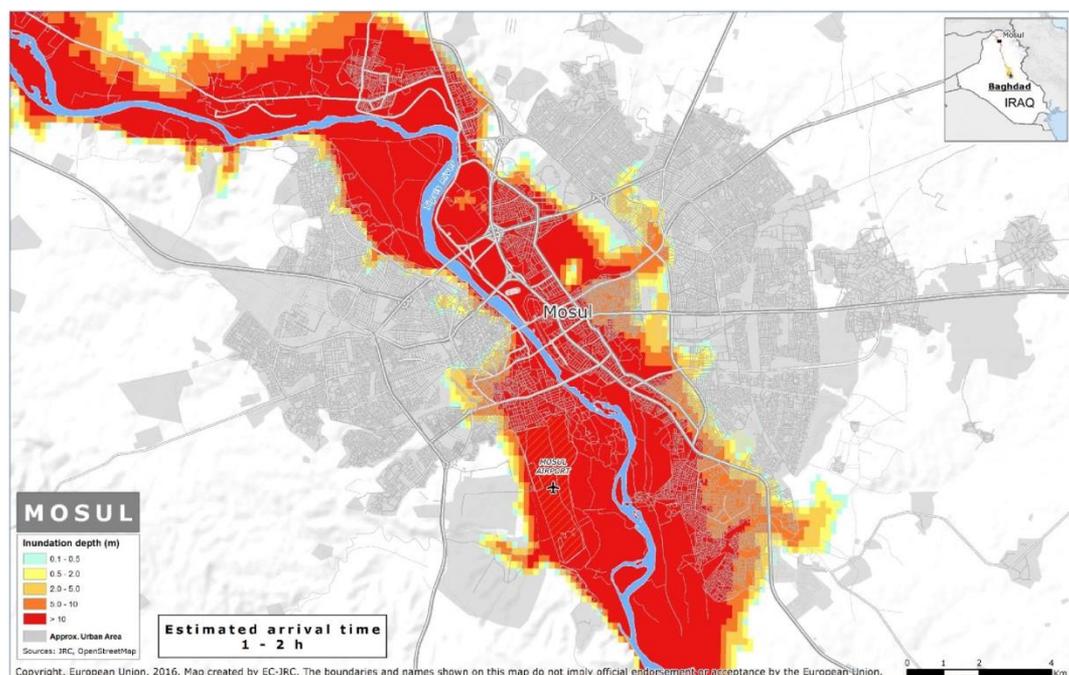
Figures 5: Inundation of Mosul city for the calculated Mosul Dam break scenarios when storage at elevation of 330m a.s.l. (Source:[9]).

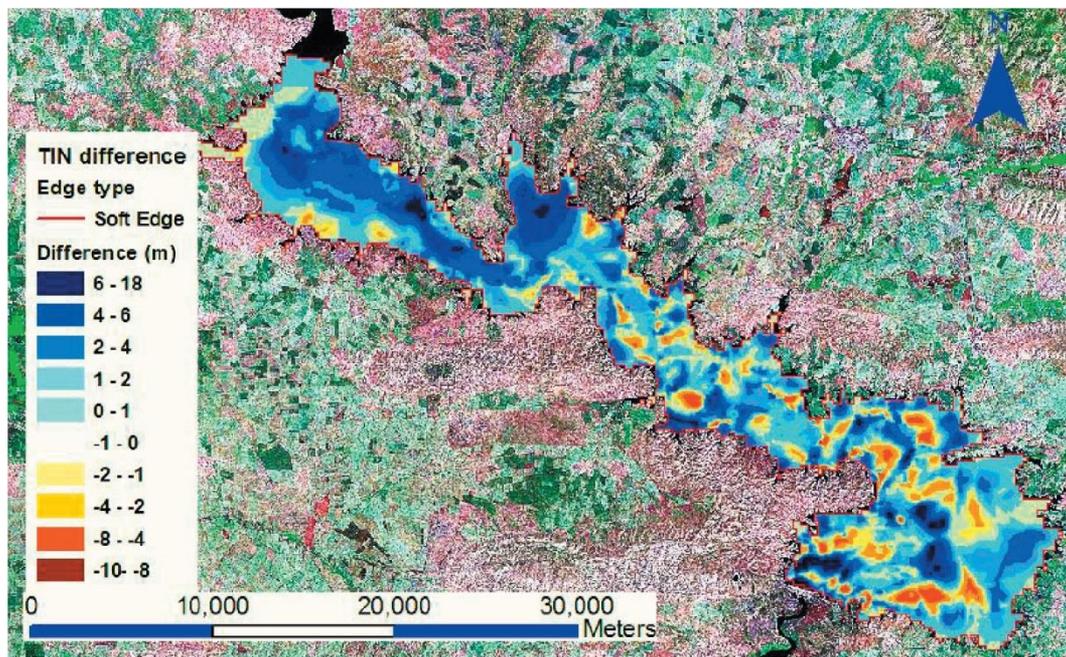
Figure 6: Bathymetric survey results of the Mosul Dam reservoir, and comparison with the topography of the lake prior to its operation. (Source:[10]).

It is wise to mention the contribution by one of the researchers who made a bathymetric survey for Mosul Dam Reservoir in 2011. The results showed that the live storage of the reservoir had decreased from 8.16 to 7.597 billion cubic meters; the dead storage also had decreased from 2.95 to 2.37 billion cubic meters. The total storage became 9.967 billion cubic meters. The annual sediment income was 45.73 million cubic meters. The survey showed that the sediments were accumulated at the beginning of the reservoir, which is very natural. The interesting finding of this study is the discovery of cavities at the bed of the reservoir; in sizes comparatively larger what had been founded downstream of the dam. Figure 6 shows the results of the bathymetric survey of the Mosul Dam reservoir and its comparison with the topography of the lake prior to its operation [10].

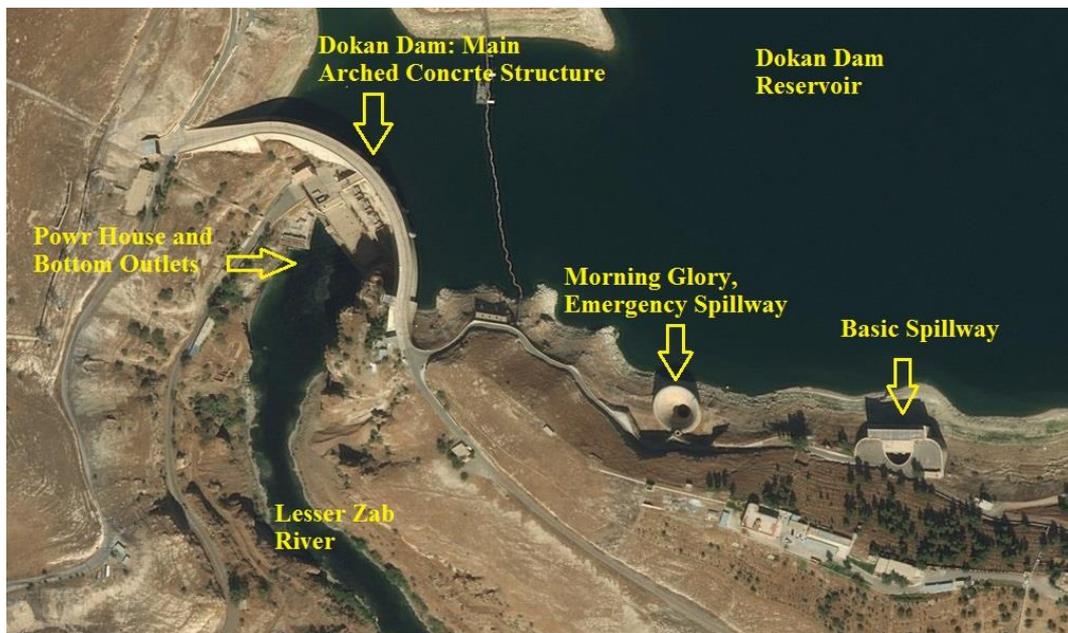
the dam at the top with side abutments is 345m and the radius of curvature is 120m. The highest operating level of the Dokan reservoir is 511m a.s.l. to impound storage of 6.8 billion cubic meters and a surface area of at that elevation equals to 270km², 6.1 billion cubic meters is the live storage. The minimum operational level is 469m a.s.l. The dam has a Morning Glory spillway with a diameter of 40.26m which is an emergency spillway works at elevation of 511m a.s.l. and the maximum discharge is 1860m³/s, this spillway built in the left shoulder of the dam, and beside on the left another spillway, which is the basic spillway, it works at elevation 496.5m a.s.l., this spillway has three openings with dimensions of (10m×6.8m). Both spillways divert the water through a tunnel buried in the left shoulder with a diameter of 11m. There are also two bottom outlets lined with steel, where the discharge for each is 110 m³/s [2, 11]. Figure 7 shows a satellite view of Dokan Dam.

Figure 7: Satellite view of Dokan Dam (Edited by Author). (Source:[13]).

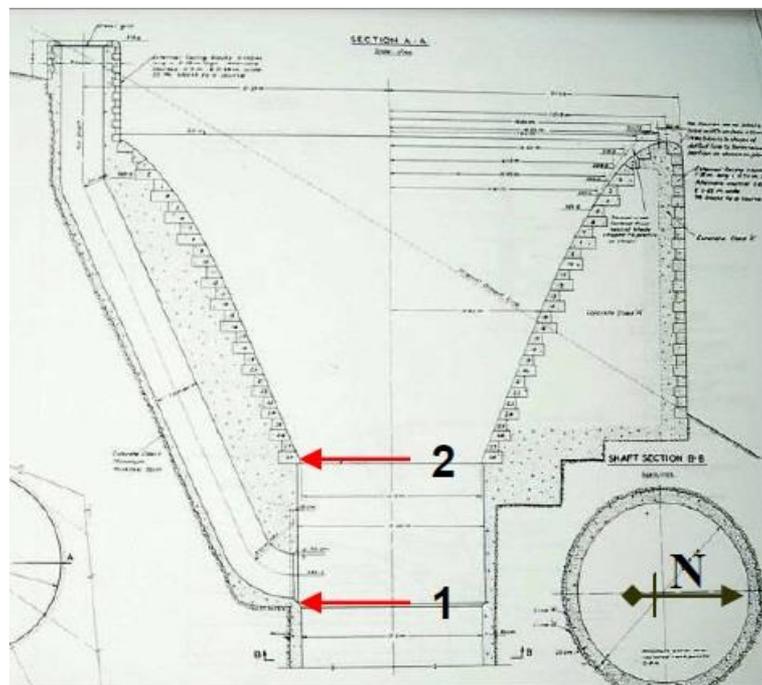
the dam in 1998, it was concluded that the source of the leak was the joints between the rock formations. The dam also needs the maintenance for gates of the outlets. Other leaking locations were observed in the structural joints of the Morning Glory spillway, where in 2000 an inspection engineers sent down through the spillway by crane, and the scenes from inside were filmed [11]. Figure 8 shows the leakage locations in morning glory spillway of Dokan Dam.

Figure 8: Leakage locations in morning glory spillway of Dokan Dam.
(Source:[11]).

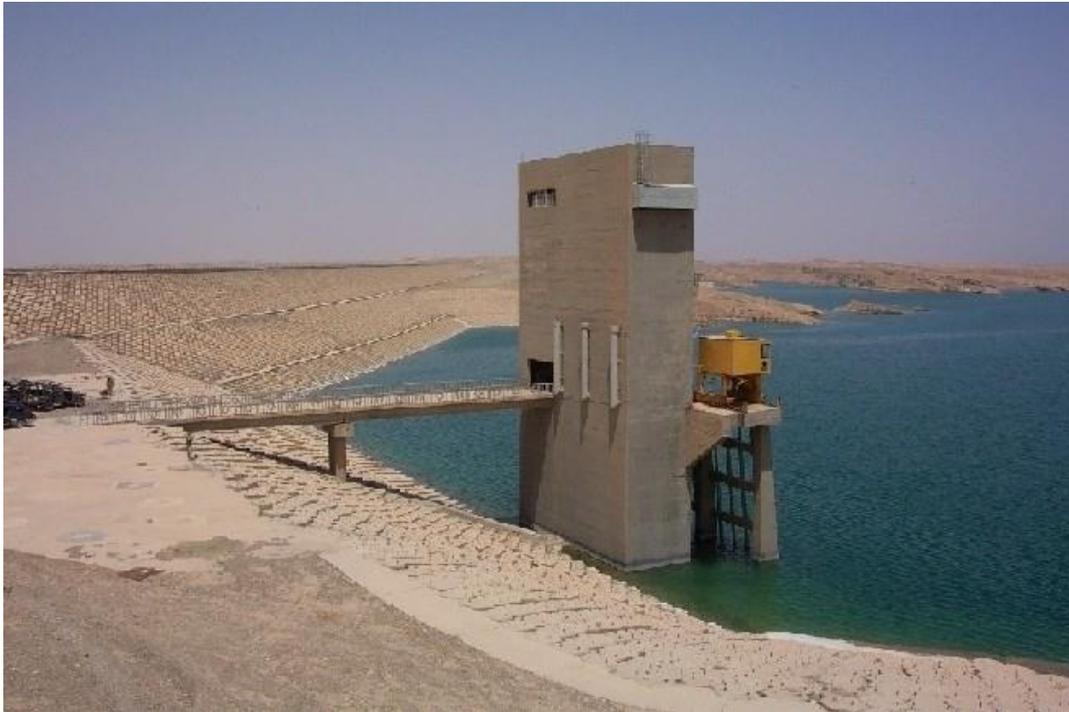
The dam project consists of the main dam body; a 3800m long earth fill dam with clay core, maximum operational level is 131.5m a.s.l. with storage of 1.5 billion cubic meters, the tallest height of the dam body is 62m. Side slope of the dam body from the upstream side has a riprap of concrete blocks with size ranges (1-1.5)m³, these blocks were based on a layer of graded gravel sub base [2]. Figure 9 shows a general view of the dam body intake structure.

Figure 9: Adhaim Dam general view for the dam body intake structure. (Source:[6]).

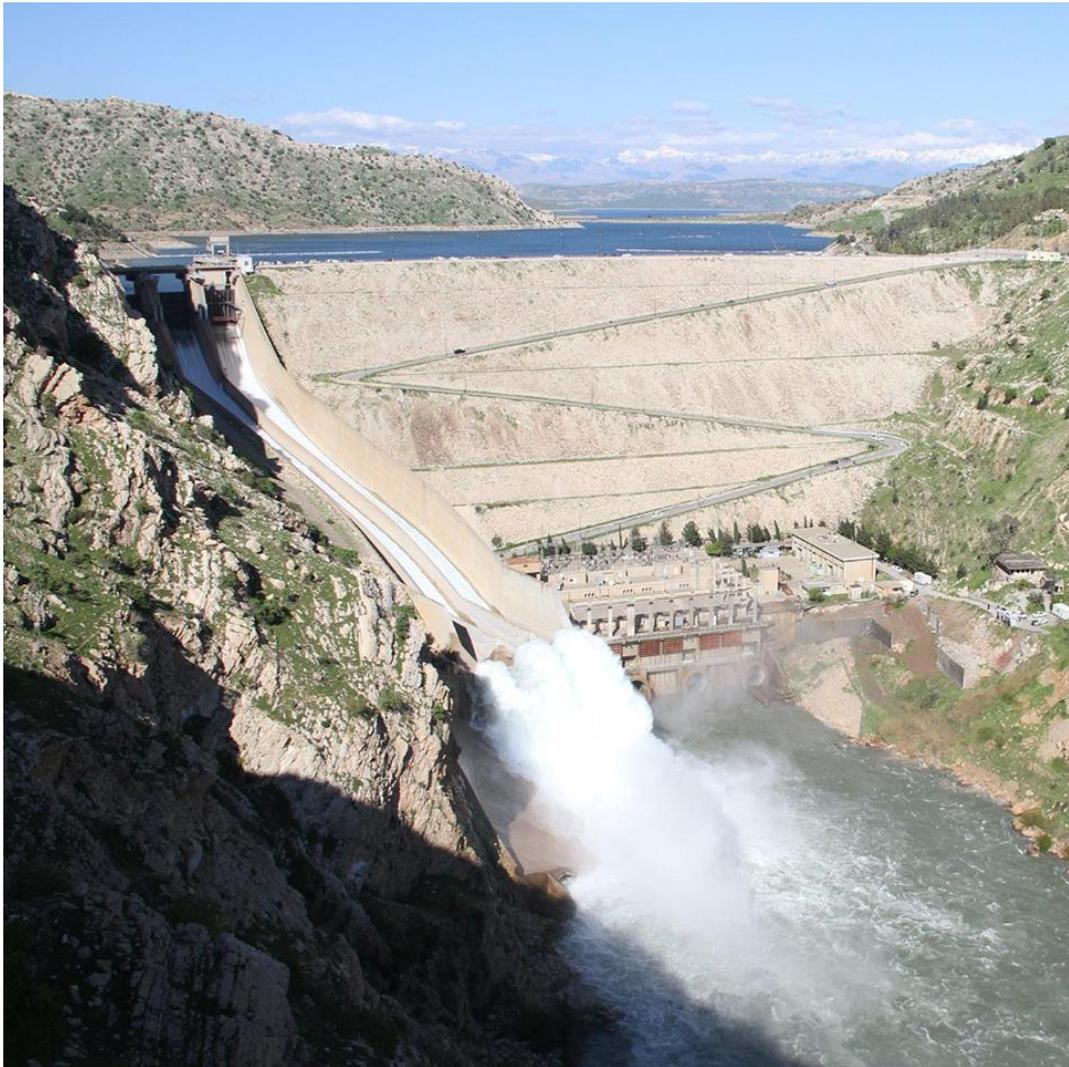
Dam body has a clay core surrounded by a stone shell. The highest elevation of the dam is 128 m and the width at the top of the dam is 535m. The maximum operational level of the Darbandikhan dam is 485m a.s.l., while the minimum operational level is 434m a.s.l. with a design capacity of 3 billion cubic meter of which 2.5 billion is a live storage. The dam includes a spillway on the right side, the spillway has 3 curved gates with dimensions of 15m×15m and spillway is divided into three sections that end with a flip bucket configuration. Spillway discharge is 5,700m³/s at the maximum operational level, while the maximum discharge is 14,000m³/s at maximum flood level of level 493.5m a.s.l. [2, 11]. Figure 10 shows a general view of Darbandikhan Dam from the upstream.

Figure 10: General view of Darbandikhan Dam from the upstream.
(Source:[6]).

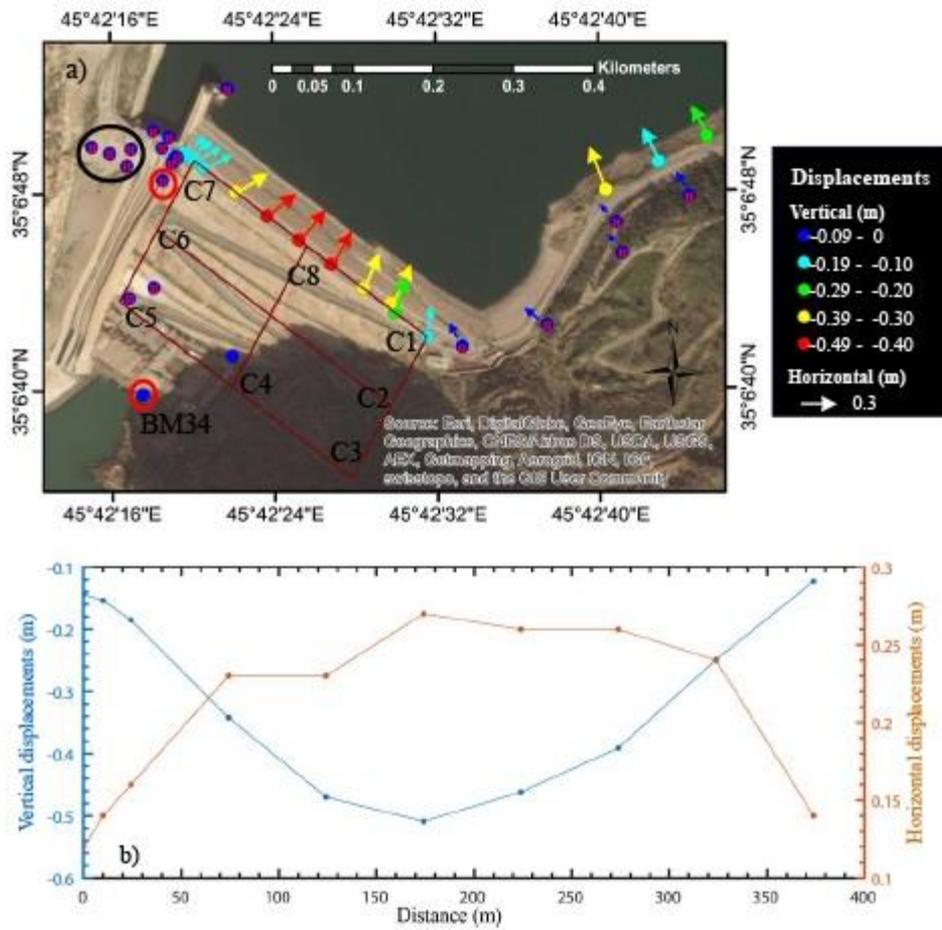
On November 12, 2017, the area nearby the dam in the Iranian city Sarpol Zahab was stroked by 7.3 magnitude earthquake, the epicenter was 30km from Darbandikhan Dam. The body of the dam was directly affected, cracks occurred in the body of the dam. The quake was followed by 53 aftershocks. Surveys were conducted by the Department of Surveying after the earthquake. There were cracks and settlements in some locations, especially at the top of the dam where the largest horizontal displacement was 27cm in the center of the dam. On the left side, it reached 14 cm and on the right side 12cm. Dam body at the top moved toward the center of the dam and to the northeast and north-west direction. While, the vertical displacement was varied from 50cm in the middle of the top and it was varied from 15 to 45cm at the sides as shown in Figure 11 [17].

Figure 11: Horizontal and vertical displacement in Darbandikhan Dam body after the earthquake in November 2017. (Source:[17]).

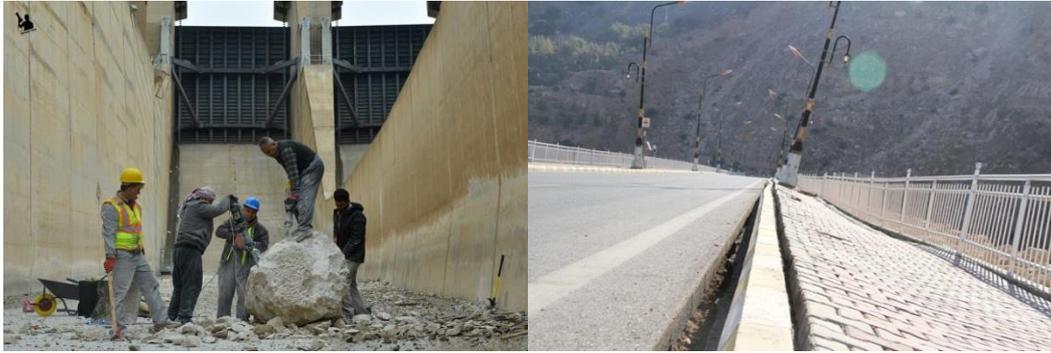
Figure 12: Aftermath of the earthquake in November 2017 at Darbandikhan Dam; a) Right: cracks in the main dam body b) left: group workers are demolishing a stone that fallen in spillway chute from the adjacent mountain.(Source:[18]).

The movement included the rocks on the right-side mountain, some of which were fallen near the dam and the administration building, and the most dangerous of what had fallen on the spillway channel. These rocks, which are large in size, pose a future danger in the event of repeated tremors or slippage due to unstable positions. The most important threat is the possibility of damaging the gates or important elements of the dam. Figure 12 shows the effects of the earthquake in late 2017 in terms of cracks in the body the main dam as well as the fall of rocks on the channel of the spillway [6, 18].

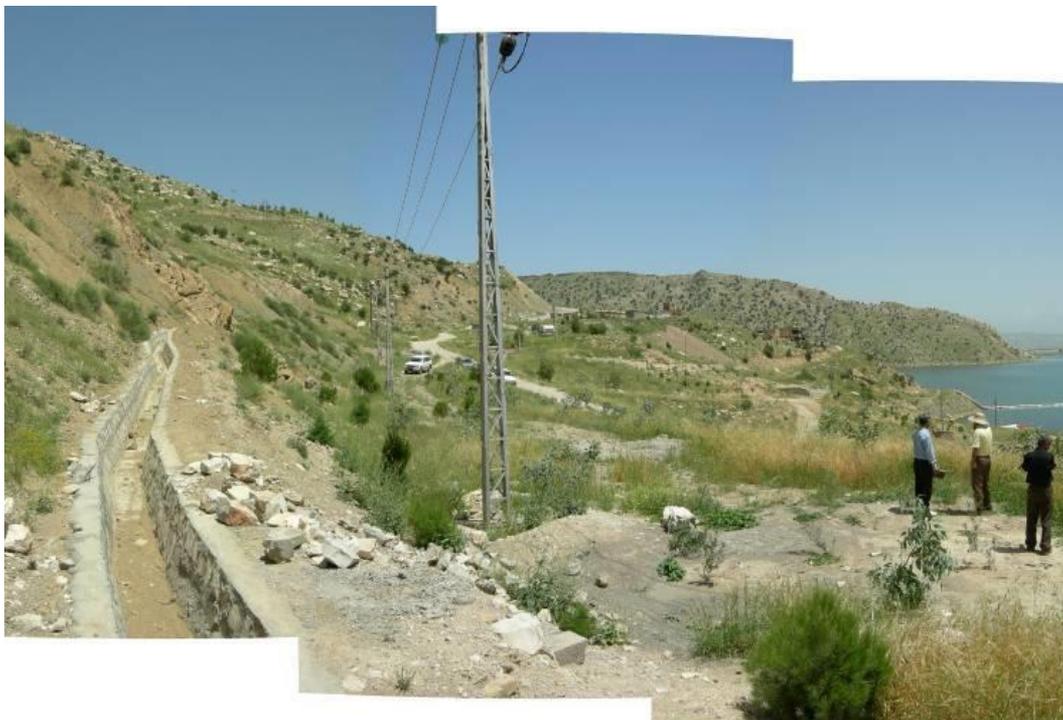
Land sliding in the right side of the lake is one of the most important issues in Darbandikhan Dam, this has been diagnosed during the construction of the dam, and measures were taken in terms of increasing the side slope of the dam body. The sliding occurred after five years of lake operation, where the sliding observed at 300 meters from the body of the dam on the right side, it was founded in 1967 that the affected section extends 350m long and 200m wide with a depression for about 1.5m. This sliding could make a mass of soil equivalent to 2 million cubic meters. The sliding was caused by precipitation occurred due to an intensive rainfall of 126mm lasted seven days, and there was further rainfall between November 1969 and January 1970 [11]. Figure 13 shows the land sliding on the right of Darbandikhan Lake.

Figure 13: Land sliding on the right of Darbandikhan Lake. [(Source:[11])]

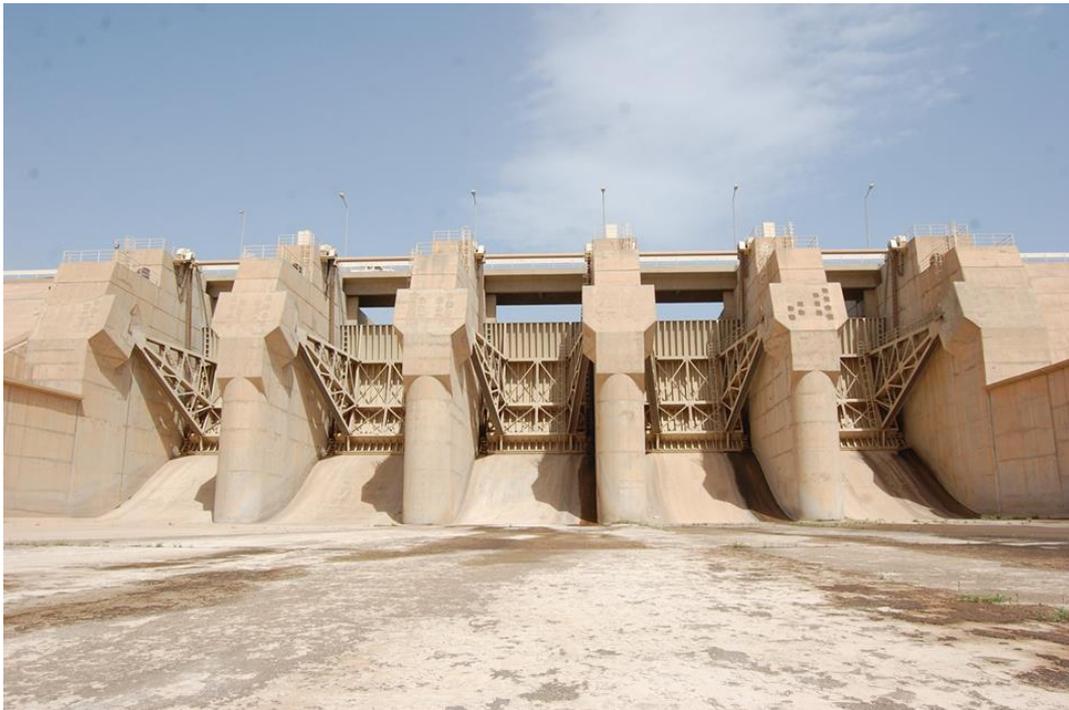
Hemrin Dam project consists of a main dam with a clay core, a height of 40m and a length of 3360m. The operational level of Hemrin Dam is 104m a.s.l., the total storage size 2.06 billion cubic meters of which 2.04 billion is live storage. The dam has a gated spillway controlled by five radial gates with dimensions of 10.6m×12.5m for each gate; the maximum discharge of the spillway is 6800m³/s at the highest flood level which is 107.5m a.s.l. Figure 14 shows the spillway gates of Hemrin Dam. The dam has also 4 irrigation outlets with total discharge of 250m³/s. There are also, hydroelectric plant with two Kaplan turbine units and total

**Figure 14: Spillway gates of Hemrin Dam, view from the downstream.
(Source:[6]).**

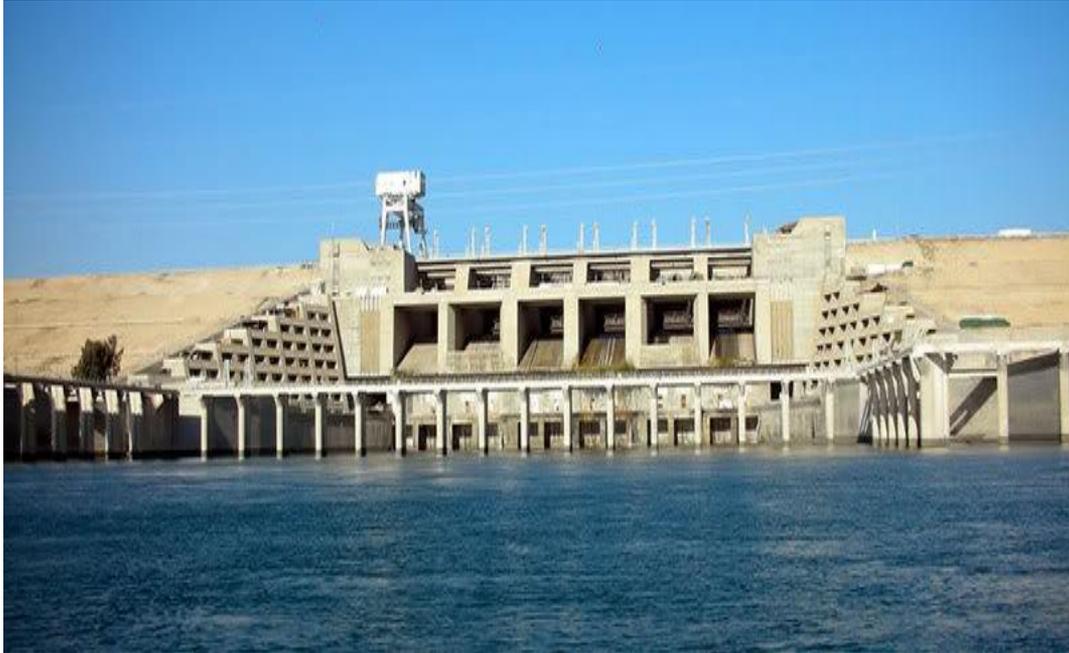
Haditha Dam project consists of the main dam with mealy dolomite core and asphaltic diaphragm in the middle, the core is shelled with mixed gravel, and the dam body lined with concrete from the upstream and it is lined with concrete blocks from the downstream as a riprap. The dam body composed of three parts, two earth fill parts and the middle concrete part. The right part has length of 3230m, the left part length is 495m, and the concrete part which constructed in the river section has a length of 580m which includes most of the concrete parts such as spillway, power house, and bottom outlets. The tallest height of the dam body is 57m and its total length is 8950m. The top of the dam elevation is 154m a.s.l. The lake of the dam has a capacity of 8.2billion cubic meters at the maximum operational level of 147m a.s.l., the live storage is 5.8 billion cubic meter. Dam includes also the spillway which controlled by radial gates, the spillway consists of 6 openings of 16m width, the maximum discharge of the spillway is $11000\text{m}^3/\text{s}$ at elevation of 150.4m a.s.l., which is the maximum flood elevation. There are two bottom outlets with dimensions of $4\text{m}\times 6\text{m}$ and discharge of $500\text{m}^3/\text{s}$, at the minimum operating level of 112m a.s.l. [2, 21, 23]. Figure 16 shows the middle section of Haditha Dam.

**Figure 16: Concrete Section of Haditha Dam, view from the downstream.
(Source:[6]).**
