Dam Safety: Use of Seismic Monitoring Instrumentation in Dams

Abstract

Seismic instrumentation of dams and reservoirs sites is accepted today as a valuable tool to understand significant seismic hazards facing existing dams or future planned dams. With the advent of digital seismic accelerometers and recorders, it can now be used today as an integral part of dam safety monitoring systems. Outputs of these instruments help in understanding the dynamic response of dams during earthquake, assessing the damage caused by such events and determining required upgrading works necessary for existing dams and designing of safer dams in the future. Measuring and recording by strong motion seismographs covers the induced Peak Ground Acceleration (PGA), velocity and displacement recorded on time scale to indicate the intensity and frequency of ground vibration at the site during seismic events. Seismometers for such measurements and recordings have undergone considerable evolution and there exist today a variety of these instruments with high degree of refinement which can even provide for remote sensing. In this work, this development is outlined and examples of seismic instrumentation in st

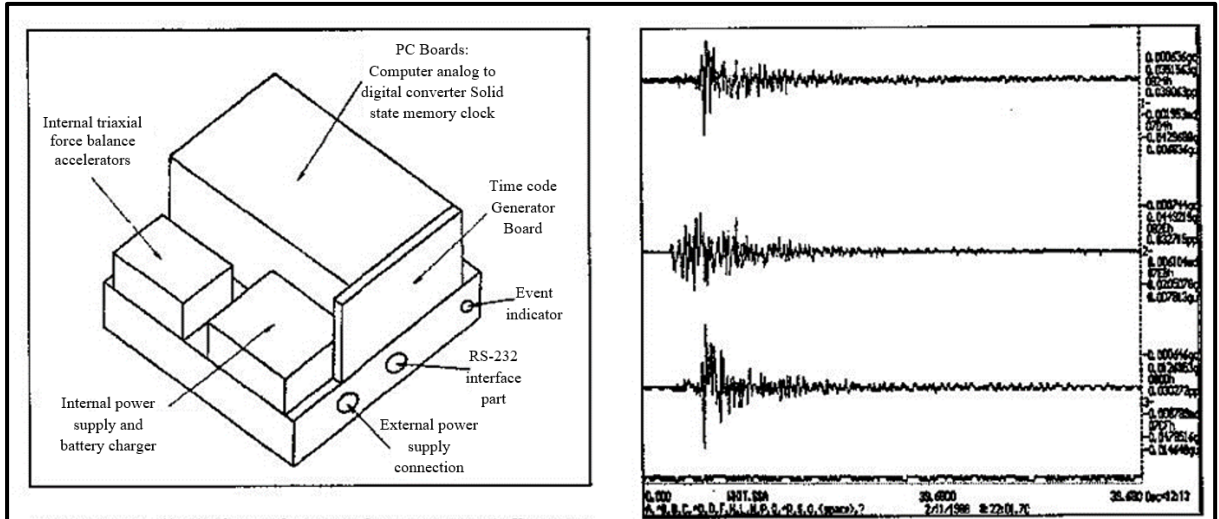
Digital recorder continuously digitalizes the three internal force balance accelerometers and stores data in solid state memory. The general arrangement of a digital accelerograph box is presented in Figure (4a), and a typical plot of such accelerograph is shown in in Figure (4b) [12].

Figure 4: (a) on the left shows the general arrangement of a digital accelerograph, (b) on the right is typical plot of such accelerograph [12]

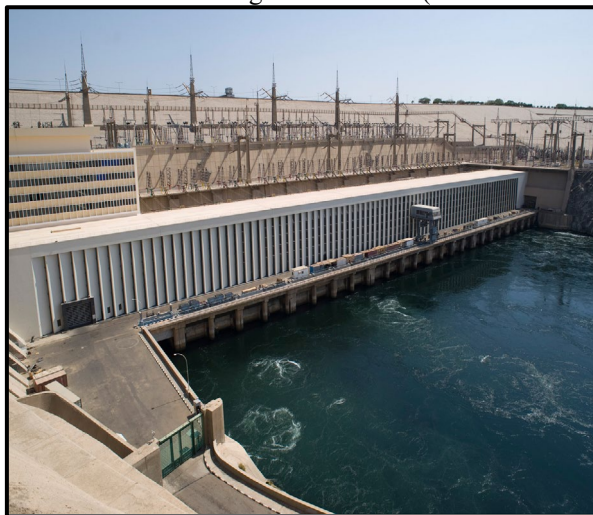
Figure 7: Downstream view of the power station at High Aswan Dam [15]

The dam is a massive structure containing 18 times the material used to build the famous Pyramid of Cheops at Giza. It is 3,600 meters long 980 meters wide at the base and 111 meters high above the river level. Figures (6,7) show some views of the dam and the power station.

The two Aswan Dams benefit Egypt by controlling the annual floods on the Nile River thus preventing the damage which used to occur along the flood plain. The High Aswan Dam increased cultivable land by 30% and provides about a half of Egypt's electrical power. The total installed capacity in its power station is 2100 MW provided by 12x175 MW Francis type turbines.

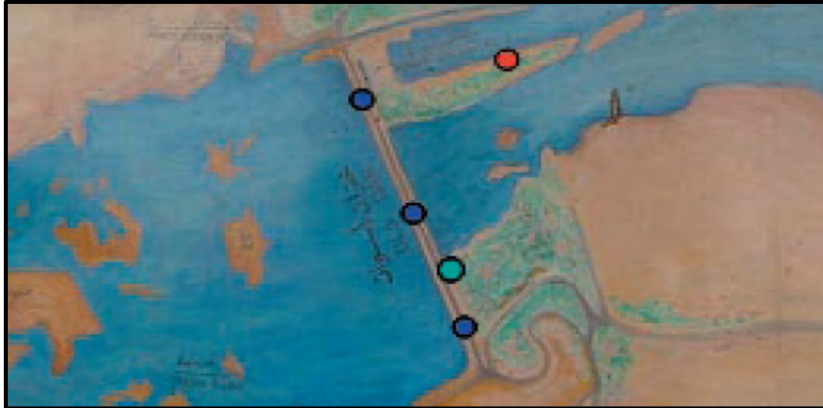
In the Old dam, and as this dam does not contain galleries, a total of five 130-SMHRs were installed near the structure; one on bedrock on the ridge of the river; one at the Dam base; three at the Dam crest, with power supplied by a solar energy system. The illustration in Figures (10 and 11) shows the location of the instrumentation.

Figure 10: Old Aswan Dam instrumentation location [16]

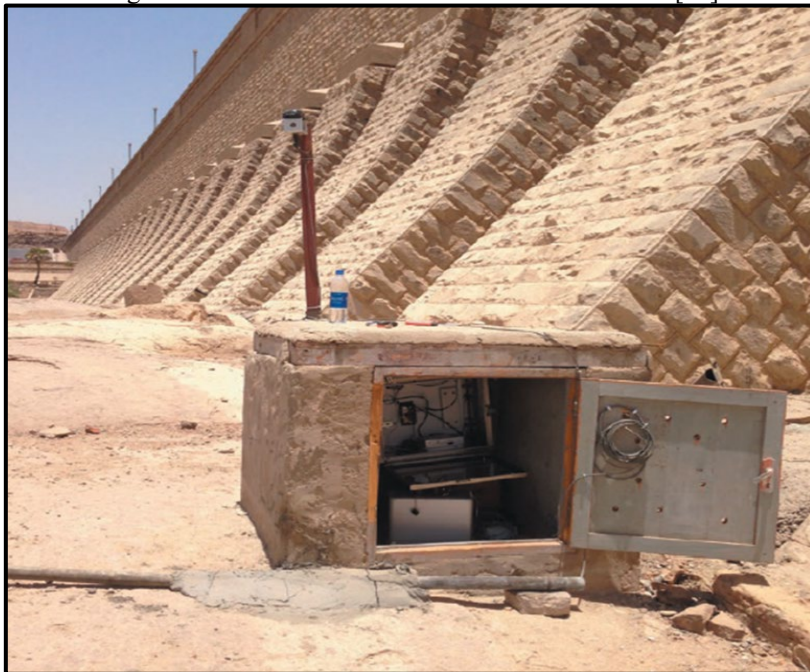
Figure 11: Old Aswan Dam Field Station [16]

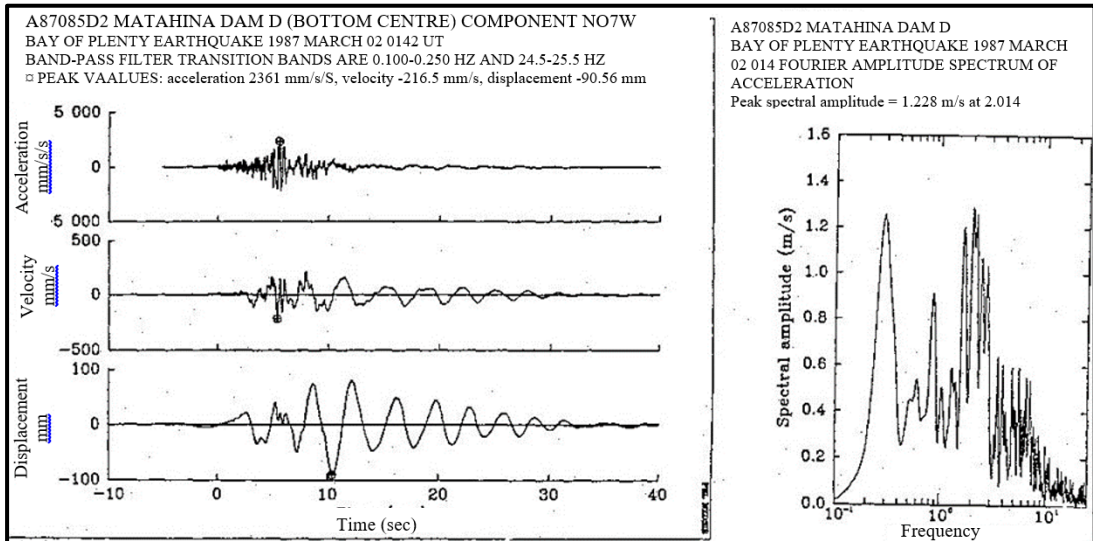
A foreshock and four aftershocks had magnitudes of over 5.0 with epicenters within a few kilometres of the main shock. The accelerometer at the base of the dam recorded M5.2 foreshock, the M6.3 main shock and the largest aftershock, the M5.5 event 8 minutes after the main shock. The transverse (upstream-downstream) acceleration, velocity and displacement record from the base of the dam and the 5% damped acceleration response spectra are shown in Figure (16a). The El Centro 1940 (N-S) response spectra is shown for comparison Figure (16b).

Figure 16a: Acceleration, Velocity and displacement at the base of Matahina Dam [19]

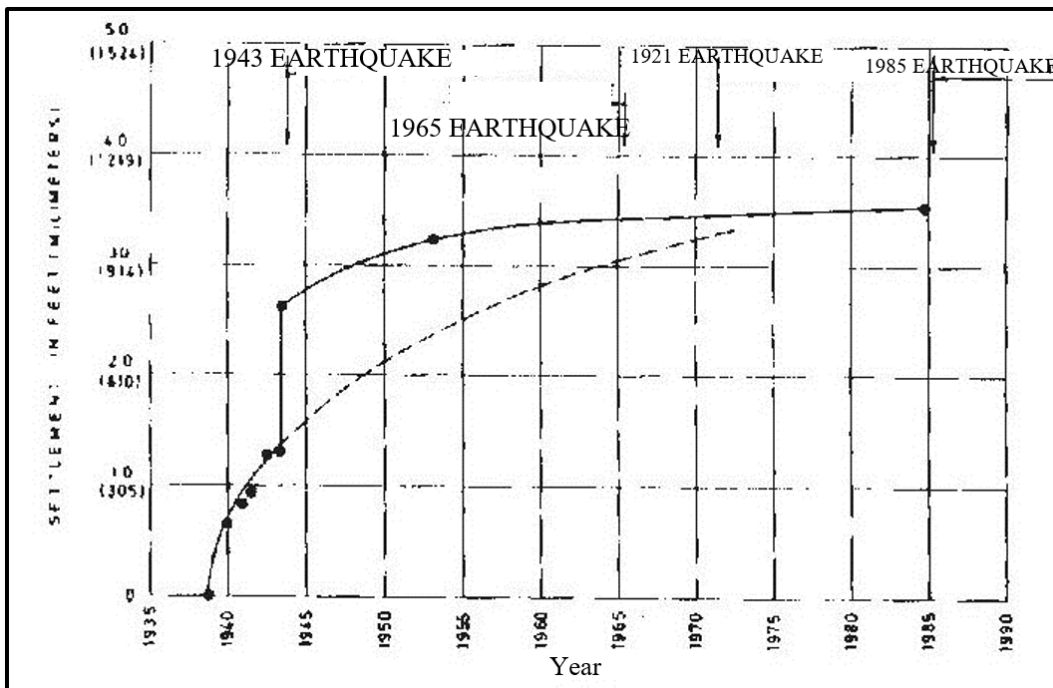
Leakage had been observed at Cogoti Dam since the reservoir's first filling in 1939. Intermittent records have been kept over the years, which indicate leakage to be directly related to the elevation of the reservoir and probably coming through the abutment or foundation, rather than the dam itself. No significant increase in dam leakage was observed as a result of the 1943 earthquake. No face cracks were caused by the earthquake. Yearly settlement and leakage data at Cogoti Dam are presented in Figures (29 and 30).

Figure 29: Crest Settlement Curve [24]

The Illapel Earthquake was centered about 95 km from Cogoti Dam. An intensity IX on the Rossi-Forel scale was reported at the dam site. The reservoir is believed to be at its normal operating level at the time of occurrence of the earthquake. The principal observed effect on Cogoti Dam was to produce an instantaneous settlement of up to 41cm. Settlement occurred throughout the length of the crest, and the extreme upper part of the concrete face slab was exposed from the downstream side, as quoted in an internal report by Empresa Nacional de Electricidad S.A., Santiago, Chile (1972). It is of interest to note that the maximum earthquake induced settlement was about equal to that observed 4.5 years at the end of construction. The point where this settlement was measured was near the center

of the crest, where the dam height is about 63 m. This was not the highest dam section, which was located close to the right abutment. The settlement at the maximum dam height was less, presumably because of a restraining effect due to the nearby presence of the very steep abutment. Minor rockslides also occurred along the downstream slope of the dam.

The dam has continued to settle after the 1943 earthquake. Interestingly, it was shaken again by three significant, although considerably more remote earthquakes: in 1965 La Ligue Earthquake, M 7.1; in 1971 Papudo-Zapallar Earthquake, M 7.5; and in 1985 Llolleo-Algarrobo Earthquake, M 7.7. These more recent events; however, were centered at distances of more than 165 km from the dam and did not induce any noticeable settlement. Yet, in 1971, even though the reservoir was empty at the time of occurrence of that earthquake, the Papudo-Zapallar Earthquake caused longitudinal cracking at the dam crest and dislodged some rocks along the downstream slope.

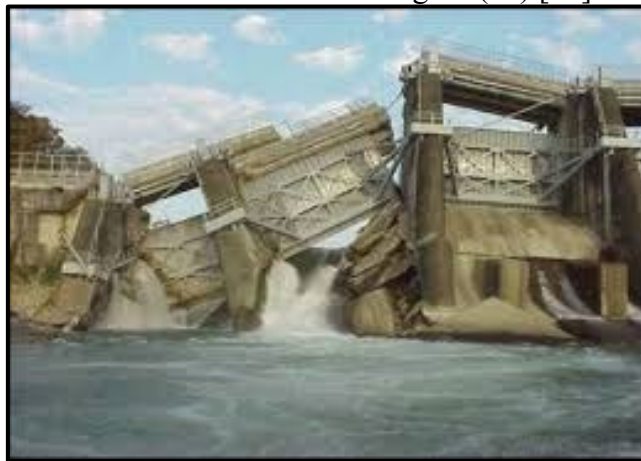
The only recorded case of concrete dam failure is the case of Shih Kang gravity Dam (Taiwan) which was completed in 1977. The dam suffered of vertical left side displacement of 36 ft, a vertical right side displacement of dam 7 ft and a diagonal offset of 23 ft. The line of fault produced by Chi- Chi Earthquake, M 7.6 Sept 21, 1999 passed exactly under the dam and peak Acceleration Recorded 0.3 miles away Horizontal 0.51 g, Vertical 0.53 g. The dam suffered of cracking along the ogee crest, along lift lines at point of changes in geometry and the dam separated from foundation. This case; however, may be considered the most extreme case due to the fact that the distance of the dam from the line of fault was zero, and the PGAs were so high, Figure (32) [27].

Figure 32: Shih Kang Dam gravity dam immediately after the Chi- Chi Earthquake on September 12th, 1999 [27].
